# QUANTIFICATION OF RAIN INDUCED ARTIFACTS ON DIGITAL SATELLITE TELEVISION RECEPTION

O. O. Obiyemi <sup>1\*</sup>, T. S. Ibiyemi <sup>2</sup>, T. H. Ogunbeku<sup>3</sup>, A. Y. Abdulrahman <sup>4</sup> and M. K. Abdulmajeed <sup>5</sup>

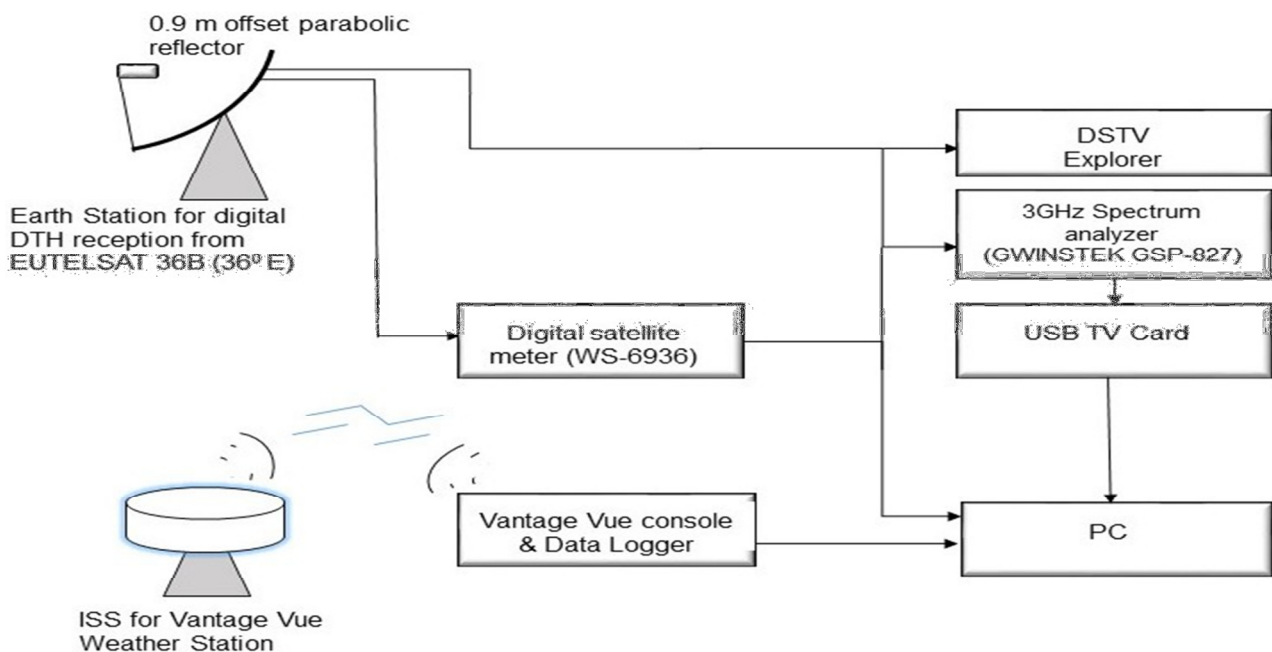
Figure 1. The block diagram of the experimental setup

The indoor unit is made up of the digital TV decoder (DSTV Explorer) - recording the digital video signals during both rainy and clear sky events, a spectrum analyzer (GWINSTEK GPS-827), the indoor console of the weather station and a central computer unit for data collection. The block diagram of the measurement setup is presented in Figure 1, while Figures 2 and 3 show the outdoor and indoor units respectively.

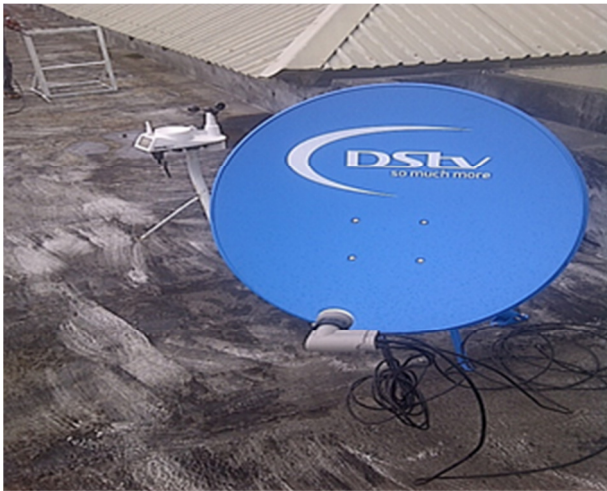
Figure 2. Outdoor unit of the measurement system

The measurement setup comprises of the outdoor and indoor units, where the digital television content is concurrently monitored with the rainfall intensity. The measurement system is installed at the Department of Electrical and Electronic Engineering and the outdoor unit of this installation is at rooftop of the College of Science, Engineering and Technology building, Osun State University (7.77°N, 4.60°E), Osogbo, Nigeria. In the outdoor unit, the Integrated Sensor Suit (ISS) of the electronic weather station (Davis Vantage Vue) is co-located with a 90 cm offset parabolic reflector, receiving digital television from Multichoice Africa via EUTELSATW4/W7 - geo-stationed at longitude 36°E for reception at 12.245 GHz. The low-noise block down converter (LNB) used is with a Noise Figure (NF) of 0.2 dB; input frequency between 10.7 and 12.75 GHz while the local oscillator frequency is 9.75/10.6 GHz.

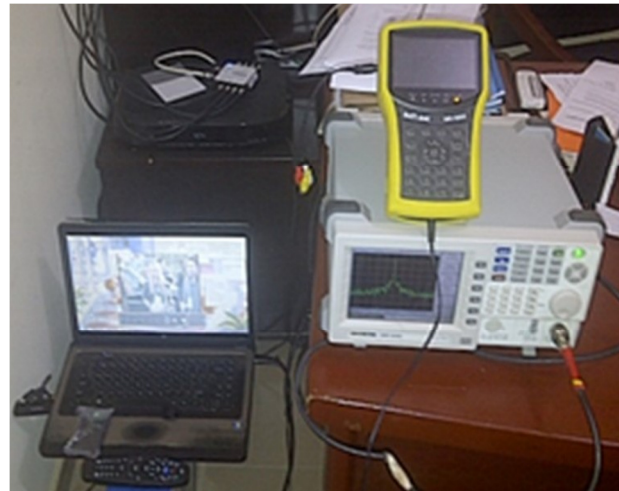
Figure 3. Indoor unit of the measurement system

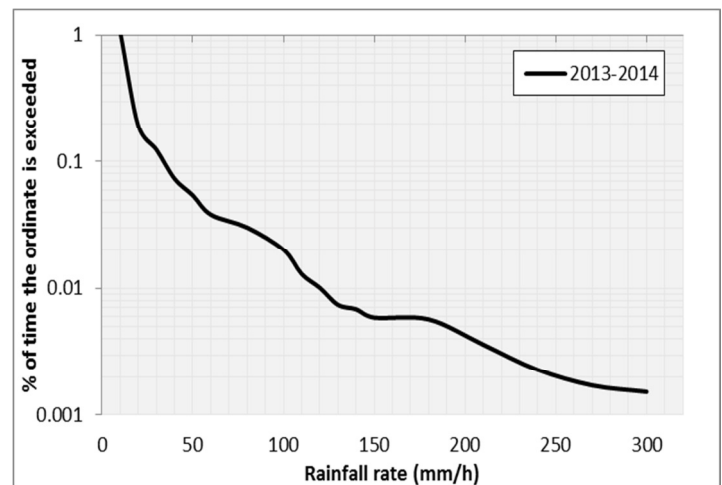
Figure 4: Cumulative Rain rate distribution for Osogbo, Osun State, Nigeria

distribution (CD) for the 17-month precipitation measurement is presented in Figure 4[16]. As shown, the rain rate exceeded at 0.01% of the time is 120 mm/h. This value agrees with predictions based on the ITU-R rainfall rate model, which confirms that Osogbo falls within the P zone of the ITU-R rain climatic zoning [17].

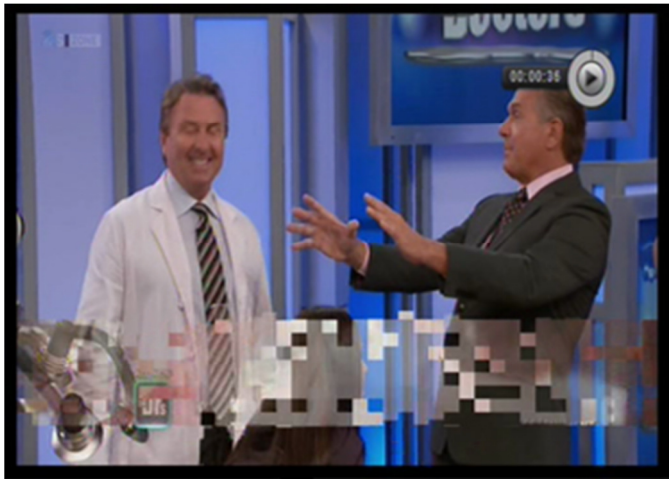
Figure 5. Recorded frame with pronounced pixelation artifact

The recorded frames are presented as still images showing the level of degradation and the corresponding artifacts. It also reveals the transition from a high definition digital imagery to complete loss of the digital content - as induced by rain. This is as shown in Figures 5 to 11. Drawing inference from the still image in Figure 5, the digital image is affected by pixelation only at the lower portion of the frame. The other portion not affected by pixelation is however

Results confirm that pixelation is present in the frames analyzed. Although mild in Figure 5 with an AP score of 0.33902, Figure 6, 7, 8, and 9 records 0.41098, 0.72536, 0.73117 and 0.98353 respectively, while Figure 10 presents a completely degraded image with an AP score of 1.

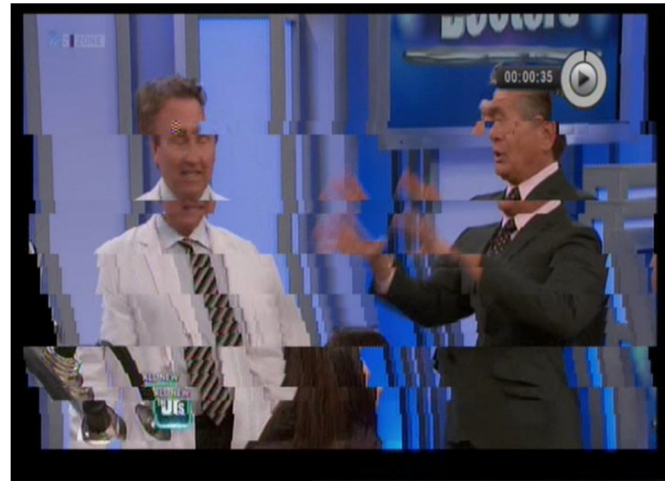
Figure 6. Recorded frame with multiple artifacts

blurred. Line-crawling artifact is also present in the still image, especially around the hands of the character at the right. Figure 6 however records more digital television artifacts. Pixelation covers more area of the frame, while line-crawling can be noticed all over the still apart from the topmost portion. Mouse-teeth artifact is also noticed around the edges of each character, although more pronounced in the left than

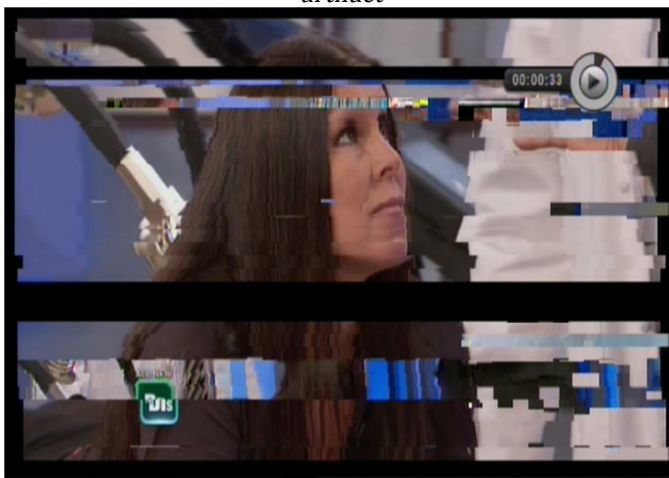
Figure 7. Recorded frame with increased artifacts

Figure 7 shows a ‘mimic’ of total signal loss with a partial image loss at the middle and upper portion of the still, while pixelation is dominant at the upper and lower sections. Although not affecting the extreme top, line-crawling artifact is also observed at the center of the frame. The degrading effect of attenuation by rain is more pronounced in the image in Figure 8. Pixelation, line-crawling and mouse-teeth artifacts are obvious in the still. Partial image loss is also spotted while the extreme top of the still is now affected by pixelation and blur, rather than blur alone. This degrading effect is worsened in Figure 9 as overlapping is still observed, while partial image loss is also noticed in larger portions of the still image. Judging from the still in Figure 10, the effects recorded in Figure 9 indicates nearness to complete signal loss. An overlapping of artifacts and blank image is observed. The signal is completely lost in Figure 11 with a blank screen during the high intensity rainfall event.

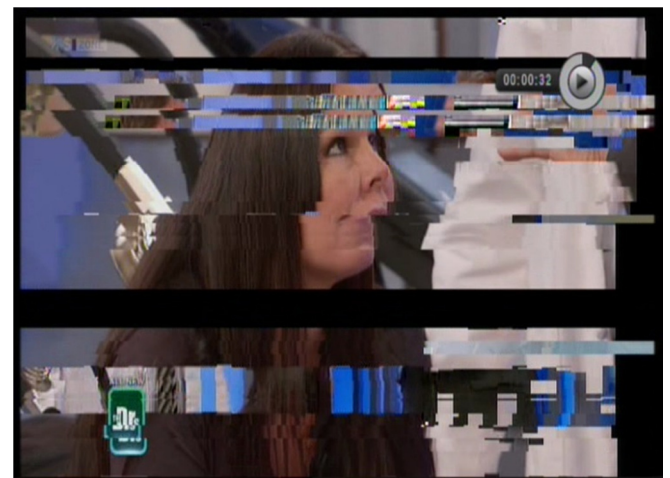
Figure 8. Recorded frame with more artifacts

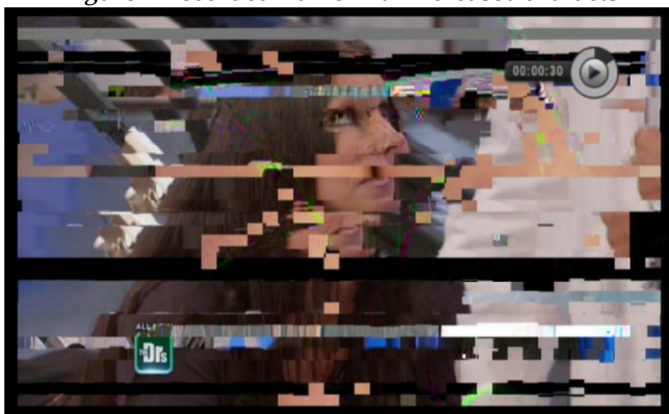
Figure 9. Recorded frame with pixelation, line-crawling, mouse-teeth, and blur artifacts

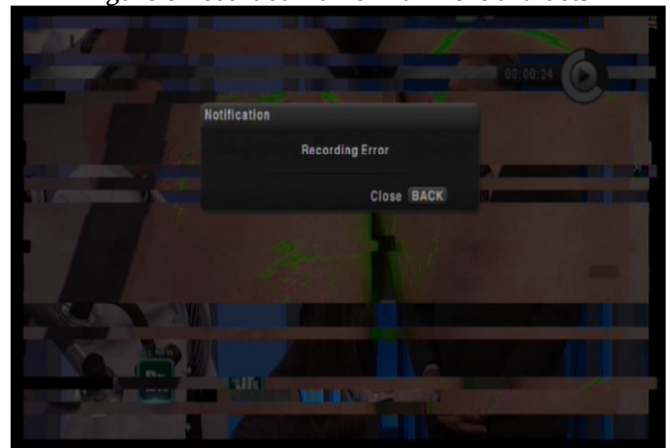
Figure 10. Recorded frame with artifact overlap

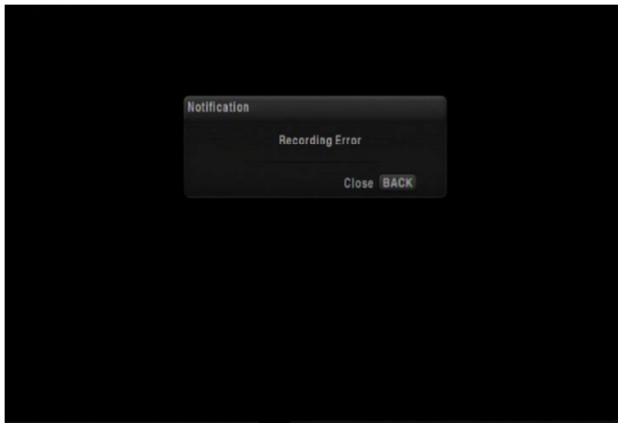
Figure 11. Recorded frame showing total signal loss to the prevailing rain event
