ASSESSMENT OF PAVEMENT CONDITION INDEX: A CASE OF FLEXIBLE ROAD PAVEMENTS ON THE UNIVERSITY OF AGRICULTURE MAKURDI CAMPUS

P. T. Adeke^{1,*}, A. A. Ato² and S. G. Orga³

^{1, 2, 3}, DEPARTMENT OF CIVIL ENGINEERING, UNIVERSITY OF AGRICULTURE MAKURDI, MAKURDI, BENUE STATE, NIGERIA

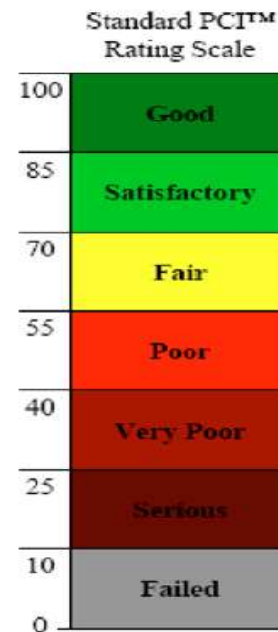
Figure 1: PCI Standard Scale [18]

of 0 to 100, where 0 and 100 represent the worst and excellent pavement conditions respectively. According to [19], PCI is one of the most widely used indexes for assessing pavement performance. Survey for PCI assessment does not examine the structural status or adequacy of the pavement structure in serviceability, but rather its physical appearance in terms of quantity and severity of defects. Figure 1 shows a standard scale established by ASTM for the classification of PCI;

This scale is used for defining the PCI of each road segment ranging from good to failed based on the quantity and severity of its defects as estimated by the preliminary procedure of pavement classification process. Pavement defects that influence the value of PCI include cracking, surface deformation, rutting, pothole, ravel, etc. The method of measuring PCI value uses a subjective approach of evaluation based on inspection and observation of the type, extent and severity of pavement surface distress. It is generally required that PCI inspection should be carried out annually on a road segment so as to ascertain periodic changes on pavement condition over time to check for the need for rehabilitation and maintenance as well as budgetary planning. PCI value is essential for assessing the serviceability, cost of rehabilitation and safety of road pavement for decision making and sustainable development [20]. PCI is assessed using standard engineering procedures stated in the American Society for Testing Materials (ASTM) manual D6433-07 published in 2007. The use of the

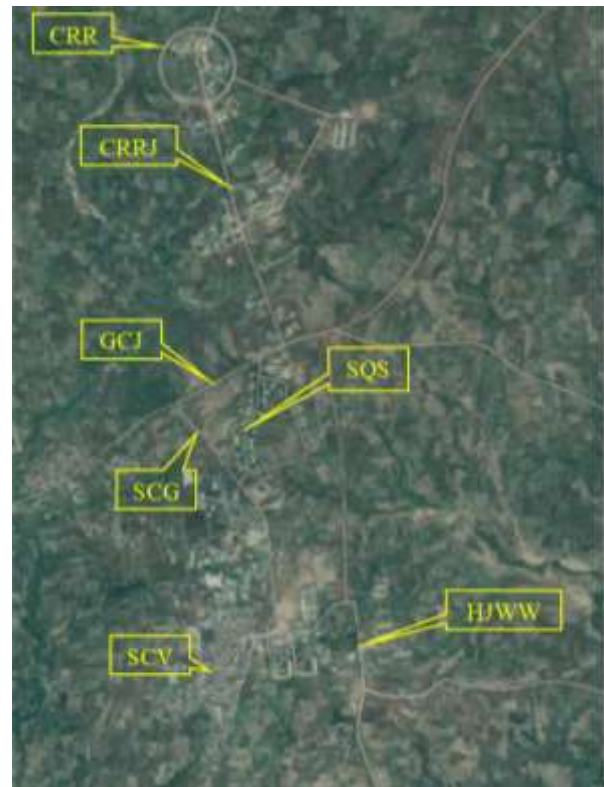
Figure 2: Layout of Road Network on the UAM Campus [21]

The University of Agriculture Makurdi is one among the three (3) basic universities of agriculture in Nigeria. The institution is situated at the northern part of Makurdi town, at its suburb with an estimated population of 21,000 students and 1,746 staff. Total length of paved roadway on the campus measures about 5.9 km and unpaved road measures about 2.7 km to serve people living and working on the campus. The paved road network on the UAM campus are made of flexible pavements only. The routes of paved roads considered by this studies included; University Entrance Gate - Clinic Junction (GCJ), Clinic Junction - Ring Road Junction (CRRJ), Ring Road (RR), South Core Bus Station – Entrance Gate Junction (SCG), South Core Bus Station - Veterinary Auditorium (SCV), Hostel Junction - Water Works (HJWW) and Staff Quarters Street (SQS). These routes have undergone series of rehabilitations and maintenance in the past. The layout of paved

road network on the UAM campus is as shown in Figure 2.
