## ASSESSMENT OF THE EFFECT OF CEMENT INDUSTRY EFFLUENT DISCHARGE ON WATER QUALITY OF NGO RIVER IN BENUE, NIGERIA

*Ngo River in Gboko, Benue State, Nigeria which serves as a source of water for domestic and agricultural purposes for the agrarian community receives effluent from Dangote Cement factory. Physicochemical analysis of the effluent outfall and water samples collected along 15 km of the river stretch were carried out in dry and wet seasons respectively. The results obtained were compared to FEPA, WHO and NESREA Standards. For effluent outfall, Temperature, TDS, pH, EC, BOD, COD, sulphate and chloride, total hardness, calcium and magnesium, were found to be within the FEPA standards, while TSS, turbidity, and nitrate, were above the standards. Along 15 km study reach, mean temperature range of 32.4°C to 29.0°C, a TSS of 224 mg/l to 218 mg/l, a turbidity of 45 NTU to 42 NTU, and DO of 1.6 mg/l to 1.2 mg/l were obtain during the dry season, while mean temperature range of 36.8°C to 36.6°C, a TSS of 255 mg/l to 252 mg/l, turbidity of 176 NTU to 168 NTU, and DO 2.8 mg/l to 2.6 mg/l were obtained during the wet seasons. These results were above WHO and NESREA temperature (25°C

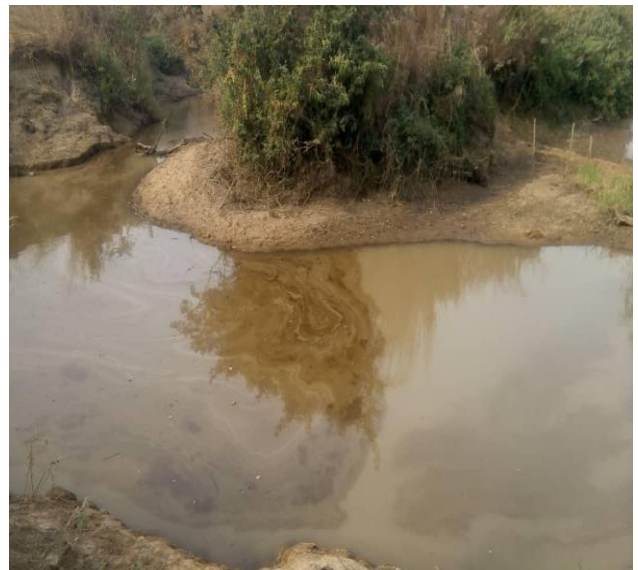
Plate 1: Effluent outfall and mixing point along Ngo River

The sampling points were located based on accessibility to site observation. Global Positioning System (GPS) was used to determine the locations and elevations of the effluent outfall mixing point and six (6) selected sampling locations along 15km of the river reach. The sampling locations were designated as 1, 2, 3, 4, 5 and 6, respectively. The geographical coordinates and the elevations of selected locations, determined by hand held Garmin GPS60 are shown in Table 1 and Figure 2. Three sampling points of 5 m apart were marked out at each of the six (6) sampling location for water samples analysis.

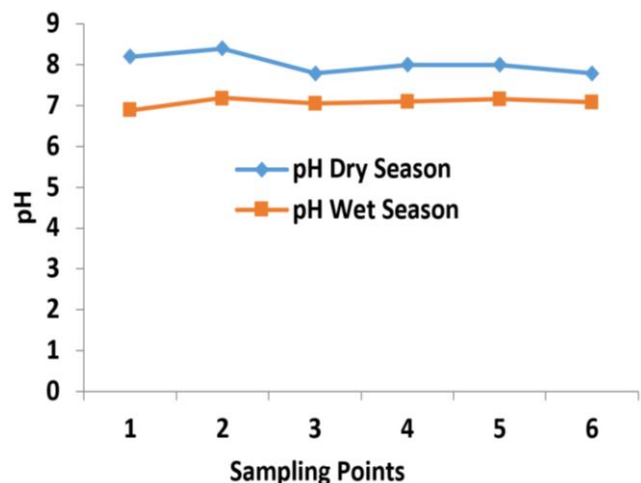
Figure 4: Variation in pH

The water quality of Ngo River was observed to have varied with the sampling periods and locations along the river stretch. Results of some of the physicochemical analysis are represented graphically in Figure 2 – 9. The observed seasonal variation agreed with [8] study on Onyi River. The variation observed in wet season can be attributed to the non-point sources of pollution from runoff that washed pollutant from the adjacent land within the catchment area into the river channel.

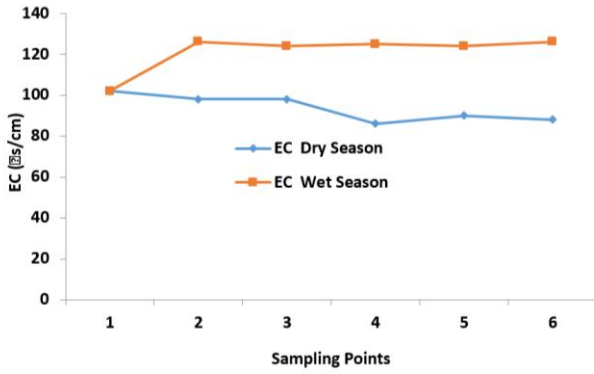
Figure 5: Variation in EC (µs/cm).

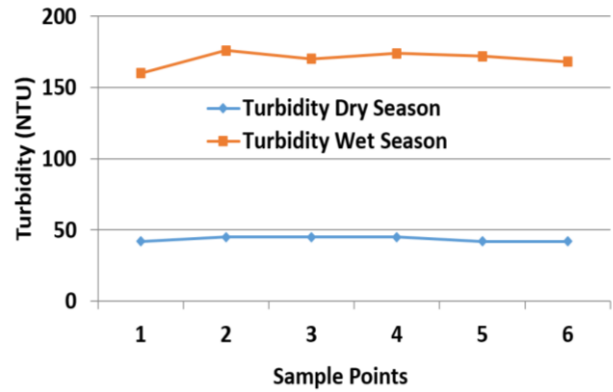
Figure 9: Variation in Turbidity (NTU)

permeability in the use of the water for irrigation, may not be ruled out. Turbidity mean range of 45 NTU to 42 NTU (dry season) and 176 NTU to 168 NTU (wet season), observed along the river stretch may also affect the fishery and water supply use of the Ngo River as it was above the 5 NTU recommended standards. The obtained results were also observed to be better than [10] study on the river a decade ago. Further, a good water body has DO of more than 5mg/l to 7.5mg/l [12 and 14], however the results of the analysis showed the river DO of 1.6 mg/l to 1.2 mg/l and 2.8 mg/l to 2.6 mg/l for both season, will affect the growth of aquatic plants and other organisms, and other uses of the river.

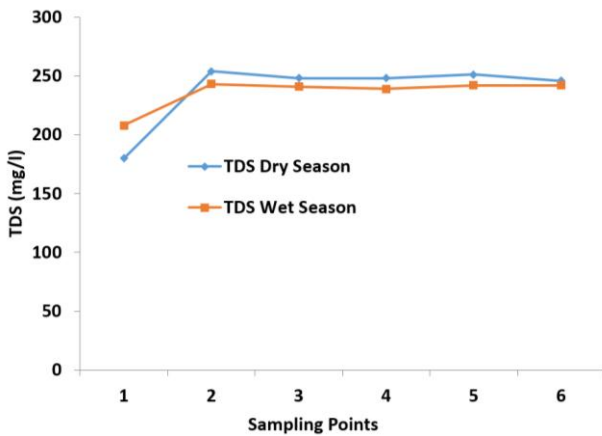
Figure 6: Variation in TDS (mg/l).
