Modelling the Deformation of Steel-bars in Reinforced Concrete Beams Submerged in Lagoon

ABSTRACT: Corrosion of steel and spalling of concrete in reinforced concrete elements have become a common occurrence in structures that are built around marine environment. This research investigated the effect of chloride on the steel in reinforced concrete beams. Mechanical tests such as; compressive, flexural and bond strengths were done on replicate concrete elements which were cast and buried for a maximum of one year in the Lagos lagoon. Twenty-four number of 150 mm x 150 mm x 600 mm sized reinforced concrete beams were cast for the flexural strength test, while forty-eight concrete cubes were cast for both compressive and bond strength tests, samples were cured in both lagoon and fresh water (The fresh water is for the control). A finite element program, ANSYS was used to model the deformation (deflection) of the steel reinforcement in the beams. Results showed a general reduction in compressive, flexural and bond strengths for the concrete samples buried in the lagoon, while those buried in freshwater showed an increase in strength as the concrete ages. The modelled results of the rei

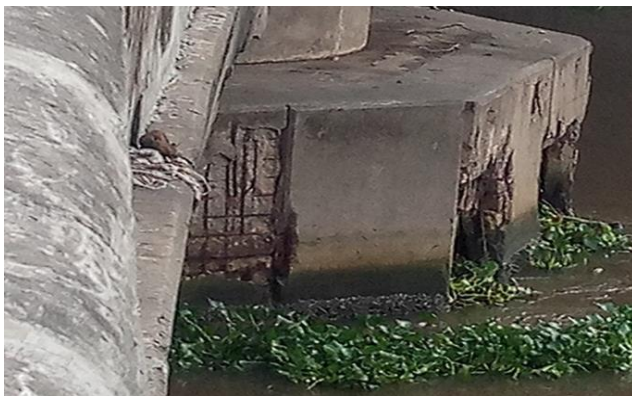
Figure 1: Corroded Reinforcement in Concrete.

neutral axis, the colour of the lagoon water was cloudy yellow, while that of freshwater was colourless, the freshwater was odourless while the lagoon water had an unpleasant sharp smell. The chloride in fresh water was very low and cannot significantly cause corrosion in steel when compared to lagoon water. It should be noted that the water samples were tested at the end of the curing days. The table showed that there is a very high concentration of chloride in the lagoon water, and the ion is known to attack iron rod in reinforced concrete structures. This must have been responsible for the deterioration observed in Figures. 1 and 2 above.

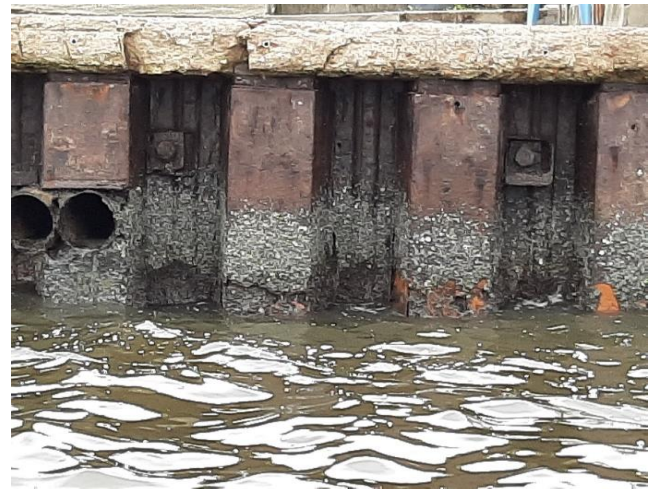
Figure 2: Corroded Sheet pile on the lagoon.

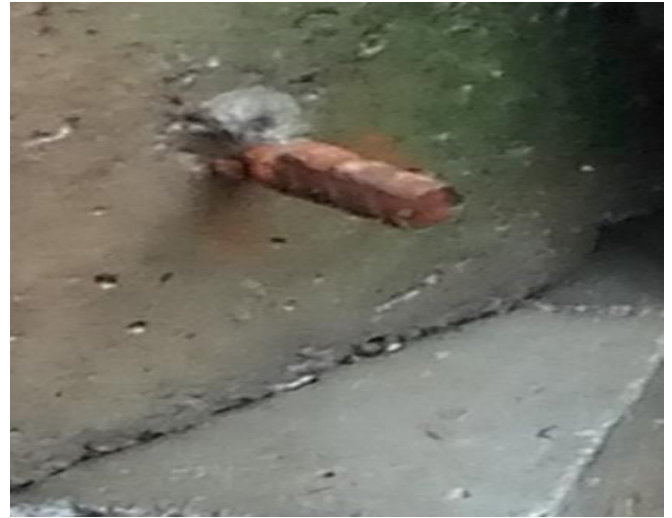
Figure 3: BL₄₀ at 28 days curing.

Figures 3 and 4 showed the cubes used for the bond test at 28 and 365 days for samples buried in lagoon water, while Figures 5 and 6 showed the samples cured in freshwater at 28

and 365 days. The rust on the samples cured in lagoon water is very conspicuous when compared to the samples cured in freshwater.

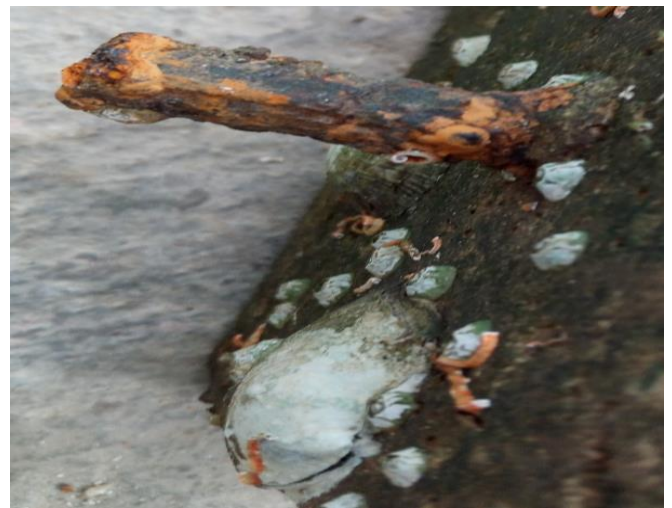
Figure 4: BL₄₀ at 365 days curing.

The general increment in bond strength of BF₄₀ overtime further confirmed the report of Falade and Oyekan (2006) “that the bond strength of reinforced concrete structural elements depended on the bond between concrete and reinforcement to ensure effective transfer of stress from steel reinforcement to the surrounding concrete and that the bond was usually high at later age because the compressive strength of concrete and the grip effect on reinforcement increased with age”. This however did not apply to the sample buried in the lagoon, due to chloride attack on the steel reinforcement, as showed in Figure 4.

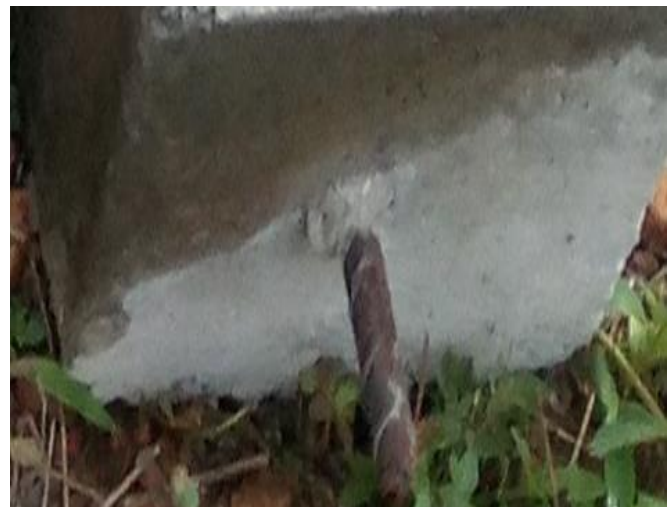
Figure 5: BF₄₀ at 28 days curing.

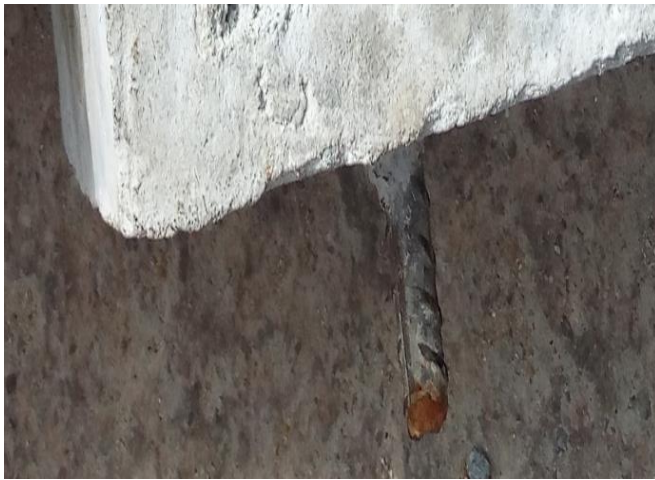
Figure 6: BF₄₀ at 365 days curing.

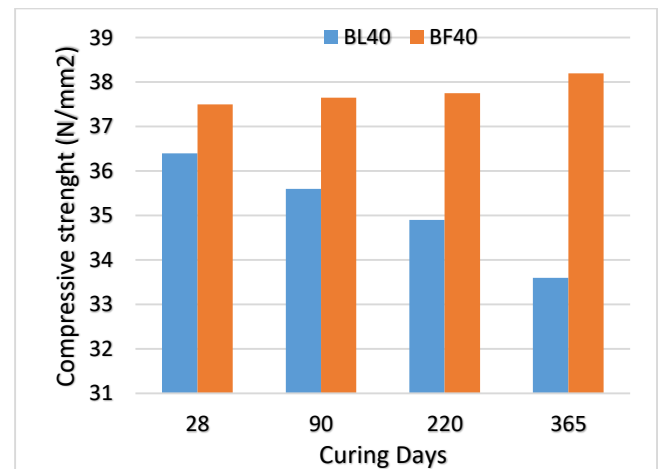
Figure 7: Compressive strength of cubes.

The compressive strength of the two specimens clearly showed that there was a gradual reduction in strength for BL₄₀ and an increment in strength for BF₄₀ throughout the curing period. The rate of increment in strength between 28 to 365 days in BF₄₀ was 1.83%, while BL₄₀ experienced a reduction in strength by 7.69% during the same period. The optimum values for 28, 90, 220 and 365 days was attained in BF₄₀. Compressive strength of concrete was highly affected by the sulphate attack in sample BL₄₀. This result is a confirmation of the concrete spalling shown in Figures 1 and 2, of some of the bridge elements on the same Lagos lagoon.

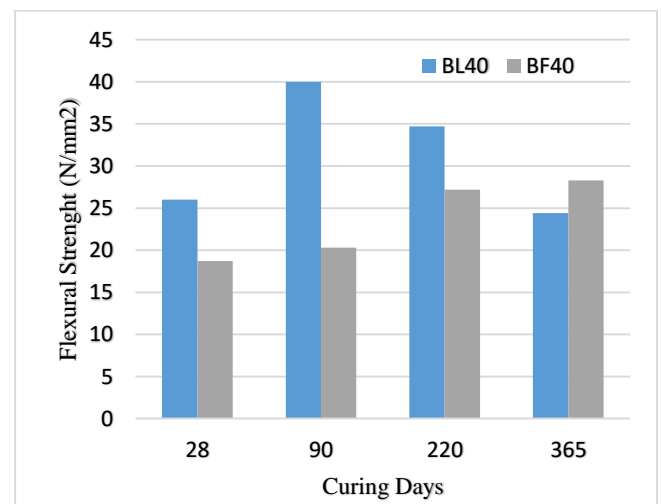
Figure 8: Flexural strength of beams.

The flexural strength of BL₄₀ in the first 90 days had the optimum average flexural strength in all curing environments. This was due to the chemical reaction between the lagoon water and the Ettringite, Ca(OH)₂, and C–S–H gel which was actively generated from an early age of the beam structures which included the steel rod buried in the lagoon. However, this reaction took a reversal after the 90th day with a gradual reduction in strength. At this stage, the negative effect of sulphate salts on the concretes and chloride on the steel reinforcement caused the reduction in strength. The freshwater cured beams gradually increased in strength from the 28 to the 365 days, leading to the optimum strength after curing for one year in BF₄₀ with a flexural strength of 28.3 N/mm² compared to BL₄₀ with flexural strength value of 24.4 N/mm² during the same period. Fig.8 showed the result of the flexural test carried out on the beams.

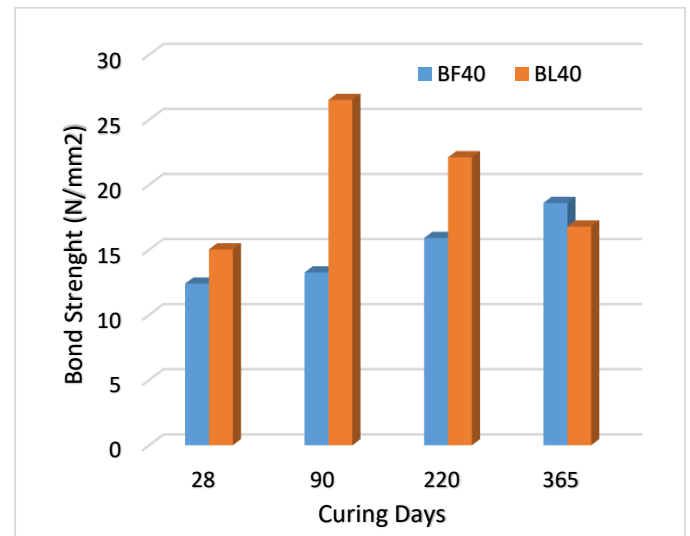
Figure 9: The bond strength result.

The pull-out test results for the determination of bond strength in reinforced concrete structures is shown in Fig. 9, while the slipping distance of steel rod from concrete is shown in Fig.10. The bond strength results generally showed that BF₄₀ had increased bond strength at the rate of 46.3% between 28 to 365 days with the peak strength at 18.60 N/mm². The BL₄₀ sample, however, behaved differently, the bond strength peaked at 90 days with a value of 26.52 N/mm² but took a downturn to 16.79 N/mm² at the end of 365 days. The bond strength results of the sample cured in lagoon water (BL₄₀) is in agreement with the findings of Demis *et al.*, (2010), Apostolopoulos (2012), Igba *et al.*, (2019). Wherein both cases the bond strength increased with increase in corrosion level at the initial stage of curing and later decreased as the concrete ages. The initial increase in bond strength was due to the increased roughness of the steel-concrete interface caused by the growth of the expansive rust. The reduction in bond strength over a long period can be attributed to the reduction in cross-sectional area of steel and the loss of adhesive properties of the steel surface due to rust.

The reverse in bond strength can be linked to the negative effect of chloride that ingresses into the concrete and attacks the steel reinforcement, whereby allowing corrosion to set in and encouraged the eventual reduction in the bond strength and increased slipping distance between concrete and steel. The slipping distance of both concrete specimens increases as the curing days increased, but the samples buried in the lagoon generally had higher slip than the sample in freshwater, the optimum slip was observed on the 365th day for both BF₄₀ and BL₄₀ at 11.5 mm and 14.5 mm respectively.

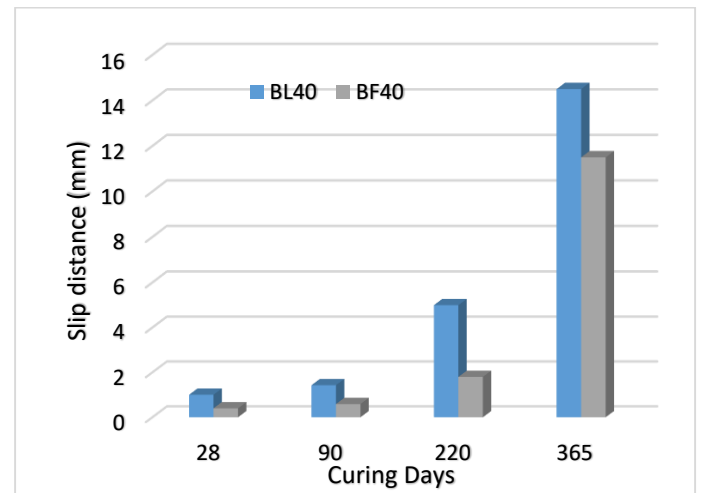
Figure 10. Slipped distance of steel rod.

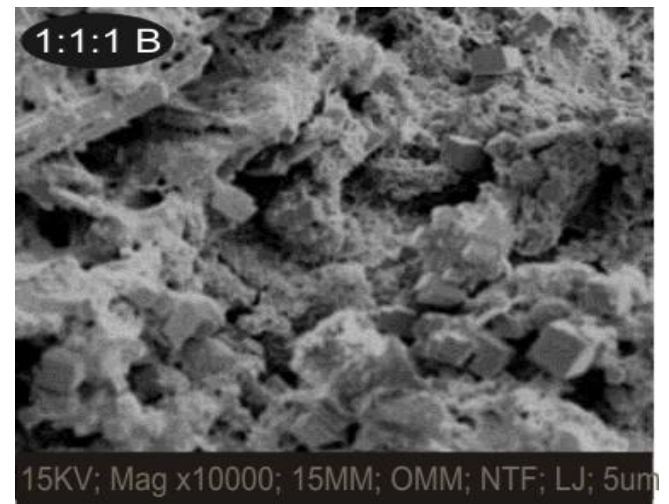
Figure 11. SEM Images of BL₄₀ at 28 days.

The purpose of this test is to determine the microstructural properties of each concrete samples at the end of the curing days. The SEM analysis results revealed the microstructural properties of each sample at 28, 90, 220 and 365 days. There were many portions of small hydration crystals and large holes in BL₄₀ samples as seen in Figs. 11-17. The main reason was due to the small number of hydration crystals and their uneven distribution in the cement matrix, resulting in the production of many large pores and a decrease in the strength when compared to samples buried in freshwater.

Activities of Ettringite, Ca(OH)₂, and C-S-H gel were actively generated in the early age of BL₄₀ and the amounts of these materials generated were confirmed to increase with time. It was believed that the full submergence of these samples buried in the lagoon water ended up creating microstructures with more defects, as lots of more pronounced micropores were noticed in BL₄₀ on the 365th-day sample.

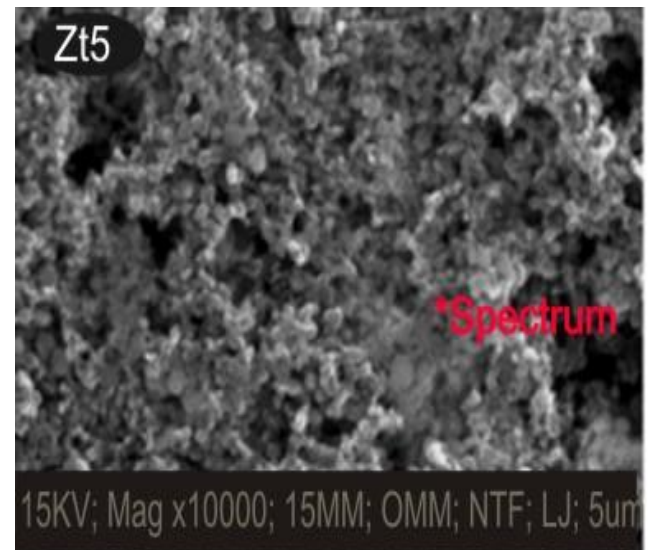
Figure 12. SEM images of BF₄₀ at 28 days.

The BF₄₀ samples showed the microstructures of the un-corroded concrete samples, there were lots of fibrous and flocculent hydrated calcium silicate, but no obvious corrosion products or micro-damage was observed in the figures as no external sulphate ions entered into the concrete.

There were smaller holes in BF₄₀ concrete samples as seen in the figures, which must have led to a general increase in strength (compressive, flexural and bond). The main microstructure features identifiable from their typical morphology were as follows: ettringite needles, calcium silicate hydrates (C-S-H), and tricalcium aluminate monosulphate hydrates (AFm) mainly seen in BL₄₀.

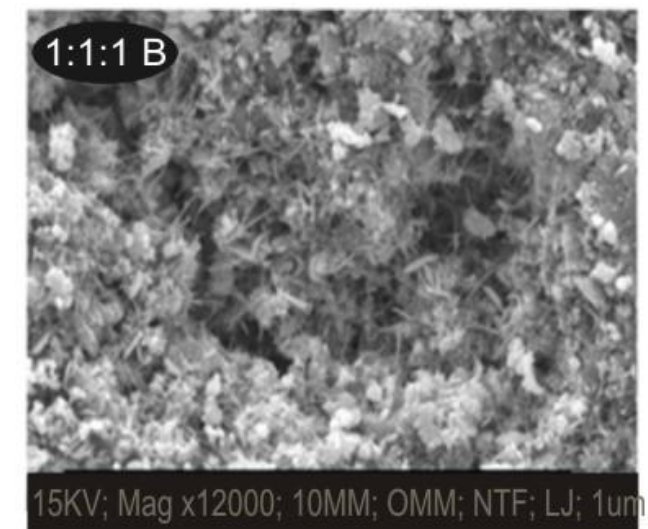
Figure 13. SEM images of BL₄₀ at 90 days.

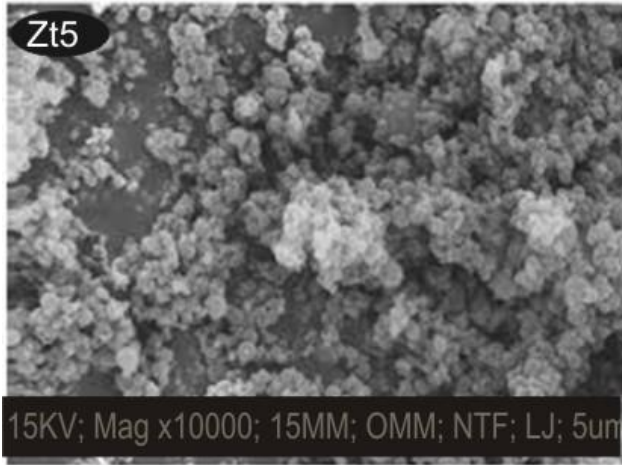
Figure 14: SEM images of BF₄₀ at 90 days.

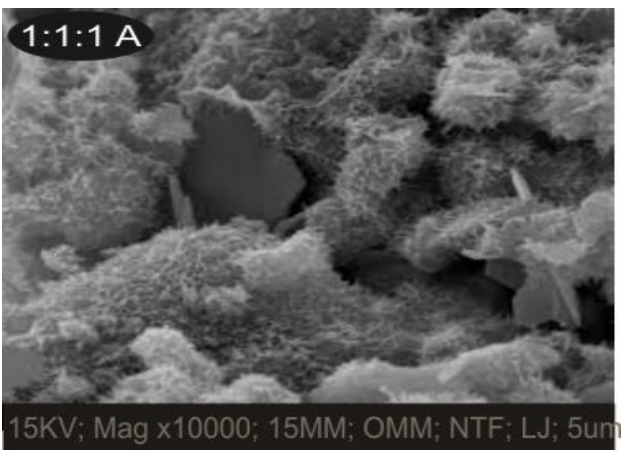
Figure 15. SEM images, of BL₄₀ at 220 days.

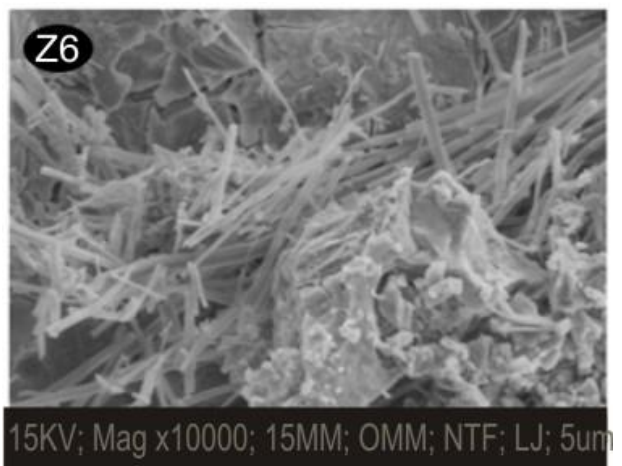
Figure 16: SEM images of BF₄₀ at 220 days.

In BF₄₀ at 220 days, (Fig.16) the microstructure indicated that the cement hydration reaction was nearly complete and produced many needle-like and sheet-like crystals. The microstructure of BF₄₀ was composed of reticular amorphous and needle-like C-S-H phase where calcium hydroxide crystals were locally embedded. The BF₄₀ had a microstructure with fewer defects which in turn increased the generation of components such as hydrated calcium silicates (C-S-H) crystals, elements that improved the composite mechanical properties.

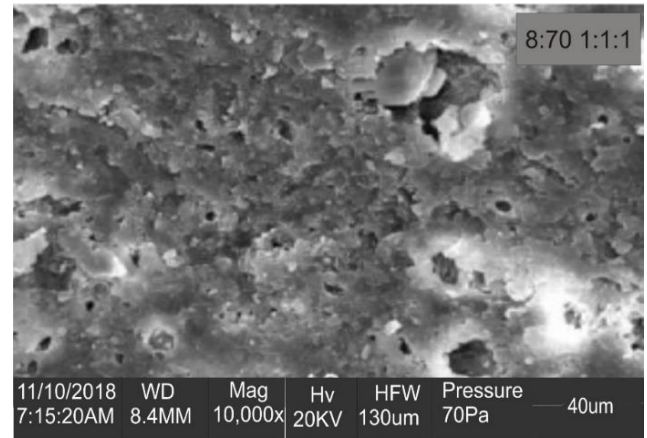
Figure 17: SEM images (g) BL₄₀ at 365 days.

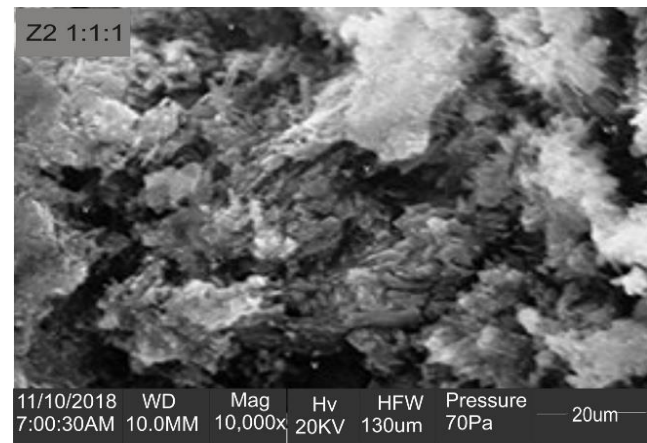
Figure 15: SEM images of BF₄₀ at 365 days.

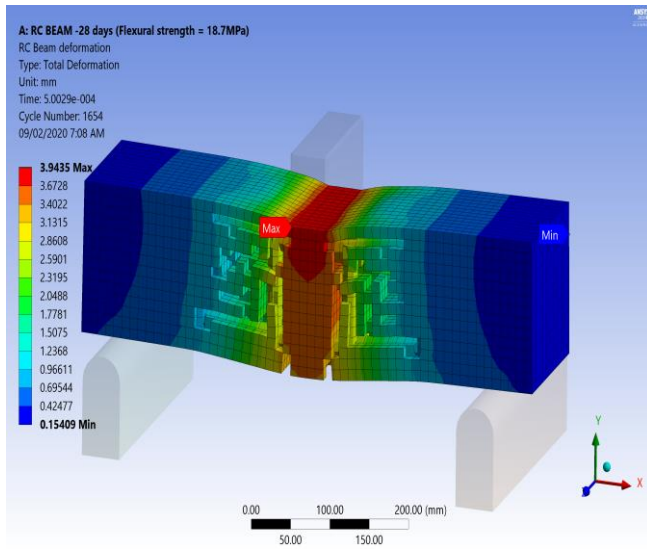
Figure 18: BF₄₀ 28 days beam deformation.

flexural resistance of the steel bar in concrete. The results from Figs. 18 – 25 showed a very interesting trend, these results are summarised in Table 2.

The results showed that the deformation of BF₄₀ samples for both days was generally lower than BL₄₀. Also, the values decreased as the curing age for BF₄₀ increased while that of the BL₄₀ samples increased as the curing age increases. This observation can be linked to the effect of sulphate attack on concrete and chloride attack on the rebar in the samples buried in the lagoon water. The weak concrete flexural and bonding strengths allowed more tensile stresses to act on the reinforcements, which allowed the large deflections experienced in the steel rod of the samples buried in the lagoon water. The deformation in the steel samples buried in freshwater was low and keep on reducing as the age increases because of the increased in concrete strength of this sample since there was a very small amount of chloride and sulphate ions that would have acted as impurities and attack the reinforced concrete beams.

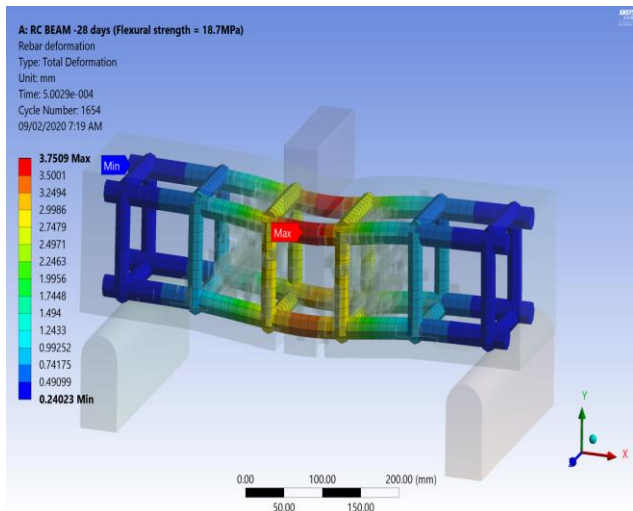
Figure 19: BF₄₀ 28 days rebar deformation.

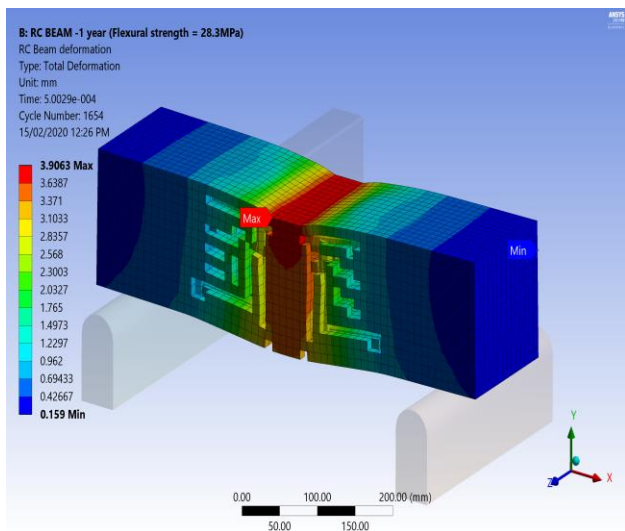
Figure 20: BF₄₀ 365 days beam deformation.

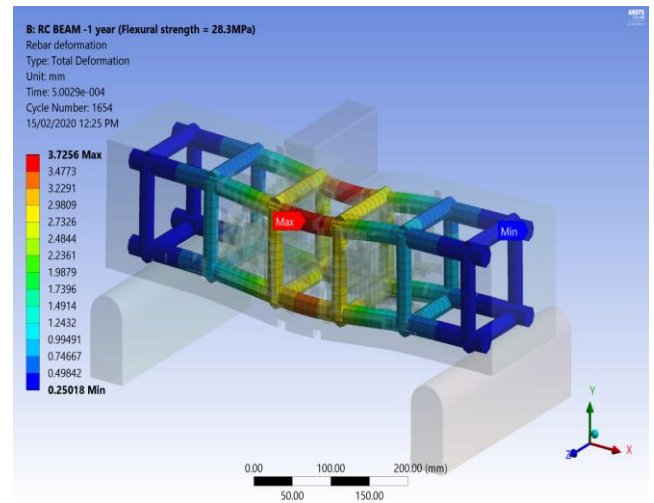
Figure 21: BF₄₀ 365 days rebar deformation.

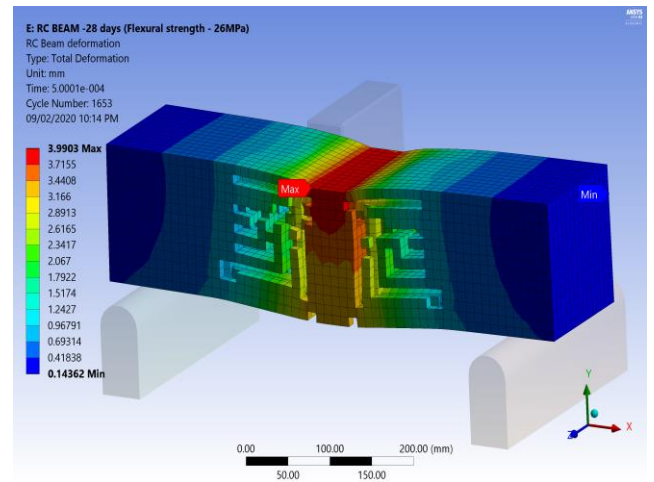
Figure 22: BL₄₀ 28 days beam deformation.

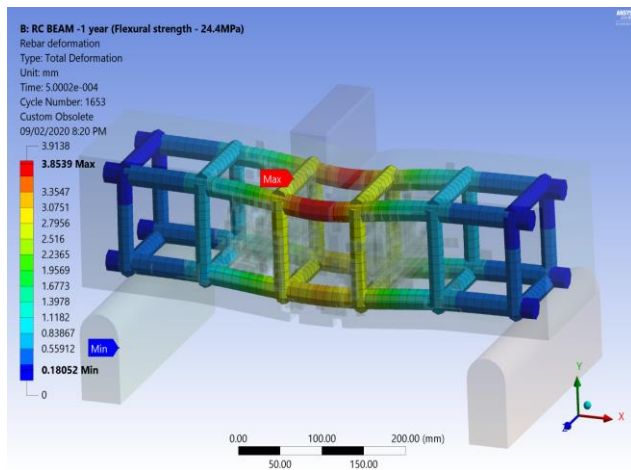
Figure 24: BL₄₀ 365 days beam deformation.

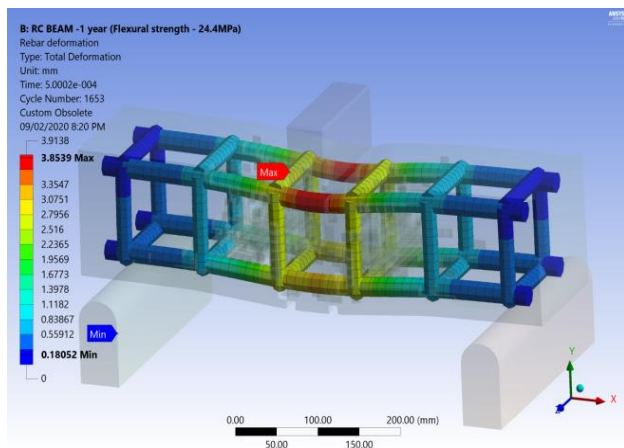
Figure 25: BL₄₀ 365 days rebar deformation.

The one-year deformation rate of steel rod in beams buried in the chloride infested lagoon is estimated to be ($r = 0.0181$ or 1.81%). Based on equation 5, the past and future deformation values can be obtained. The estimate for the deformation of the steel in ten years from the present will be 4.52 mm, while the value in ten years ago is estimated to be 3.15 mm. Most of the concrete structures on the Lagos lagoon have an average age of 40 years, going by the current values, the deformation of the rebar in forty years ago can be
