Images in clinical medicine

Sonde de Dormia enclavée dans le cholédoque: une complication peu connue

Dormia catheter trapped in the bile duct: an unknown complication

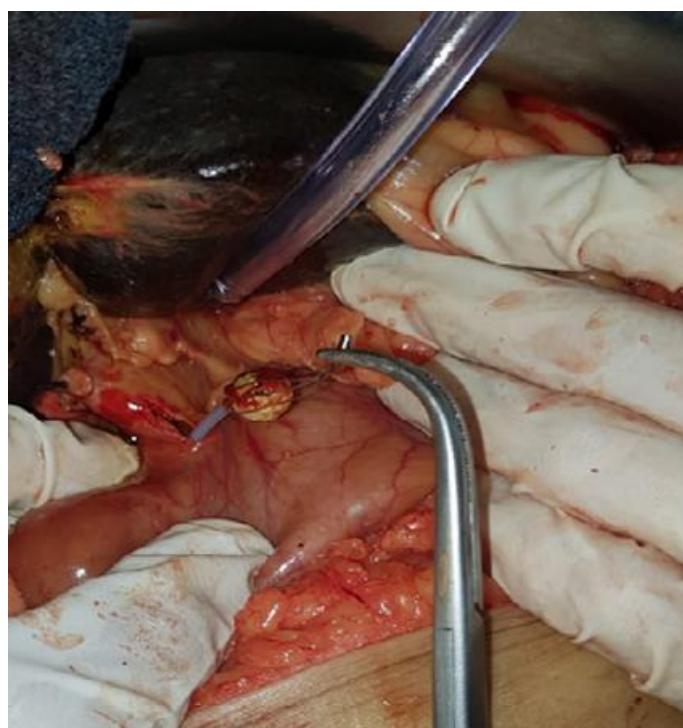
Figure 1: la sonde de Dormia, restée enclavée dans le choledoque

include bile duct injuries, which are a well-known surgical problem. Injuries specifically related to the use of catheter have been less reported and seem to be underestimated. We here display an image showing Dormia catheter trapped in the bile duct around a fixed stone which couldn't be removed after endoscopic exploration in a 60-year-old patient with cholangitis caused by lithiasis. Choledochotomy for removal of stone was performed.

de Dormia. Plusieurs facteurs de risques d'échec d'extraction d'un calcul de la voie biliaire principale sont connus. Le facteur probablement le plus important est la taille du calcul supérieur à 15 mm ou lorsque le diamètre du bas de la VBP est inférieur à celui du calcul où il faut veiller à ne pas impacter le calcul dans le sphincter d'Oddi ou dans la Dormia afin de ne pas compromettre la suite de l'extraction. Parmi les complications liées à l'utilisation de la sonde de Dormia, les plaies biliaires, constituent un problème bien connu des chirurgiens, mais les lésions spécifiquement liées à l'utilisation de la sonde sont moins et paraissent sous-estimées. Nous rapportons une image où la sonde de Dormia est restée enclavée dans le choledoque autour d'un calcul qui est resté lui-même fixé sans possibilité de la retirer après exploration endoscopique chez un patient de 60 ans en angiocholite lithiasique nous obligeant à faire une extraction chirurgicale par choledocotomie.
