## **Stereotypic Behavior and Stable Accident in a 17-year-old Decrepit Part – Arab Stallion**

This case describes a stable accident in a 17-year-old part-Arab albino stallion kept in a stall constructed about 30 years ago. Abnormal behaviors like, wood chewing, cribbing and coprophagy were observed and these could be as a result of a distorted gastrointestinal system pH. The body score of the horse was 2. The stallion was found dead with the head trapped in a hay rack. Postmortem result revealed a greenish frothy exudate in the trachea, congested lungs and watery blood. This paper looks into a possible association of abnormal behavioral events in a horse with an increased risk to stable accident in a 30 years old horse facility.

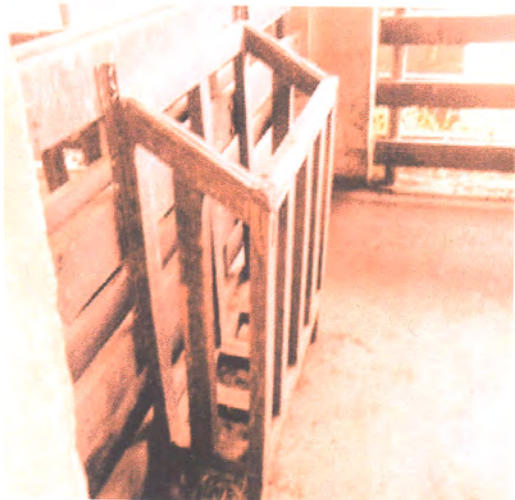
A 17 year old decrepit stallion weighing 213 kg kept in a stall that had a dimension of 2.74/2.74 m made up of concrete, metal and board that was constructed about 30 years ago. The door to the stable was made of a single swing metal door which opened into Isle workplace. The heavy duty hinges had already given way, and the door sagged. The door is 0.96 m high above the ground and 1.31 m wide. The door latches and clasps were at the reach of the horse. The hayrack dimensions were 0.76 m by 0.30 m foot with a height of 0.76 m from the concrete floor (Fig. 1).

**Fig. 1.** Hayrack

Though the hay rack design and dimensions conformed to the conventional hayrack for horses, however in this case there seems to be a high risk of accidents compared with those fixed above the ground. Hay racks, hay nets, hay bags can keep forages off the ground which is more advantageous than the ones fixed to the ground. In order to reduce the risk of head trapping, the bottom of hay rack, net or bag should be at the wither height for the horses and it should not be too high so as to prevent dust from falling into the horses eyes and nostrils and not too low in order to prevent the horse from been entangled.

Stall partitions should be about 8 feet high and be flush with the stall sub-floor to prevent hooves from getting caught underneath. Boards can be spaced up to 1½ inches apart to enhance air movement between stalls while discouraging encounters between stall occupants. With spaced boards, use vertical center bracing to stabilize the 12-foot-long wall and prevent the boards from breaking if kicked. Horizontal wood edges are vulnerable to being chewed by horses unless capped with metal. Stall walls do not have to be solid all the way to the top. An open panel design at the top allows for better ventilation and easy observation of the horse. It also allows horses to see their companions and other barn activities to decrease boredom and vices. An open panel partition has solid materials along the bottom 48 - 60 inches with an open panel on top. Bars of ¾ to 1-inch diameter pipe are equivalent (Wheeler and Zajockowski, 2002).

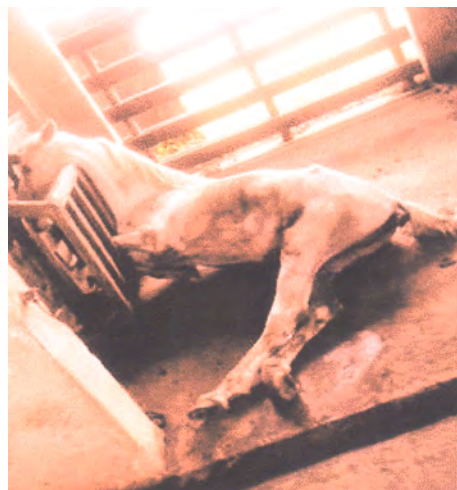
August 20<sup>th</sup> at about 8:00 am the horse was found dead with its head trapped within the hay rack (Figs. 2 and 3). There was evidence of struggling seen inside the stable, before death. The knee was trapped within the horizontal wooden boards of the hay rack and the partition of the stable. The horse's body score was 2.

**Fig. 2.** Head and forelimbs trapped in hayrack

The space between the wooden board, measuring 8" to 9" was wide enough to allow the muzzle of a horse to access the neighboring stable and within the hay rack, also the space within the wooden board gave way for the muzzle of the horse leading to the ramus of the mandible anchoring the whole weight of the horse on the horizontal wooden board of the hay rack thereby leading to asphyxiation.

The partition design could have been another possible risk factor complementing the behavioral event that lead to the head been trapped. The horse stable partition design also poses a great risk for the horse in this situation the features include a board made up of thick timber wood with a vertical bracing to stabilize the 5 feet high partition. The space between horizontal boards which is 8" is wide enough to allow the hoof get stocked when the horse kicks which may result into fracture and injury to the lower limbs.

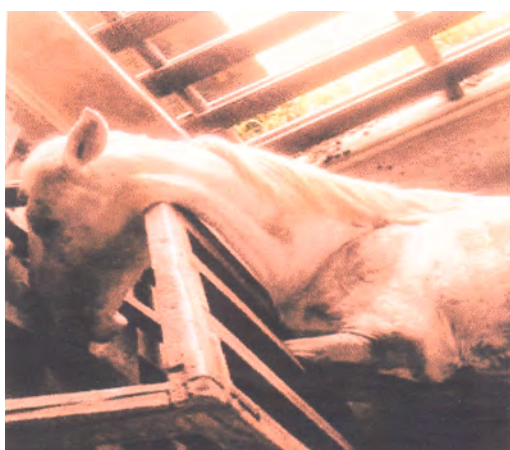
The post mortem results revealed a greenish frothy exudate in the trachea, congested lungs, and characteristic watery blood diagnostic for asphyxia.

**Fig. 3.** A closer view of the head and forelimbs trapped which resulted in asphyxiation
