## **Experimental characterization of friction wear and mechanical behavior of train wagon brake shoes made of carbon/carbon (C/C) composite material with an organic matrix**

Issam Benbrinis<sup>\*1</sup> & Bachir Redjel<sup>2</sup>

<sup>1</sup>Mechanical Engineering Department, University of Badji Mokhtar, Po Box 12, Annaba, 23000, Algeria

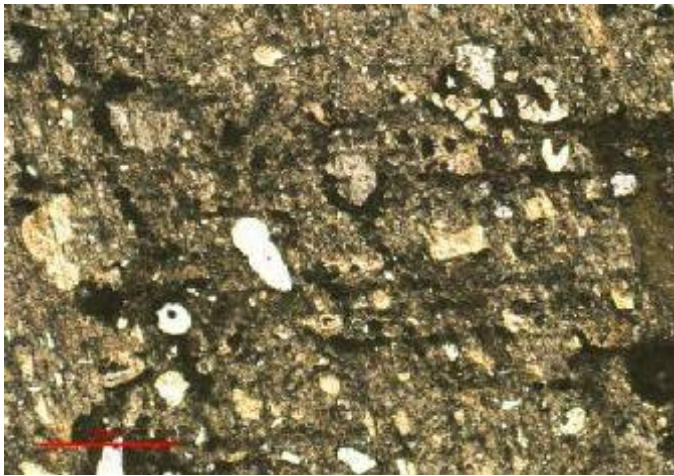
Figure 1: Example of microstructure of the C / C composite

The brake shoe product used by SNTF is a carbon / carbon composite material referred to as "C/C". It consists of a solid carbon matrix reinforced by fibers that are carbon itself. Complementarity and the combination of qualities of the two components that are the fibers and the matrix should give the overall material an interesting mechanical thermal and tribological performance [18]. Figure 1 shows a micrograph of the structure of the C/C carbon-carbon composite. A large number of filaments are grouped within the structure to distribute the local micro defects that may exist within the filament and subsequently obtain a basic wire diameter sufficient for quick handling.

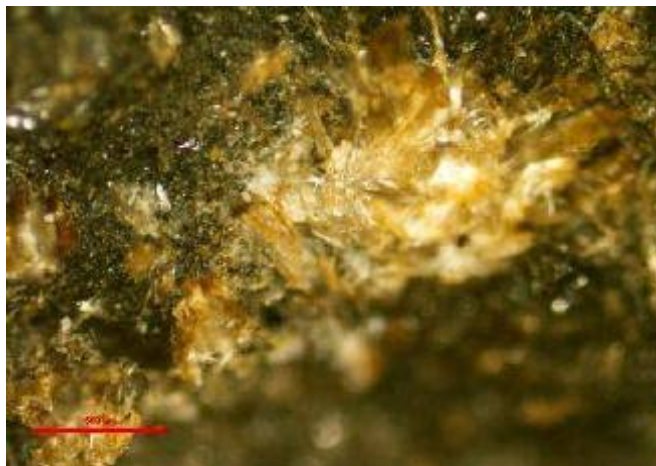
Figure 2: Microscopic view of the composite structure "Before rupture (500  $\mu\text{m}$ )"

The micrographs of figure 2 and figure 3 show respectively microscopic views of the structure of the material.

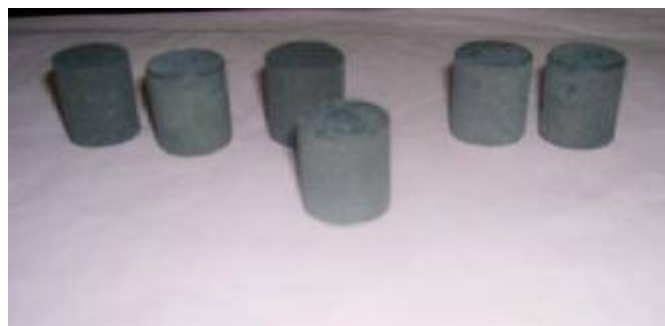
Figure 4: samples used for the measure of the hardness

The test pieces for the Rockwell hardness tests are first prepared by cutting cylindrical samples of 25 mm in height and 20 mm in diameter of the packing at the specified location on the sole of the brake (Fig. 4). They undergo thereafter machining of the back until the disappearance of the entire iron sheet and supports until obtaining a smooth surface parallel to the upper braking surface.

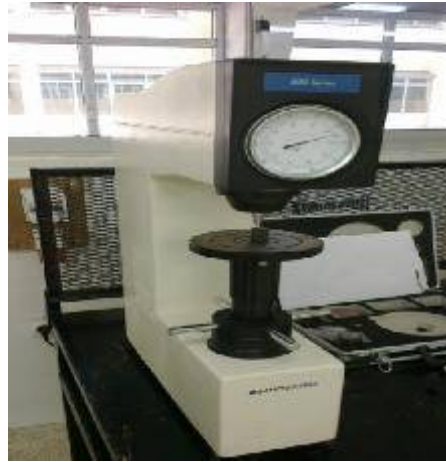
Figure 5: Apparatus used for the classic measure of the hardness

The Rockwell hardness test is performed conventionally in accordance with ASTM Method D 785-65 on an apparatus intended for this use (Fig. 5).

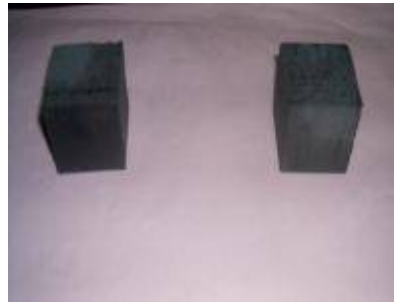
Figure 6: cubic samples used for the compressive characterization tests

The specimens for compressive characterization of the material were removed from the shoes are then packaged immediately preceding the test for three days at a temperature of  $23 \pm 2$  ° C and a relative humidity of  $50 \pm 5\%$ . Two types of tests were used : cubic pieces of  $40 \times 40 \times 40$  mm<sup>3</sup> (Fig. 6 ) and cylindrical samples of 25 mm in height and 20 mm in diameter conform to normative requirements EN 12350-1, EN 12390-1, EN 12390 -2 and EN 12504-. The diameter and height of the samples are measured with an accuracy of 10 µm.

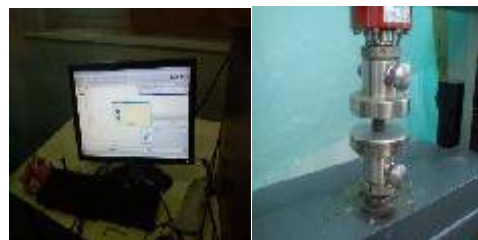
Figure 7: Compressive test device in cylinder sample tests

The specimens were subjected to the crushing test according to ASTM D695 standard with a compression press with a digital display for the cubic samples. The loading speed is slow and constant and is of the order of  $1500 \text{ KN.s}^{-1}$ . The tests on cylinders are carried out on an universal machine of type Zwick Roell Z 20 at a travel speed of the crossbar of 5mm/min (Fig.7). The tests are conducted until the samples are completely broken.

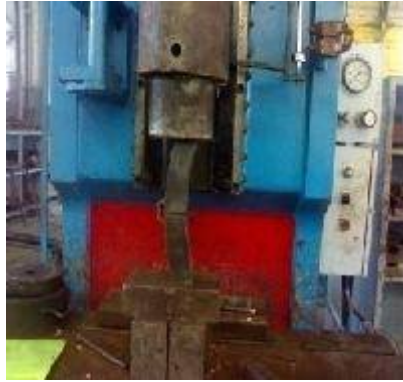
Figure 8: Device for the shear test on a hydraulic press

The tests were conducted by adopting a device using a hydraulic press as shown in figure 8 in accordance with the UIC specifications 2006 [6]. An iron sheet was placed between the two sides of the sole to ensure a good transmission of the effort.

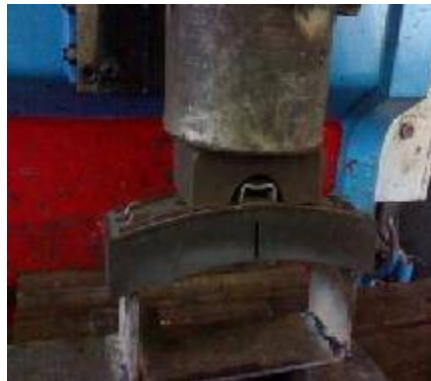
Figure 9: Application of the flexure test number 2

**Test N° 1:** in accordance with the UIC 2006 requirements concerning the application of a force of about 19 KN for a type K sole [6] and a length of 320 mm, a composite sole was subjected to a monotonous increasing effort applied by a hydraulic press (Fig. 9).

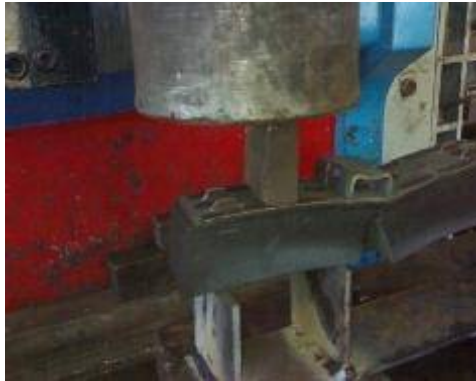
Figure 10: flexure test number 2

**Test N° 2 :** this test is used to define the actual cause of the deformation if it is due to the notch separating the two parts of the sole or if it is a poor quality of the material (Fig. 10).

These two tests are performed each time with new soles. The stress is applied monotonously at a speed of 30 mm / min.

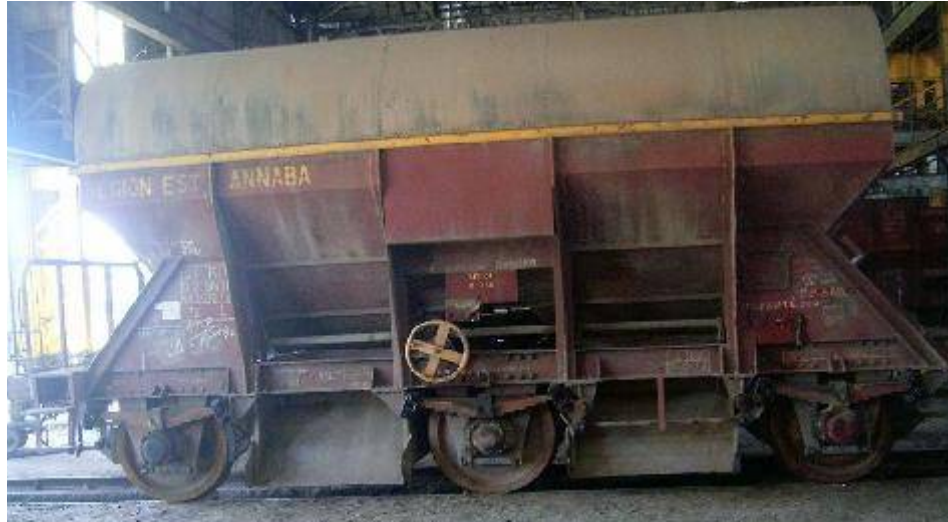
Figure 11: Example of an axle car equipped with 8 extreme wheel hooves

The 32 cars operated include 256 brake shoes. Each wagon is equipped with 8 clogs. Figure 11 shows an example of an axle wagon used for the transport of the phosphate equipped with 8 shoes with extreme wheels.

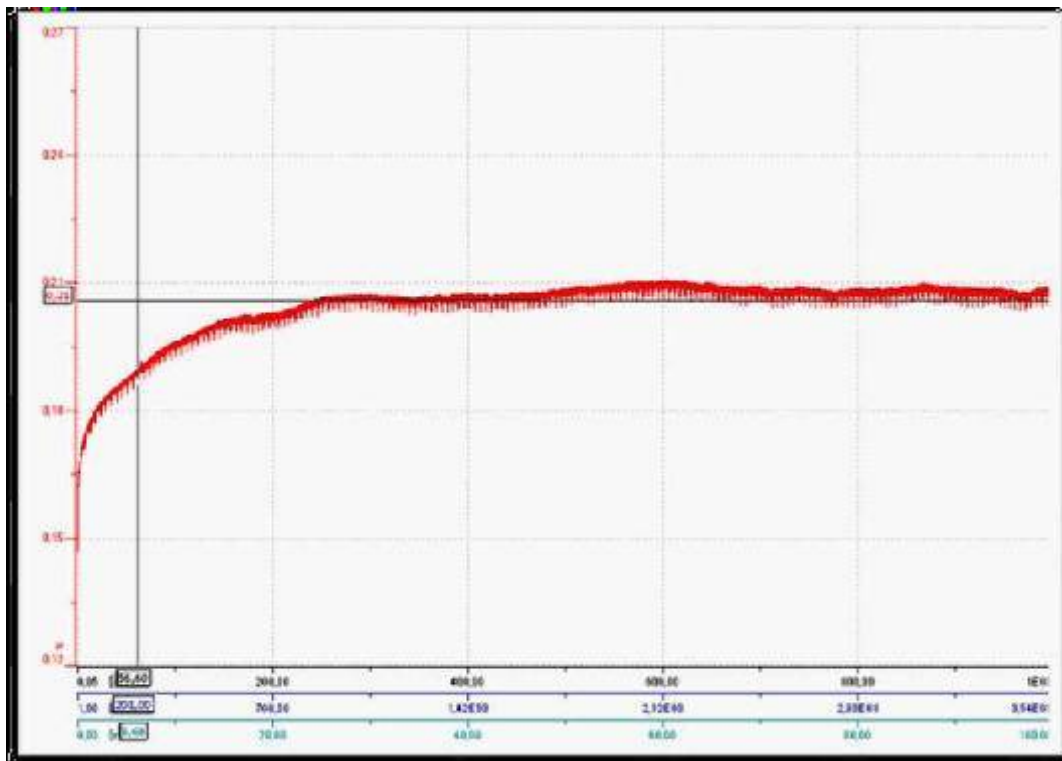
Figure 12: variation of the coefficient of friction as a function of time, displacement and the number of turns.

The tracking of the coefficient of friction and wear is an essential aspect in understanding the damage mechanisms that occur on industrial devices such as brake shoes. A typical example of the variation of the coefficient of friction according to three parameters : time, displacement, number of turns is shown in figure 12.

The coefficient of friction increases rapidly at the beginning of the simulation and stabilizes thereafter around a constant value of 0.21 from 200 s. This value remains comparable and consistent with that given by the manufacturer. It should be noted that recent work highlights the importance of the thermal properties of 2D / 3D C/C composites in their performance in braking simulation [11]. FM Kustas et al. [16] note that the friction of the C/C 3D composites at room temperature under vacuum is low compared to the friction obtained with the reference test.

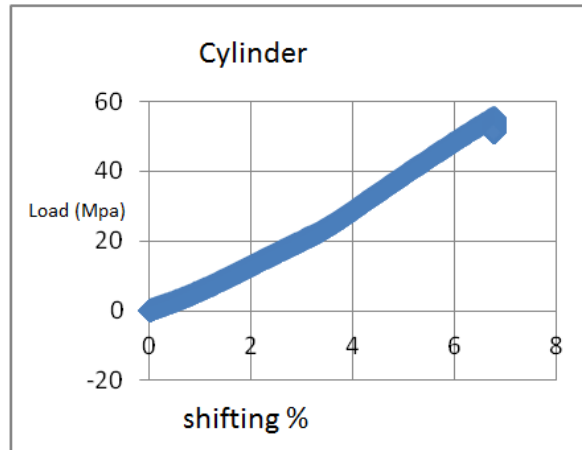
Figure 13: Compression behavior of the cylindrical specimen

Figures 13 and 14 show examples of the statement of load-displacement curve obtained during the compression test for both types of specimens tested. These curves have the same appearance and are linear from the beginning of the test until the total rupture of the sample reflecting the resilient elastic character of the C/C composite. It should be noted that the sampling of cylinders and cubes were made in different locations on different shoes

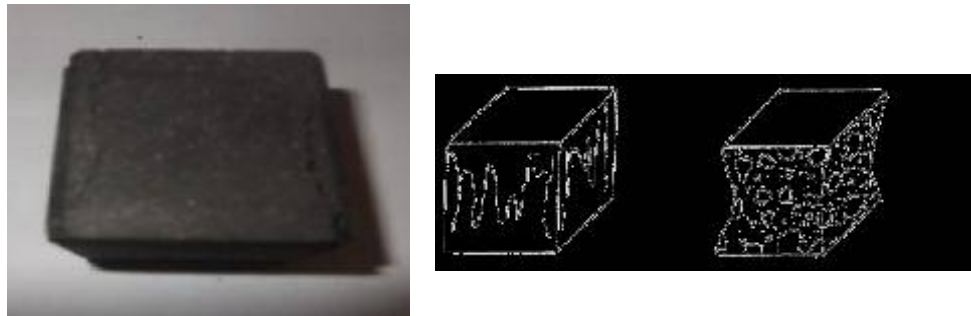
Figure 15: example and schematization of the mode of rupture of the cube

The fracture of the cubic specimens in compression takes place in oblique planes with the formation of two truncated pyramids and opposed by the small base as shown by the examples of this ruin mode in figure 15. This mode of rupture is typical on cubic specimens. It is a mechanism similar to that observed on concretes and cement based materials and it is mainly conditioned by the friction forces that develop between the faces of the specimen and the press plates and which are directed inside of the block which stops the development of transverse deformations [31].

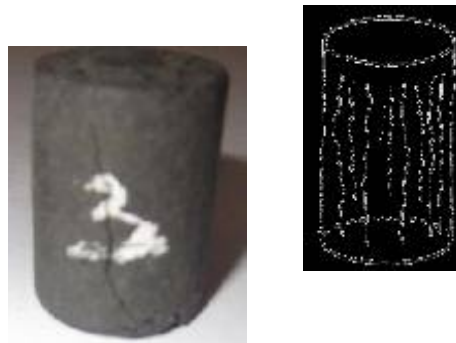
Figure 16: Example and diagram of the cylinder failure mode

The mode of fracture of the cylindrical specimens is shown in figure 16. The mechanism ruin is characterized by the emergence and formation of rupture lines in planes parallel to the direction of the compression load as shown schematically in figure 16. This is an illustrative example of a proper cylinder break.

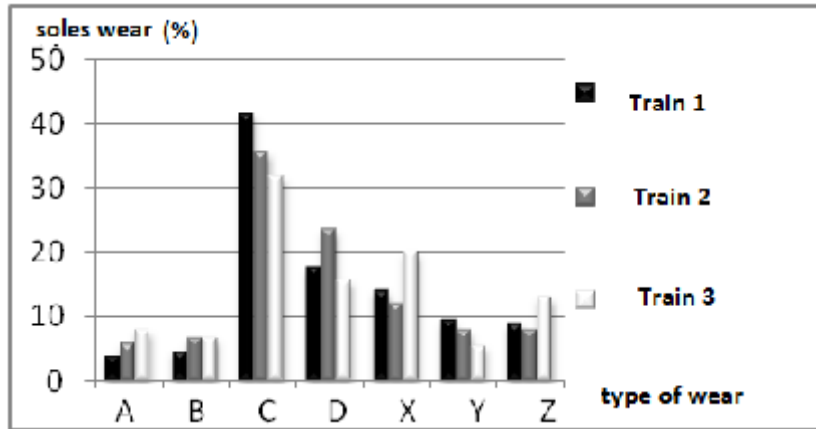
Figure 17: Histogram of worn shoe rate for different types of wear in winter.

These results are shown in the histogram of figure 17.

The analysis of the results of recorded measurements makes it possible to draw the following observations:

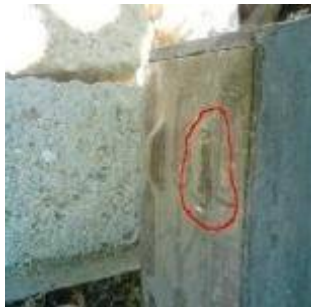
Figure 18: Fixing device

- Type of wear (A) : wear on one side of the shoe is at a rate varying from 3,9 to 7,81. This type of wear is generally due to the geometrical defects of the soles. It may also be caused by a defect in the keying device of the fastener as shown in figures 18 and 19:

- For wear A and according to the geometrical characteristics of the soles, the fastener does not appear to meet the standards in force (p.ex.ISO- 2768) [1].

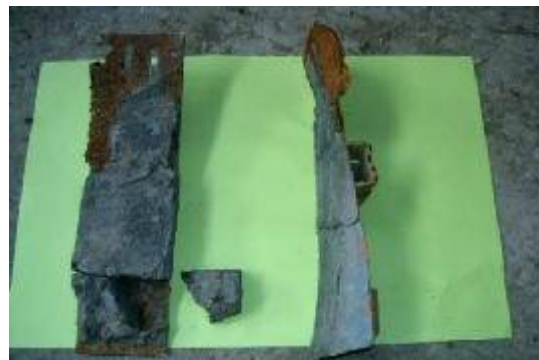
Figure 23: Exceptional wear of shoe

- Type of wear (X) : [14.06 - 19.92] : usually this type of wear is rarely encountered in similar climatic conditions (Fig. 23). Its consequences sometimes cause very serious incidents on-line including brake failure as even the slack adjuster cannot catch the sole link wheel-shoe

- The same observations can be made for wear X: a composite sole according never wear out beyond its wear limit, which is 10 mm in accordance with a mileage 45000Km course.

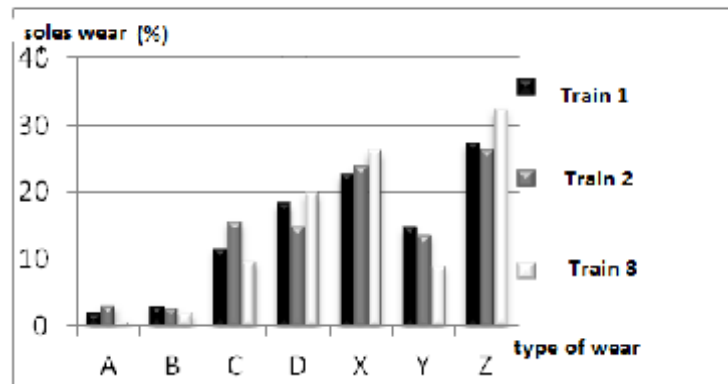
Figure 24: Histogram of the rate of worn shoes of different types of wear in the summer.

These results are shown in the histogram of figure 24.

In order to objectively analyze these results, a comparison between the two periods better explains the influence of temperature on wear clogs.

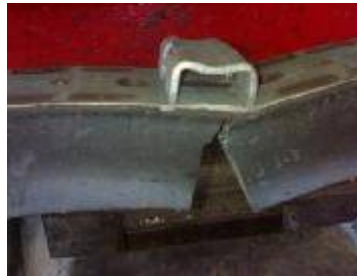
Figure 27: Result of the Type 1 flexural test

**Type 1:** after application of a load (the first development effort after 4 S) base began to rapidly flex and even before the load reaches 10 KN, the sole has broken just medium and an abrupt manner (Fig. 27). It is clear from the observations found that plastic deformation appears and the notch being in its presence the seat of high stress concentrations promotes crack propagation.

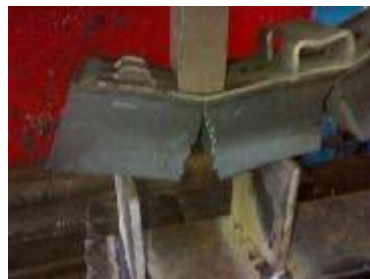
Figure 28: Result of the type2 test of flexion

**Type 2:** same findings of Test No. 1 of the reflection on the homogeneous part of the shoe have been identified on the type2 test (Fig.28).
