Land Characteristics, Run-Off and Potential for Rainwater Harvesting in Semi-Arid Areas of Tanzania

Rwehumbiza, F.B.R^{1*}, N. Hatibu² and M. Machibya

¹Department of Soil Science, Sokoine University of Agriculture, Tanzania.

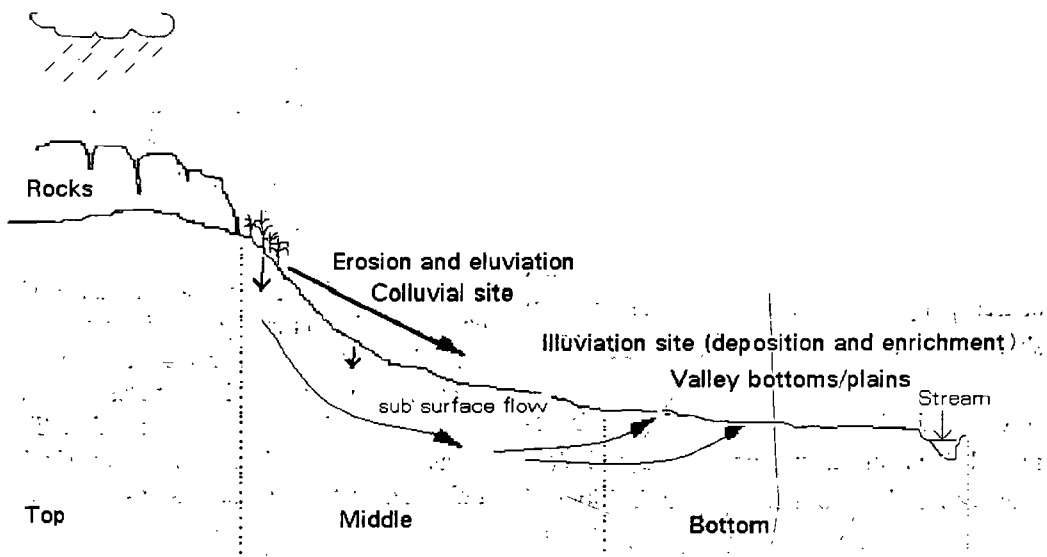
Figure 1: Water moyement in a generalised catena

A catena is considered as a natural set-up for land use planning and hence for rainwater harvesting. The top section acts as a natural generator of runoff and the bottom two sections act as natural receivers (Figure 1). Important land characteristics on the catena include soil type, hydraulic properties down the profile, soil variation along the toposequence, slope and vegetation cover. The relative proportions of the three sections in a given catena, how they are used and managed, determine the amount of runoff, erosion and the potential for rainwater harvesting (RWH). The top, middle and bottom parts of the catena may vary greatly in their relative sizes.

In most semi-arid areas of Tanzania, three soil types dominate the catena. The top of the catena is normally occupied by *Lithisols*. These are usually coarse sandy soils with poor moisture retention properties. A complex of soils but usually *Cambisols*/ *Arenosols*/ *Ferrosols* occupy the middle part, which is usually subjected to erosion. Soils with vertic properties commonly *Vertisols* are found at the bottom of the catena. Water and products of weathering, including nutrients accumulate at the bottom. Soils with vertic properties are the most im-

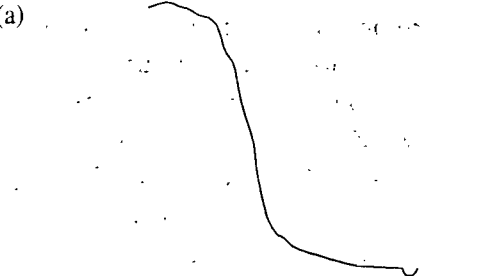
<p>Very steep catchment, run-off in deep gullies and moves fast. Difficult to use in the pediment, but spreads naturally further down in the lowland plains where it is opportunistically used by farmers. A good example is Kifaru village in Mwangi.</p> <p>High potential for RWH.</p>
<p>(b)</p>

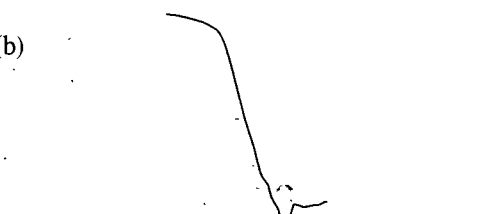
<p>Very steep, a lot of run-off, no area at the bottom to use it. Common in Morogoro north of the Uluguru Mountains.</p> <p>Poor potential for RWH.</p>
<p>(c)</p>

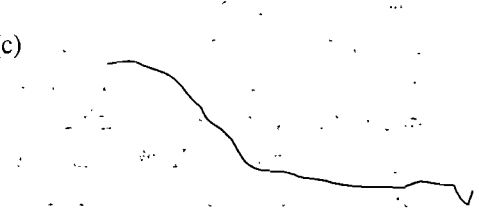
<p>Runoff generating area well matched with receiving area. Common in some parts of Maswa District.</p> <p>High potential for RWH.</p>
<p>(d)</p>

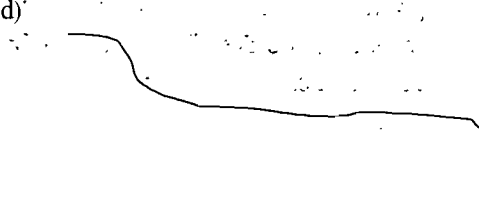
<p>Small area generating limited run-off, large area on which to use it. Demand of water exceeds supply. Common in many areas of Maswa District.</p> <p>Medium potential for RWH.</p>
<p>(e)</p>

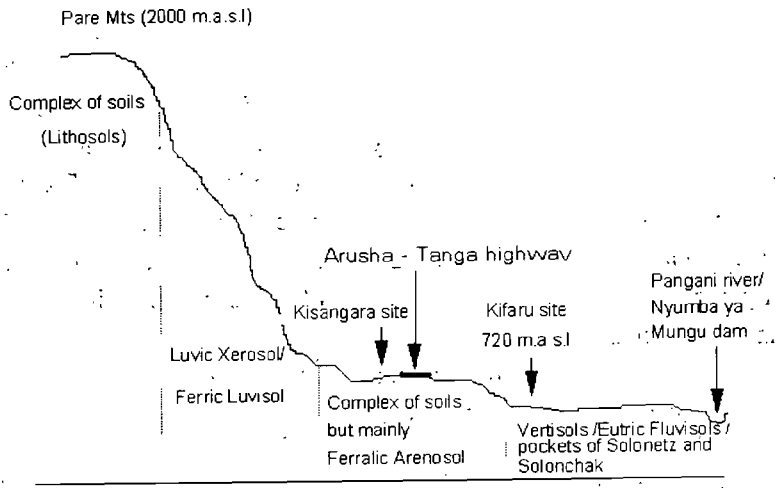
Figure 2-(a): Western Pare lowlands - a catena based on soil survey by Rwehumbiza and Diwani (1998), Ngatoluwa *et al.* (1995) and studies by De Pauw (1984).

The terrain on the upper part is strongly dissected and composed of steep rocky hills and sloping pediments (10 - 40%) developed on intermediate metamorphic rocks (De Pauw, 1984). On the foot of the mountains, there are flat and wide topographical depressions developed on young alluvium. The flat alluvial plains towards river Pangani are poorly drained and contain some pockets of salt affected soils. The landscape of the WPLL study area portrays the characteristics of a catchment with very steep slopes and only a limited area for using the runoff (Figure 2-a). The management of generated runoff is complicated by the concentration through few road and railway culverts and bridges. The effect of too much run-off generated by steep slopes in these areas was also observed by Anderson (1982) and Kisanga (1997).

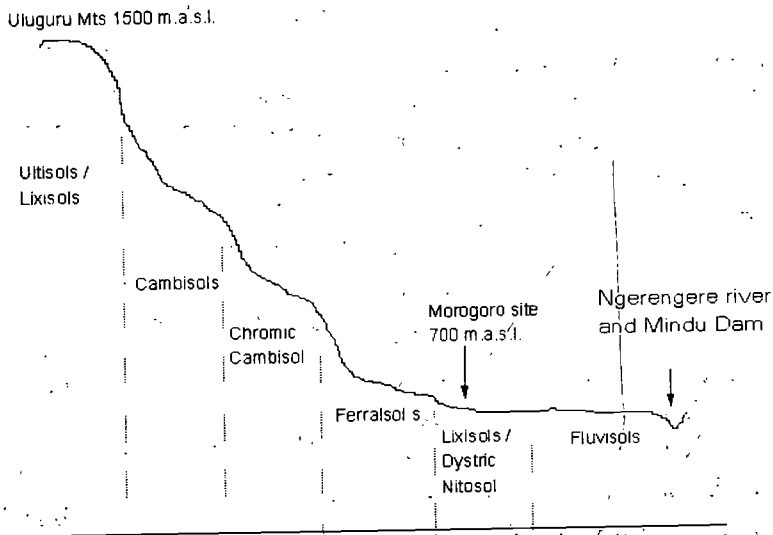
Figure 2 (b): A catena from Uluguru Mts. to Ngerengere river. (Modified from Moberg *et al.*, 1982; with data from Kaaya, 1989).

The Morogoro case study is focusing on northern slopes of the Uluguru Mountains (Figure 2 b). The upper part is a strongly dissected mountain plateau with steep to very steep slopes (15 - 30%) and narrow valleys strongly affected by erosion and soil creeps (Rapp *et al.*, 1973; Moberg *et al.*, 1982). The lowlands are well drained undulating to rolling plains (2 - 10% slope) at low altitude (<750 m.a.s.l). Steep granite inselbergs with moderately sloping foot slopes (2 - 8%) can be seen on the Kihonda - Mkundi lowland areas. Seasonal cropping (maize and vegetables) on the mountain slopes without conservation measures is causing erosion and severe siltation of Mindu dam and valley bottoms. Deforestation and bush fires are the main causes of loss of ground cover on the slopes.

The landscape characteristic is that of very steep slopes and very limited flood plains in

the vicinity of the slopes (Figure 2(b)). The runoff generated on the mountain flow into rivers and flash floods flow quickly to the ocean. The flashy nature of the stream flow was observed in flow studies reported by Rapp *et al.* (1973). These studies recorded peak flow rates of $2 \text{ m}^3/\text{s}/\text{km}^2$ and the overall run-off coefficient was about 46%. This represents very high level of runoff generation.

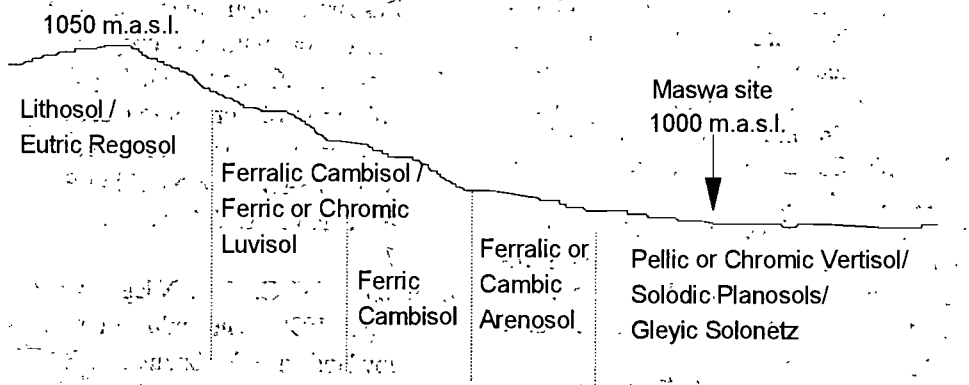
Figure 2(c): A catena across Shishiyu Maswa (constructed with information from Meertens *et al.*, (1999), Mahoo *et al.*, (1998), Ngailo *et al.* (1994) and, De Pauw (1984)

Unlike the WPLL and Morogoro cases, which have very steep mountains overlooking the lowlands, this area has small hills that cover relatively small areas compared to the extensive plains (Figure 2(c)). Rainwater harvesting is wide spread, and most runoff is harvested into banded paddy fields. The generated run-
