CONCRETE CRACKING IN COASTAL AREAS Problems and Solutions

S.R. Mpinzire

Department of Civil Engineering, University of
Dar es Salaam, P.O. Box 35131, Dar es Salaam
Tanzania.

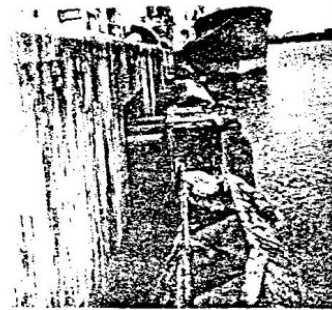
Fig. 7 Corrosion of steel bars in concrete piles at the port area

Figs. (7) and (8) show location and condition of concrete steel bars in concrete piles and broken off fender system due to corrosion at a sea port area. Concrete around the piles and fenders has badly deteriorated and cracks due to reinforcement corrosion, even though appropriate cover was provided during construction. In this case poor quality of the concrete mix, confirmed by low compressive strength results was responsible for chloride penetration and subsequent rapid steel corrosion.

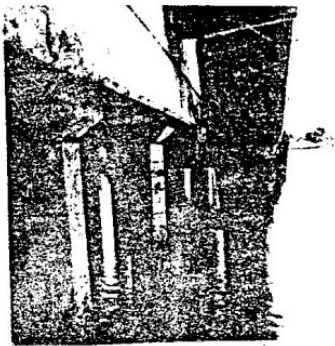
Fig. 8 Broken off fender system due to corrossion of support areas
