Determination of Cyanide Concentration Levels in Surface Water and Soil from Artisanal Small-Scale Gold Mining Villages at Chunya, Mbeya - Tanzania

Consolatha A. Mbare, Mahir M. Said[†] and Rwaichi J. A. Minja

Department of Chemical and Process Engineering, University of Dar es Salaam, Dar es Salaam, Tanzania

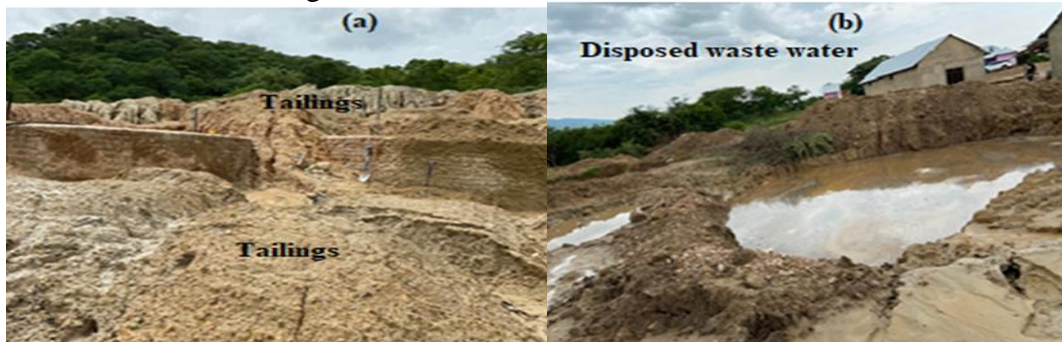
Figure 3: Effect of Gold mining extraction (a) Tailings and (b) Disposed wastewater at Ifumbo mining sites.

These results reveal that the soils at Mwasenga and Ifumbo mining sites are contaminated with cyanide. This is because of improper disposal of tailing and wastewater as shown in Figure 4, which is

contrary to the environmental requirements (EPA, 2021; Botz, 2001). Furthermore, it was observed that the dumped tailings in these mining sites were not properly managed as they are dumped without treatment procedure. As a result, when it rains, the cyanide leached to the ponds, rivers and soil.

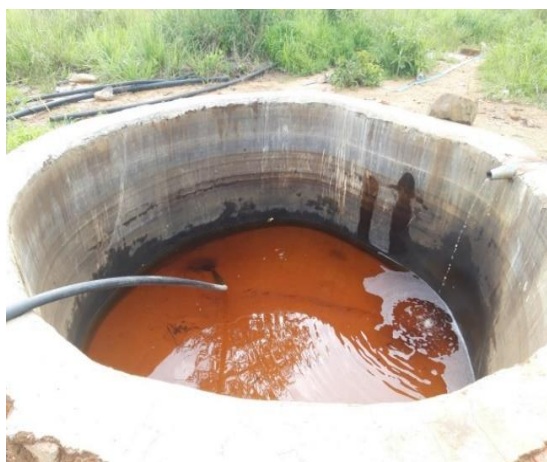
Figure 4: Artificial tank for storing wastewater at Godima

In case of Godima, Nyatula, Itewe and Ashishira mining sites, the non-detection of cyanide is attributed by management of contaminated wastewater through construction of artificial tanks, ponds and trenches for recycling of collected runoff wastewaters from tailings as observed in Figure 5.

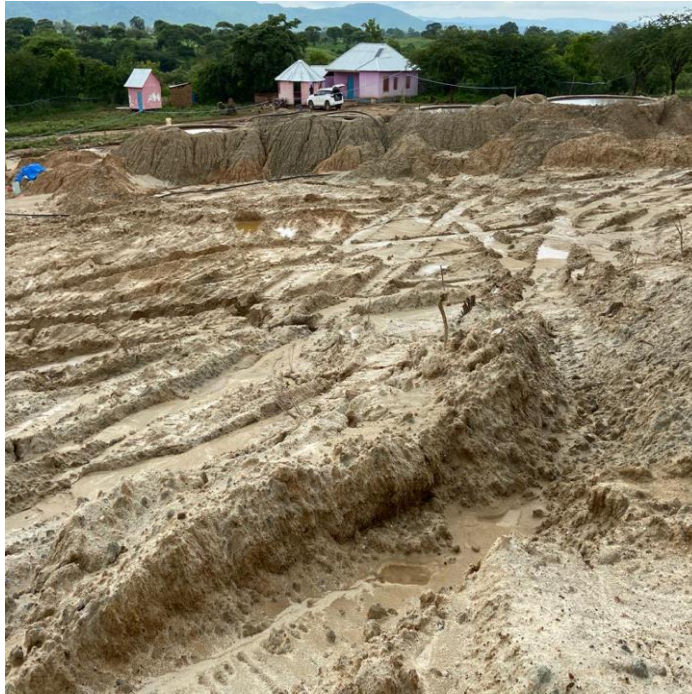
Figure 6: Disposed tailings at Mwasenga Mining site.

nearby the mining sites as shown in Table 3. A similar finding has been reported by Allen (1989). Higher concentration of cyanide was observed in the area closer to

the barren tanks as a result of continuous disposal of tailings, Figure 7.
