Requirements for sustainable operation and maintenance of rural small-scale water infrastructure in Limpopo Province, South Africa

MS Selala¹, A Senzanje¹ and K Dhavu^{2*}

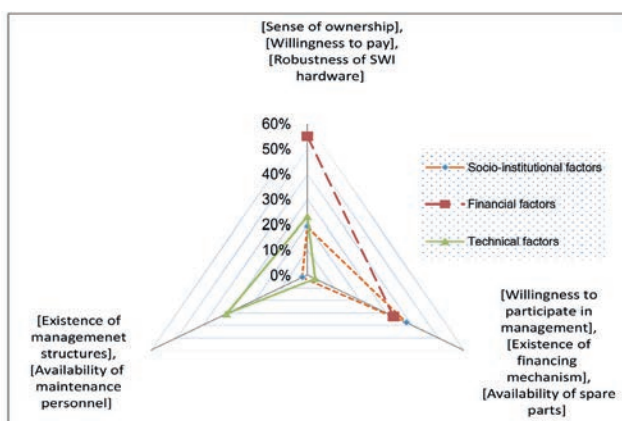
Figure 2

Percentage of respondents on the presence or existence of requirements for sustainable operation, maintenance and rehabilitation of SWI in sampled communities

From the results in Fig. 2, 7 of the requirements assessed in this study were said to be present by less than 40% of the respondents in all surveyed communities, with the exception of one of the financial factors (willingness to pay for O&M and rehabilitation of SWI) which was demonstrated to be present by 55% of the respondents. A moderately high willingness to pay for O&M and rehabilitation of SWI observed in communities

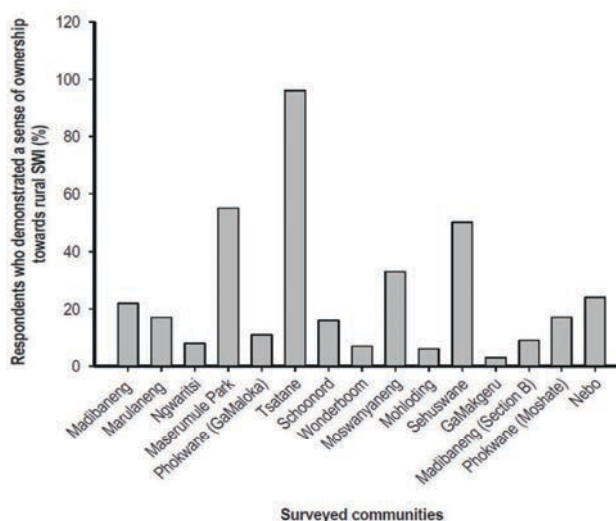
Figure 3

Percentage of respondents who expressed a sense of ownership of SWI in communities of Makhudutamaga Local Municipality

A sense of ownership towards SWI was expressed by less than 33% of the respondents in 73% of the surveyed communities (Fig. 3), indicating a high sense of ownership for SWI by respondents at only 3 of the 15 (20%) surveyed communities, namely Tsatane (96%), Sehuswane (50%) and Maserumule Park (55%).

On average, a sense of ownership towards SWI was expressed by 24.9% of the SWI users in all 15 communities surveyed in this study, indicating a low sense of ownership towards SWI. At Tsatane community, where sense of ownership was highest (96%), the SWI was developed through beneficiaries' contributions and users participated in its construction. In contrast, at Ga-Makgeru where sense of ownership was lowest (3%), the SWI was developed though government-funded projects and had been abandoned during the study. Thus, sense of ownership appeared to be linked to users' contribution towards installation of the SWI. For example, at Maserumule Park users mentioned that they

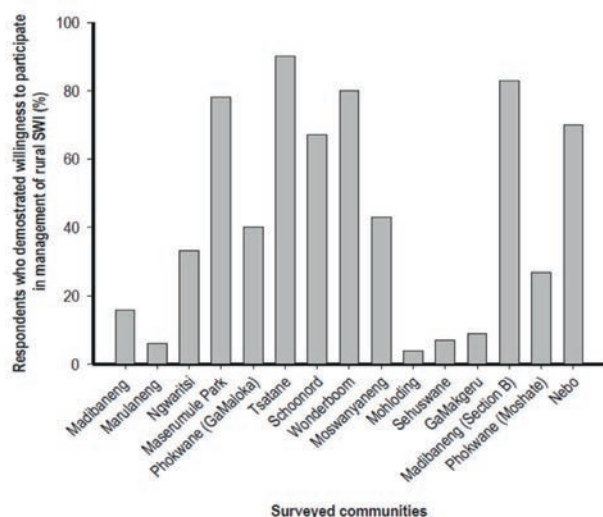
Figure 4
Percentage of respondents who demonstrated willingness to participate in the management of SWI in communities of Makhudutamaga local municipality

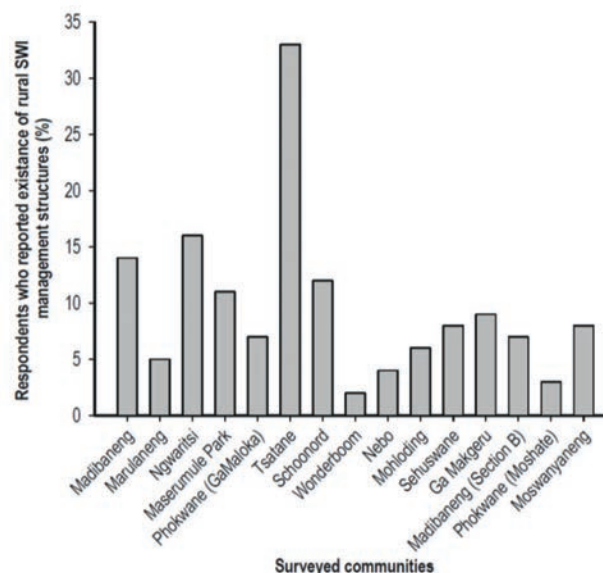
Figure 5
Percentage of respondents who reported the existence of SWI management structures in communities of Makhudutamaga local municipality

Management structures (such as WPCs) were said to be available by less than 16% of the respondents in 93% of the surveyed communities and by 33% of the respondents at Tsatane (Fig. 5), suggesting the lack of formal management structures in all the communities sampled in this study.

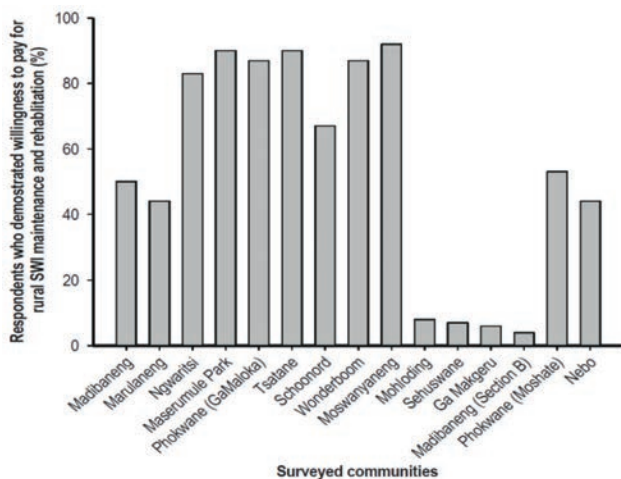
Figure 6

Percentage of respondents who demonstrated willingness to pay for operation, maintenance and rehabilitation of SWI in communities of Makhudutamaga local municipality

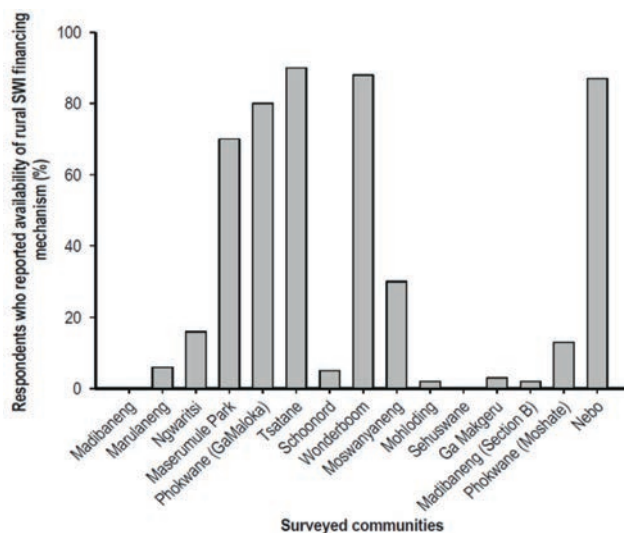
Figure 7

Percentage of respondents who reported availability of financing mechanisms in communities of Makhudutamaga Local Municipality

Financing mechanisms were said to be available by less than 30% of the respondents in 67% of the surveyed communities and by more than 70% of the respondents in the remaining 33% of the surveyed communities, suggesting that some form of financing mechanism was available in communities such as Ngwaritsi, Maserumule Park, Phokwane (Ga-Maloka), Schoonord, Wonderboom and Moswanyaneng, with a high likelihood of unavailability of financing mechanisms in the remaining communities as shown in Fig. 7.

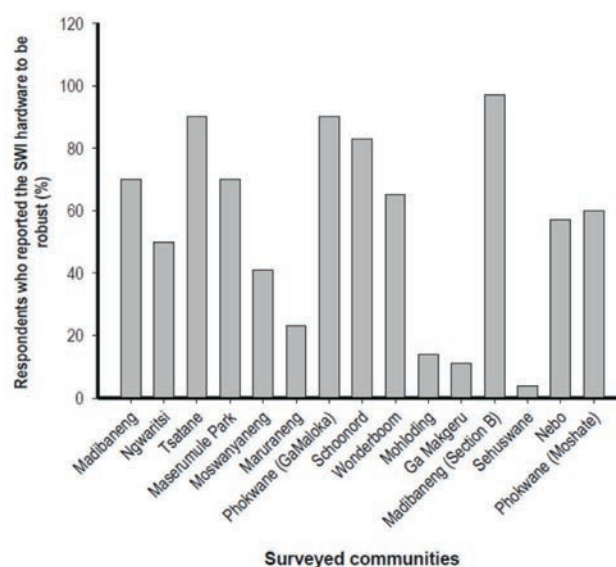
Figure 8

Percentage of respondents who reported SWI hardware to be robust in communities of Makhudutamaga Local Municipality

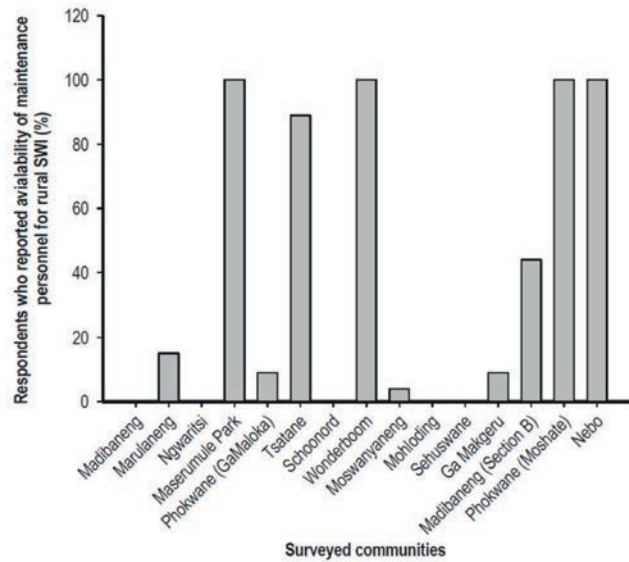
Figure 9

Percentage of respondents who reported availability of maintenance personnel in communities of Makhudutamaga Local Municipality

Maintenance personnel were said to be available by less than 16% of the respondents in 60% of the surveyed communities, and by more than 44% of respondents in 40% of the surveyed communities (Fig. 9), indicating a low availability of maintenance personnel. It was observed that maintenance personnel were said to be available in communities where standpipes were used. This was mainly because most, if not all, standpipes in the study area were operated by the Water Services Authority, which is a subdivision of the local municipality and has qualified maintenance personnel.

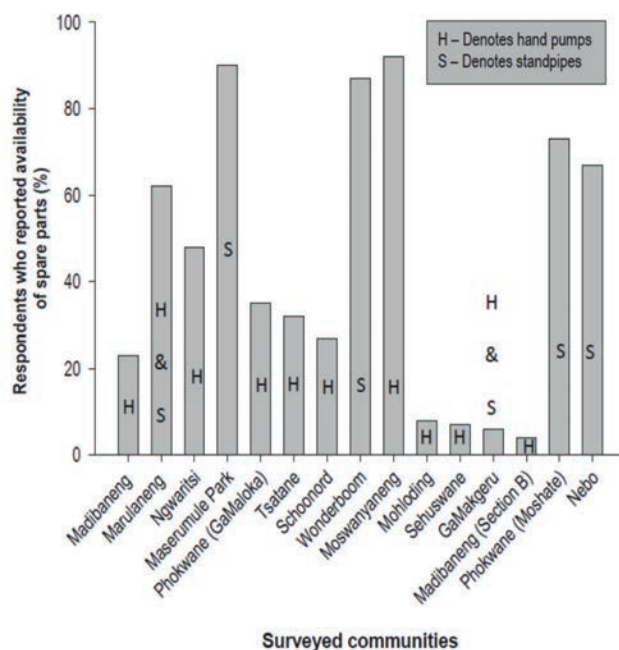
Figure 10

Percentage of respondents who reported availability of spare parts in surveyed communities

Spare parts were said to be available locally by more than 50% of respondents in surveyed communities for standpipes and by less than 45% of the respondents in surveyed communities for hand pumps (Fig. 10), indicating that spare parts for standpipes are found locally while spare parts for hand pumps are rare locally.

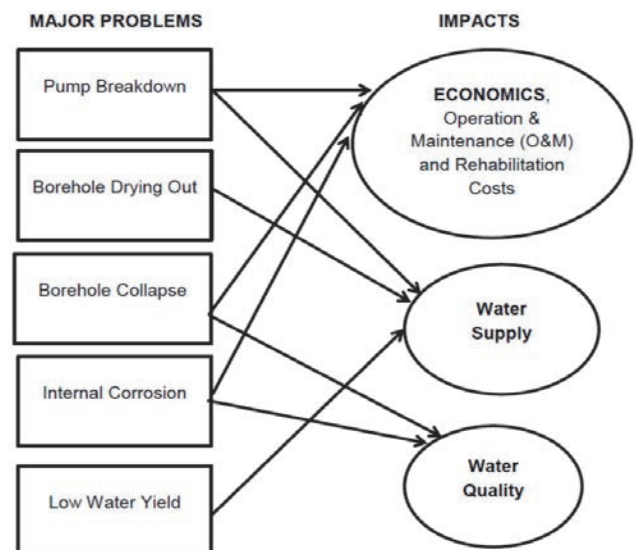
Figure 11

Small-scale water infrastructure major technical problems and their impacts (adopted from Karaa, 1984)

Nkambule, 2012). The service provision from SWI is largely dependent on the condition of the SWI (Senzanje et al., 2013). When the SWI hardware has a technical problem, the service provision can be halted or interrupted. Some of the technical problems and impacts associated with them are shown in Fig. 11. The results of the continuity and functionality of the SWI in the study area are as displayed in Table 6.

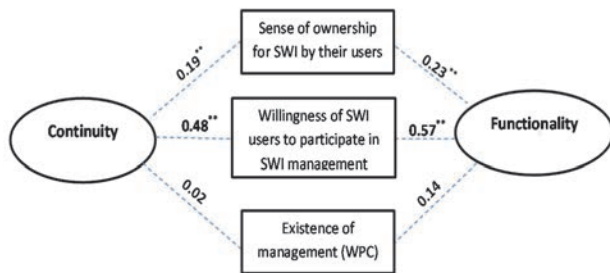
Figure 12

NB: ** denotes statistical significance at 0.01 levels (2-tailed)

The results of a two-tailed test of significance (see Fig. 12) indicated that there was a significant positive relationship between users' sense of ownership towards SWI and continuity of the service provided by the small-scale water infrastructure

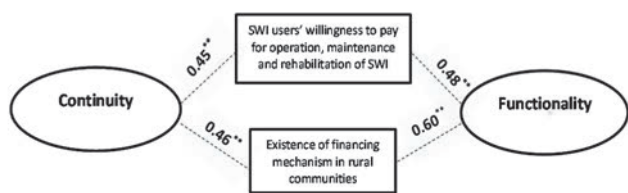
Figure 13

NB: ** denotes statistical significance at the 0.01 level (2-tailed)

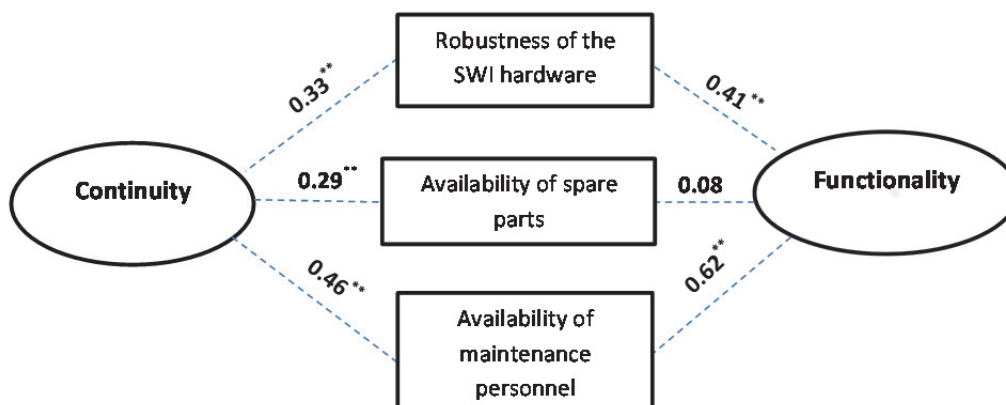
Figure 14

NB: ** denotes statistical significance at 0.01 levels (2-tailed)
