PROBABILISTIC ASSESSMENT AND FIELD TEST VERIFICATION FOR STRENGTH EVALUATION OF BRIDGE WITH DEFECTIVE GIRDER

This study looked into performance assessment of a 20.50m defective reinforced concrete girder (bridge at km 69+937, Agula-Barahle road segment) caused by construction fault by which concrete of a lower grade than that specified in the specification has been used. The bridge was built in 2014, and a performance evaluation was conducted four years later as there was a defect on one of the interior girders (problem with concrete quality). The objective of this research was to investigate the safety level of a defective girder using

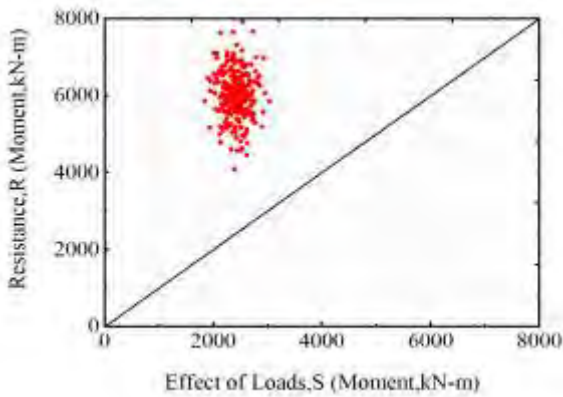
Figure 6 Distribution of moment resistance and effect of loads

For reliability assessment of the defective girder, 256 combinations of random variables of Latin Hypercube Sampling (LHS) were used [2]. For the computational analysis, a MATLAB code was prepared which enabled to compute the cross-section resistances, effect of loads, design margin, rating factors. It was also used to plot the corresponding probability density curves. The relationship between resistance and effects of loads for both bending moment and shear force are shown in Figures 6 and

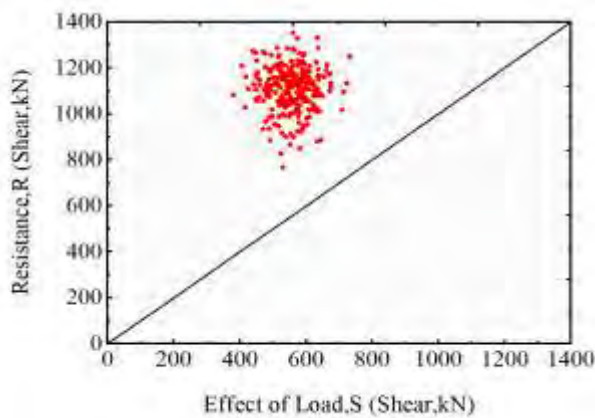
Figure 7 Distribution of shear resistance and effect of loads

7, respectively. The RF for each case was computed and the scattered plot of RF for shear force and bending moment is shown in Figure 8. The probabilistic assessment results are summarized in Table 6. The mean values of rating factors for shear force and bending moment were found to be 3.71 and 6.41, respectively, which are 40% to 80% higher than those obtained using the deterministic approach. Furthermore, the probabilistic distributions of bending

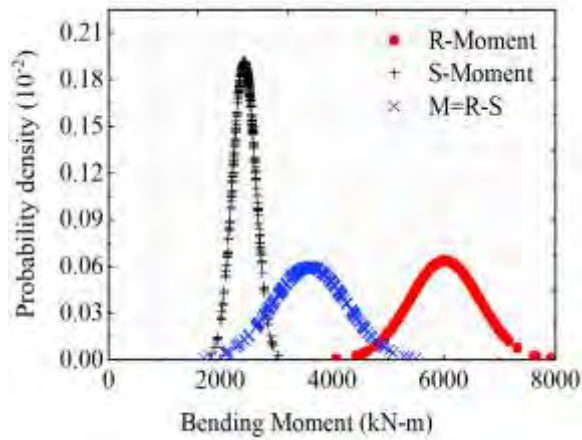
Figure 9 Probabilistic distributions of R, S and M for Moment

moment and shear force are shown in Figures 9 and 10, respectively.

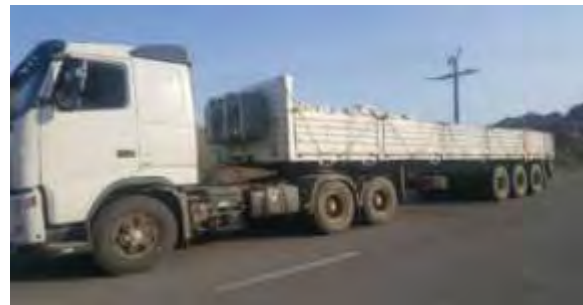
Figure 11 Truck used for loading test

The truck loading test was mainly aimed to assess the strength and stiffness of the defective girder under moving load action of the loaded truck. The truck weighed 60.6 tons (Figure 11) and was made to pass on the bridge with its central axis aligned with the defective bridge. Three different speeds (5km/hr, 20km/hr and 40km/hr) were considered to assess any potential change in the response of the defective girder due to speed or impact. The load arrangement of the truck used in the load test is shown in Figure 12. The axle loads are given in tons and the axle spacings are given in meter.

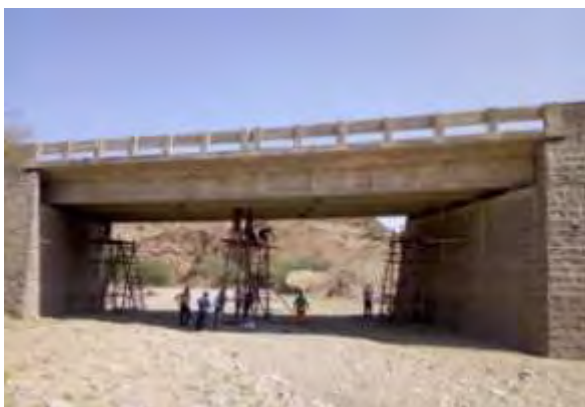
Figure 13 Set-up for truck loading test

For each loading case, measurements of deflection of the defective girder with its counterpart non-defective girder were recorded. Furthermore, the truck was made to pass with its edge wheel positioned at a distance of forty percent of girder spacing (=0.92m) from the curb [8, 9] and similar records were made as well. In addition to the deflection measurements, any possible formation, opening/closure of flexural and shear cracks were observed.

The recorded mid-span deflection value while the truck was passing with its central axis coinciding with the alignment of the defective girder is shown in Figure 13. Mid-span deflection under moving load passages at 5km/hr; 20km/hr; 40km/hr; edge position with 5km/hr (non-sustained and sustained loads) is shown in Figure 14.

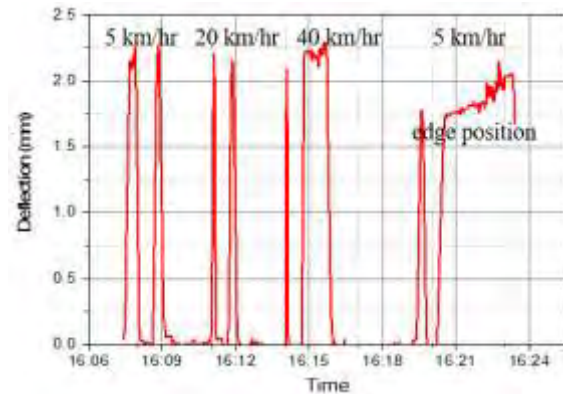
Figure 14 Mid-span deflection under moving load passages

The three initial curves indicate the response for the running speeds of 5km/hr, 20km/hr and 40km/hr, respectively. The fourth curve indicates the response for the girder deflection with the trucks edge wheel positioned at 0.92m from the curb and at a running speed of 5km/hr. However, during the return of the third set of curves, the truck was allowed to stop when maximum mid span deflection was observed. This step was intentionally made in order to observe the effect of sustained load. The truck was sustained at this fixed position for nearly 60 seconds.

As can be observed from the mid-span deflection of the defective girder (Figure 14), the maximum deflection was 2.3mm. For comparison, mid span deflection of the non-defective adjacent interior girder was simultaneously measured and the maximum mid-span deflection recorded was 1.9 to 2.0 mm. The last loading passage was made towards the edge of the curb and the corresponding deflection of the defective girder was observed to be 1.8mm. In addition, the truck was made to stop at the center and sustained for 60secs, resulting in a deflection of 2.2mm.

Overall, the defective girder is safe against stiffness and strength limits, with a maximum deflection of 2.3mm under the 60.6tons truck load, compared to the limit of 25.75mm. The actual recorded mid-span deflection was one-eleventh of the mid-span deflection limit, making the girder reasonably safe against serviceability and strength requirements.

During the field load test, as strain gauges were not attached to the girder, the K_a factor was calculated based on deflections of the defective girder obtained by the test vehicle (T) and the rating vehicle (W). According to elastic analysis, the deflection of the defective girder caused by the rating vehicle (W) was computed as 6.81mm (in this case, gross moment of inertia of a section, $I=294.2 \times 10^9 \text{mm}^4$ was used) and the maximum deflection of the bridge due to the test load was taken as 2.3mm (Figure 14). Using Eq. (7), the value of K_a was calculated to be 1.96.
