APPRAISAL OF THE CAUSES OF PAVEMENT FAILURE ALONG THE ILESA - AKURE HIGHWAY, SOUTHWESTERN NIGERIA USING REMOTELY SENSED AND GEOTECHNICAL DATA

Remotely sensed and geotechnical data have been used to establish some of the causes of perpetual pavement failure along the Ilesa Akure highway in the southwestern part of Nigeria. Four failed segments and two control stable segments were selected for the geotechnical study. The remote sensing investigation involved the processing and interpretation of Landsat-7 ETM+ images covering the study area and its environment for lineaments. The geotechnical investigation involved grain size analyses, Atterberg Limits, Compaction Test and California Bearing Ratio (CBR) determination. Lineaments were identified across virtually all the failed localities with a predominantly N-S structural trend. The geotechnical properties of the soils beneath the stable and failed segments of the highway show significant overlap which suggests that the cause of road pavement failure along the highway may be due to factors other than or complementary to the geotechnical factors. The pavement failure may have resulted from suspected near-surface linear (geological) fe

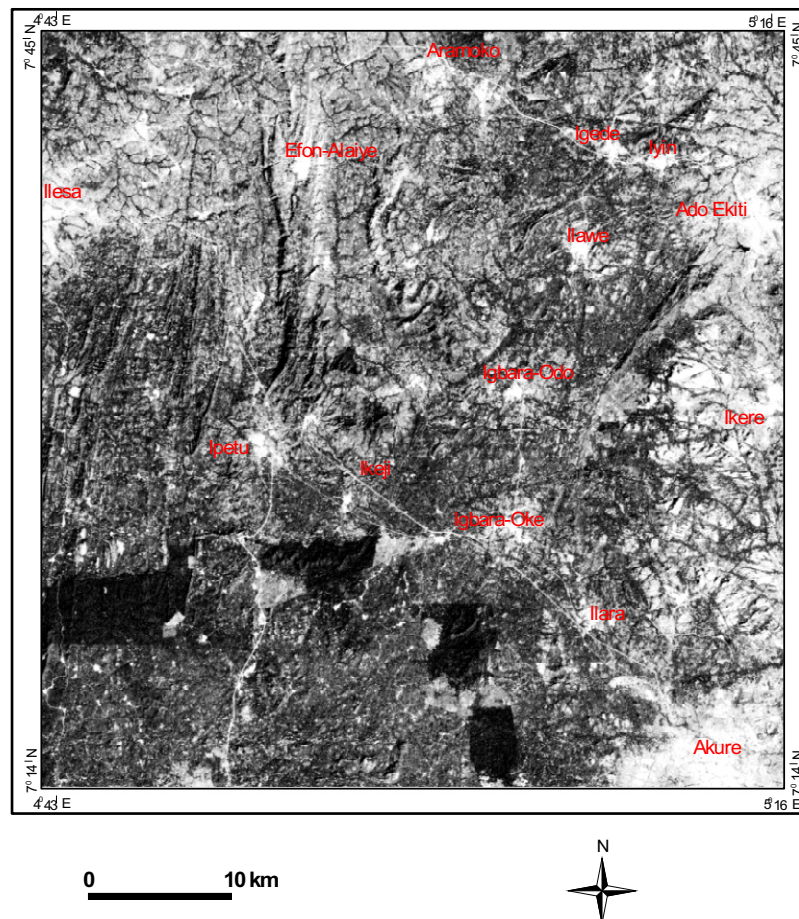
Fig. 5: Enhanced Landsat ETM + Band 7 of Ilesa- Akure Area

equated with structural elements such as folds, fractures, faults and joints (Viljoen et al., 1983). Some of the lineaments in which the road cut across may be fault particularly those that show relative displacement. Other linear features are suspected to be fracture and fissure zones. As shown in the rose diagram (Fig. 7), the four major

structural trends (N-S, NNE-SSW, NW-SE, and E-W) that are typical of the Nigerian Basement Complex (Rahaman, 1989) are represented in this area. The N-S lineament trend constitutes the dominant structural trend. As shown in Figure 6, several of the linear features cut across the highway investigated and most especially within

and around failed segments of the highway. It is suspected that such linear features may be one of the factors responsible for the perpetual failure of the failed segments of the highway, since linear features are characteristic zones of weakness.

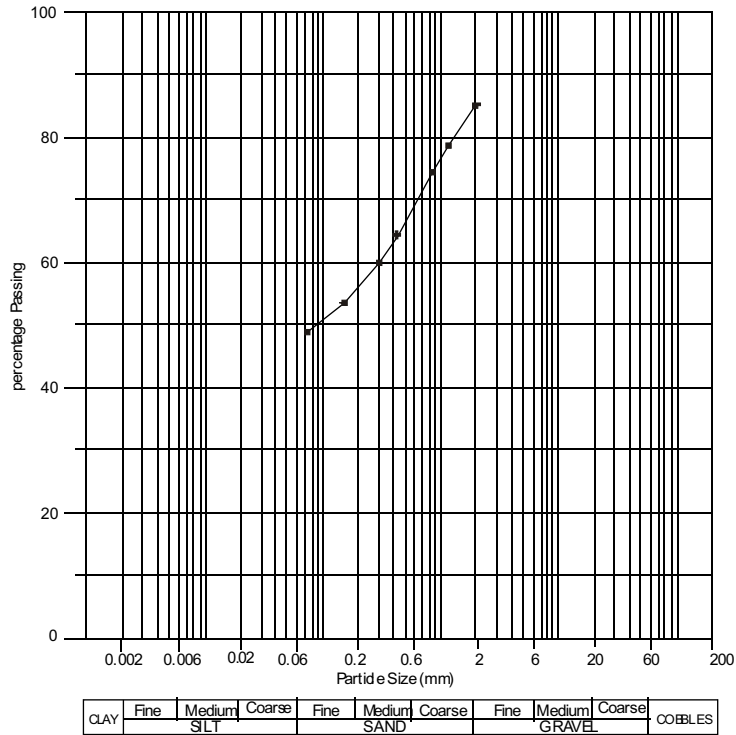
Fig. 8: Grain Size Distribution Curve for Soil Sample taken from Stable Segment 1 (St1a)

The results of the grain size distribution analyses are presented in Table 1. Typical grading curve is presented in Figure 8. The soils from control stable segments have percentage finer (percentage

passing 0.075mm) ranging from 33 - 83%, while that of failed and classified stable (?) segment ranges from 31-70% and 25 - 59% respectively. From the grading curves, the soils can be classified as well graded soil. Most of the soils have percentage passing No. 200 (0.075 mm) of more than 35%, hence, the soils range in group

classification from A-4 to A-7 and are generally rated as fair to poor sub-grade highway materials (Table 2). Most of the studied soils (stable and failed localities) did not fall within the Federal Ministry of Works and Housing (FMWH) (1972) grading specification (Table 3). The ranges of the percentage finer of the soils beneath the stable and failed segments (Table 1) show significant overlap; hence the perpetual failure of the failed segments of this highway can not be explained base on grain size distribution only.

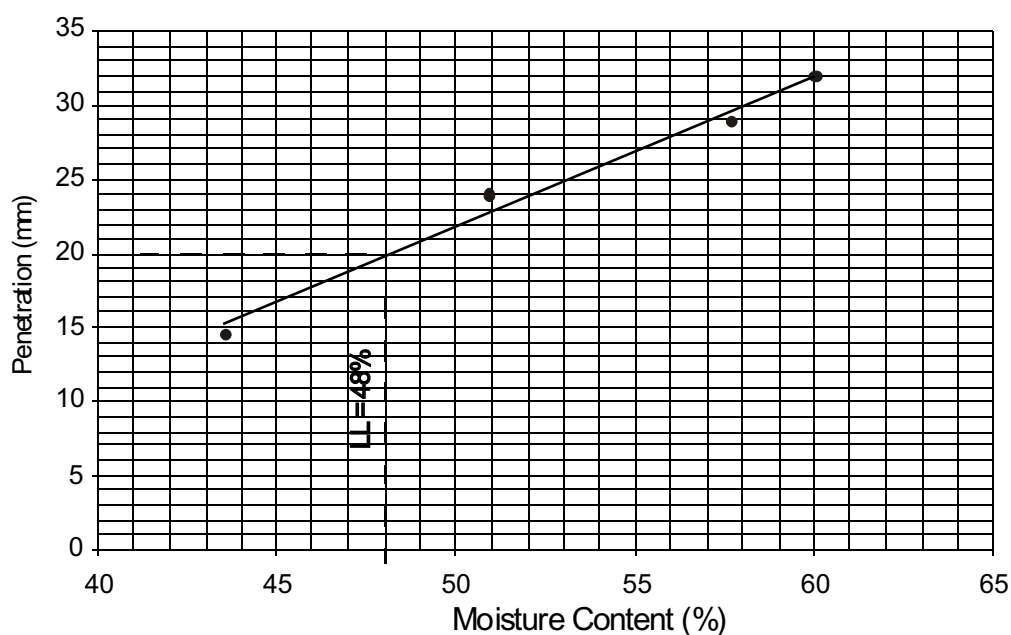
Fig. 9: Liquid Limit Graph for Soil Sample taken from Failed Segment 10 (Fs10a)

As shown in Table 1, the Liquid Limit of the soil samples from the control stable segments ranges from 38-56%, while those from presently classified stable (?) and failed segments range from 24 - 55% and 20-66% respectively. Typical Liquid Limit curve is shown in Figure 9. The Plastic Limit of the soils ranges from 21-38%, 16 - 36% and 10-41% for the control stable, current classified stable (?) and failed segments respectively. The Plasticity Index of soils beneath the control stable segments ranges from 9-21%, while that of the currently classified stable? and failed segment ranges from 8-28% and 1-25% respectively. Most of the soils (stable and failed localities) investigated fall within the FMWH (1972) specification (Table 3), and are suitable sub-grade materials. Using the America Association of State Highway and Transportation Officials (AASHTO) (1962) classification system

shown in Table 2, the soil samples from both the stable and failed segments belong to group A-4 to A-7, hence the soil can be rated to be of fair to poor sub-grade materials. The Casagrande (1948) Chart (Figs. 10a and 10b) generally indicate medium plasticity for both the soils beneath the stable and failed segments, hence, the soils are expected to exhibit low to medium swelling potential (Ola, 1982). The Linear Shrinkage of the soils beneath the stable and classified stable (?) segment ranges from 1-8% and 3-12% respectively, while that of the failed segments ranges from 3-16% (Table 1). The Linear Shrinkage of most of the soils are $\leq 8\%$ recommended by Brink *et. al.* (1982) and Madedor (1983) for highway sub-grade, hence the soils are good sub-grade materials. As discussed above, the consistency limits of the soil beneath the stable and failed segments of the studied highway did not exhibit significant difference and generally fall within the recommended specification by FMWH, 1972. Both soils are rated poor to fair for pavement materials, hence, the cause of failure along the failed segments of this highway may be difficult to explained from the point of view of consistency limits only.

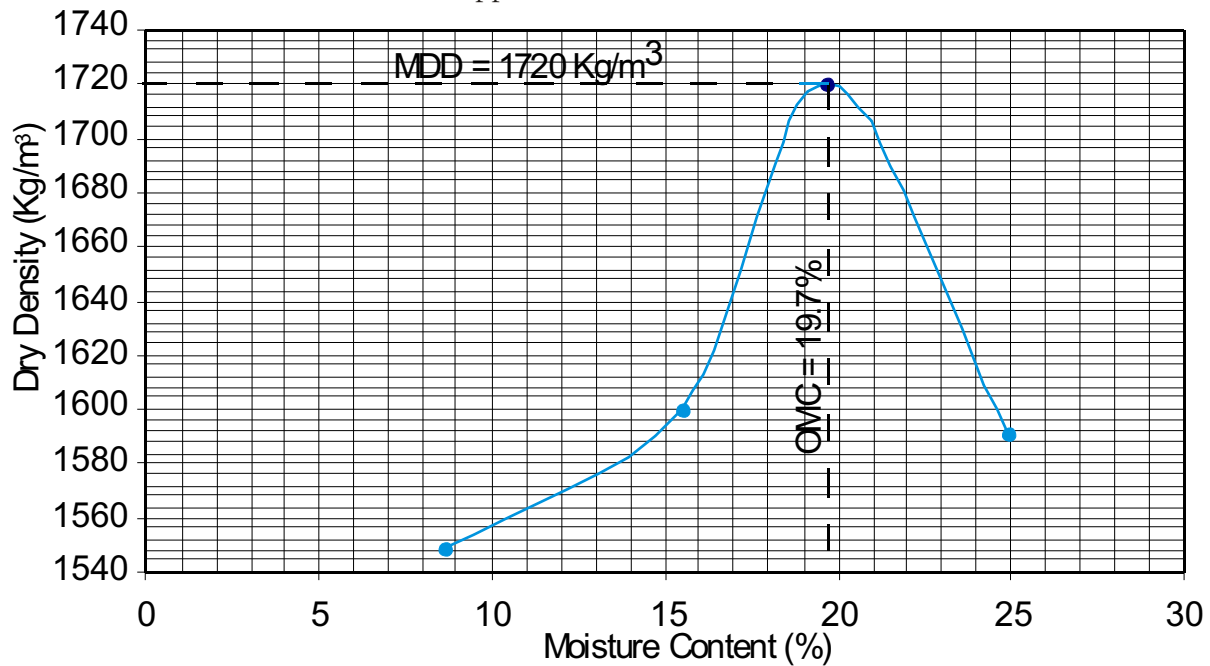
Fig. 11: Compaction Curve for Soil Sample taken from Failed Segment 1 (FS1d)

Optimum Moisture Content (OMC) ranges from 7-28% for soil beneath the control stable segments and 10 -20% for soil beneath the classified stable (?) segments, while that of failed segments ranges from 9-29%. The Maximum Dry Density (MDD) ranges from 1457-1950 Kg/m³, 1620 - 1900 Kg/m³ and 1571-2040 Kg /m³ for subsoil beneath control stable, classified stable (?) and failed segments respectively. There is significant overlap between the values of compacted parameters of the soils beneath the control stable segments and failed segments; hence compaction characteristic of the soils may not be a good index for the highway pavement stability.
