RESEARCH PAPER

**A HOLISTIC SURVEY OF DAMPNESS IN A SIX BEDROOM  
RESIDENTIAL APARTMENT**

**K. Agyekum<sup>1</sup>, J. Ayarkwa<sup>2</sup> and C. Koranteng<sup>3</sup>**

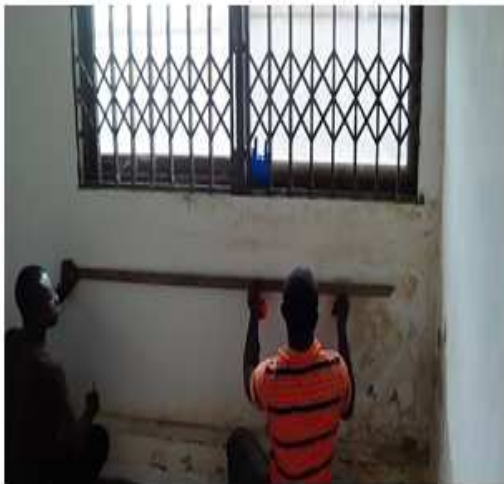
for moisture measurements using a tape measure and light wooden batten (Figs. 2 and 3). Damp walls in the southern, northern and eastern orientations extended up to 900 mm and grids were drawn as shown in Fig. 3. A similar procedure was used for the walls in the western orientation where dampness reached a height of 1200 mm for the walls of the bedroom and bathrooms respectively.

**Fig. 2: Marking grid points with light wooden batten**

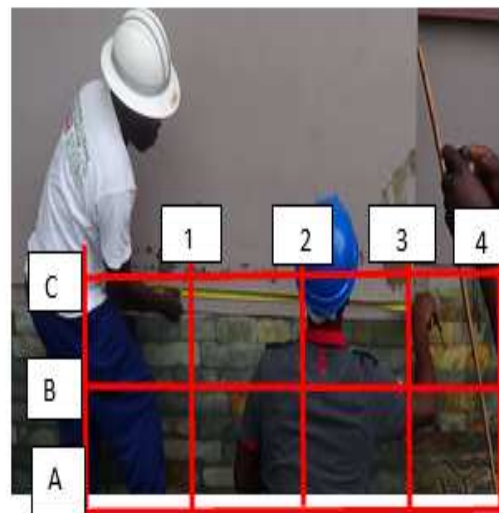
**Fig. 3: Tape measure laid against wall**

The gridlines were coded using alphabets (for horizontal gridlines) and figures (for vertical grid lines) as shown in Fig. 3.

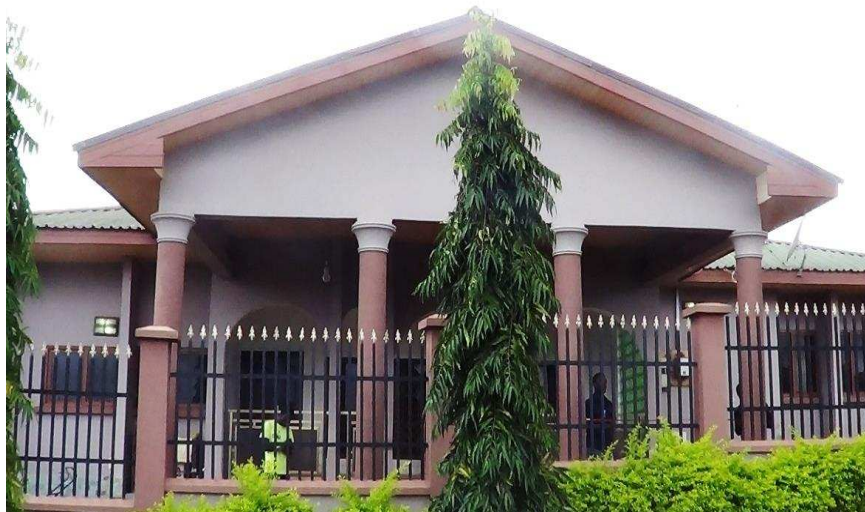
**Fig. 4:** Front part of the building under study

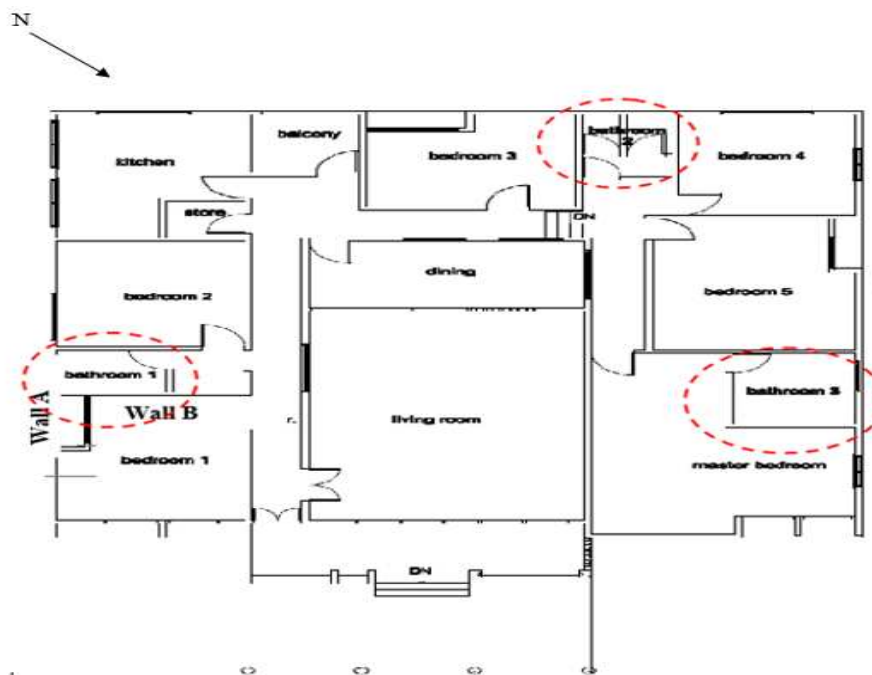
Inside the building, the walls of all the six bedrooms showed signs of dampness. The partition walls between the bedrooms and washrooms showed serious symptoms of dampness. Bedroom 1 (Fig. 5) was severely identified with this problem. Blistering of paint, flaking of

**Fig. 5:** Ground floor plan of building under investigation (not to scale)

Bathrooms 1 and 2 (Fig. 5 marked in red) had similar problems. Steady drips in concealed voids from around the spindles of the traditional stop valves amounted to substantial water escapes over prolonged periods and these penetrated the walls. In Fig. 16, drips of water is seen as a plumber tries to solve the problem.

The bathroom in the master bedroom (Fig. 5) suffered similar problems as seen in the first two bathrooms.
