## Condition Assessment of Heritage Structures: The Case of Fort Ikoma Historical Building in Serengeti National Park, Tanzania

The Fort Ikoma Historical Building, initially constructed by the Germans in 1905 and repurposed several times, holds significant cultural and military importance. Over the years, the fort has served as a hotel, an army-training centre, and an administrative centre and has undergone various structural and architectural changes. The main objective of this study was to assess the physical condition of the Fort Ikoma historical building in Serengeti National Park. This study assessed the fort's architectural and structural conditions through historical surveys, visual inspections, and materials analyses. The findings revealed significant deterioration due to weather exposure, lack of maintenance, and inappropriate interventions, leading to extensive decay in walls, roofs, and other structural elements. Nevertheless, a comprehensive Building Condition Assessment Rating System (BCARS) has revealed that the fort severely deteriorated with significant structural, architectural, and service-related defects. The building is rated five at a critical condition level,

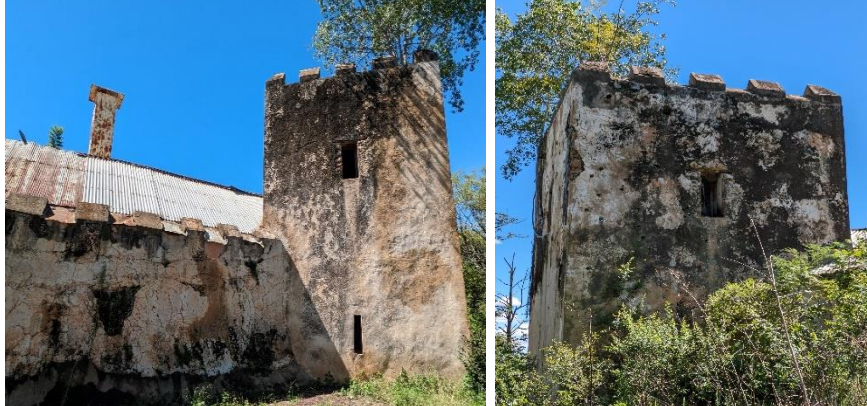
9

Spalling, Vegetation, Dampness, Fungus, and Efflorescence of Walls

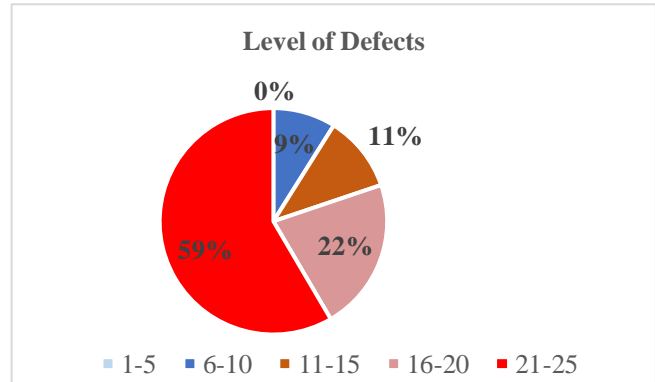
Figure 14  
 Defects Level Percentage for the Fort Ikoma Historical Building

No	Building Components	Number of Defects	Percentage
1	Building Structure	43	42
2	Building Fabric	50	49
3	Building Service	9	9
	<b>TOTAL</b>	<b>102</b>	<b>100</b>

$$\text{Building rating} = \frac{2098}{102} = 20.57 \approx 21(1)$$

Therefore, 21 Building Rating equals Rating 5.
