## Corrosion evaluation of glass fiber reinforced plastic (gfrp) Tanks & pressure vessels using acoustic emission technology

Mathias André<sup>1</sup>, Denis Siguret<sup>2</sup>, Anthony Foulon<sup>3</sup>, Salim Benmedakhene<sup>1\*</sup>, Pierre Mékarbané<sup>2</sup>, Abdelouahed Laksimi<sup>3</sup>, Christian Lemaitre<sup>4</sup>, Jérôme Favergeon<sup>3</sup>

<sup>1</sup> Technip: Parc Technologique des Rives de l'Oise, COMPIEGNE Cedex, France.
 <sup>2</sup> ARKEMA-Centre de Recherches Rhône-Alpes, PIERRE BENITE, France.
 <sup>3</sup> Université de Technologie de Compiègne, Laboratoire Roberval, COMPIEGNE cedex, France.
 <sup>4</sup> Université de Technologie de Compiègne, Equipe Avenues-GSU, EA 7284, COMPIEGNE cedex, France.

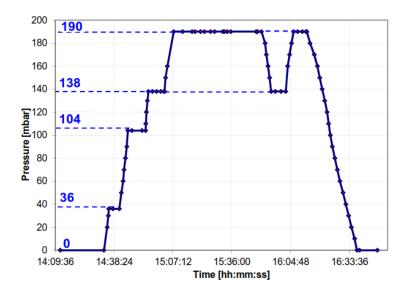
Figure 5. Loading sequence of the AE proof test on GFRP tank

For the passive monitoring, the bromine level was held at the in service level (70%) for 2 hours. For the AE proof test, the bromine was replaced with water (for safety reasons). Due to density difference, the water was pressurised up to a Pmax, pressure equal to 110% of the maximum pressure applied in service. The maximum pressure applied in service is equivalent to the in-service bromine liquid level. Figure 5 shows the loading sequence. The initial hold period (0 mbar) and the hold period at Pmax (190 mbar) were at least for 30 minutes. The intermediate hold periods were at least for 4 minutes. At the end of the sequence, an unloading followed by a reloading were applied in order to verify the Felicity effect.
