## UNDERPINNING AND EROSION PROTECTION AT THE UNIVERSITY ROAD BRIDGE, DAR ES SALAAM

# BRIDGE AT DARAJANI ON UNIVERSITY ROAD

UNIVERSITY ROAD BRIDGE  
UDSM, DEPT. OF CIVIL ENGINEERING

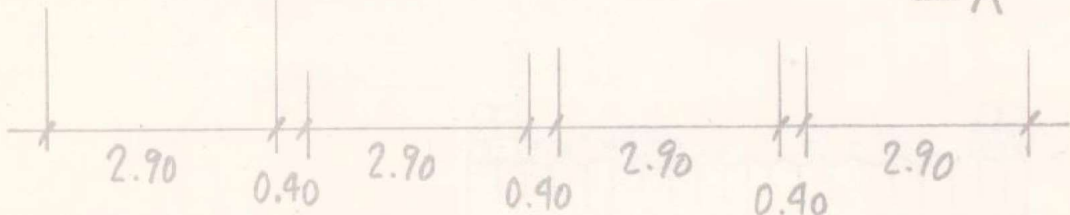
### A-A

MASONRY BROKEN OUT

The proposed measures are shown in the figures on page . The designed as masonry walls founded on plain concrete strip footings in a depth of 1 m below the slab.
