# Evaluation of MRI Artifact in some selected centers in Kano Metropolis, Nigeria

Sidi Mohammed, Muhammad Abubakar

Bayero University, Department of Medical Radiography.

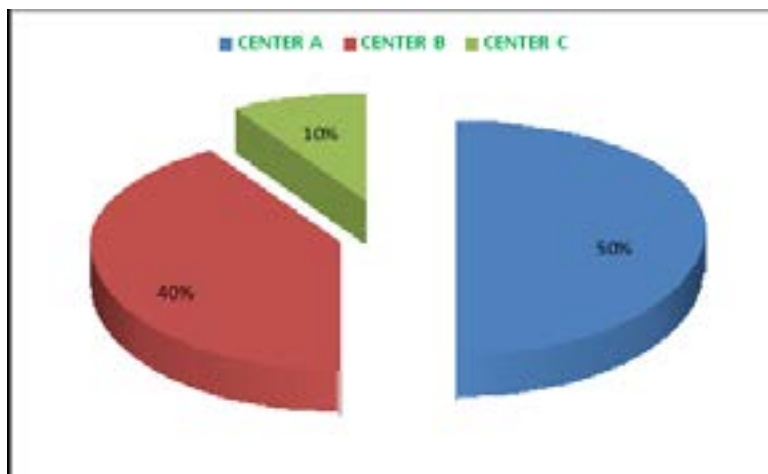
**Figure 1:** MR images from the study centres

The findings of the current study show that, 35 (50%) of the encountered artifacts were found in the series obtained from the Center A, 28 (40%) from the Center B, and 7 (10%) from the Center C as shown in Figure 1.
