# Surveillance of Gully Erosion in Damagum Town and Environs, Fune Local Government Area, Yobe State of Nigeria

## Abstract

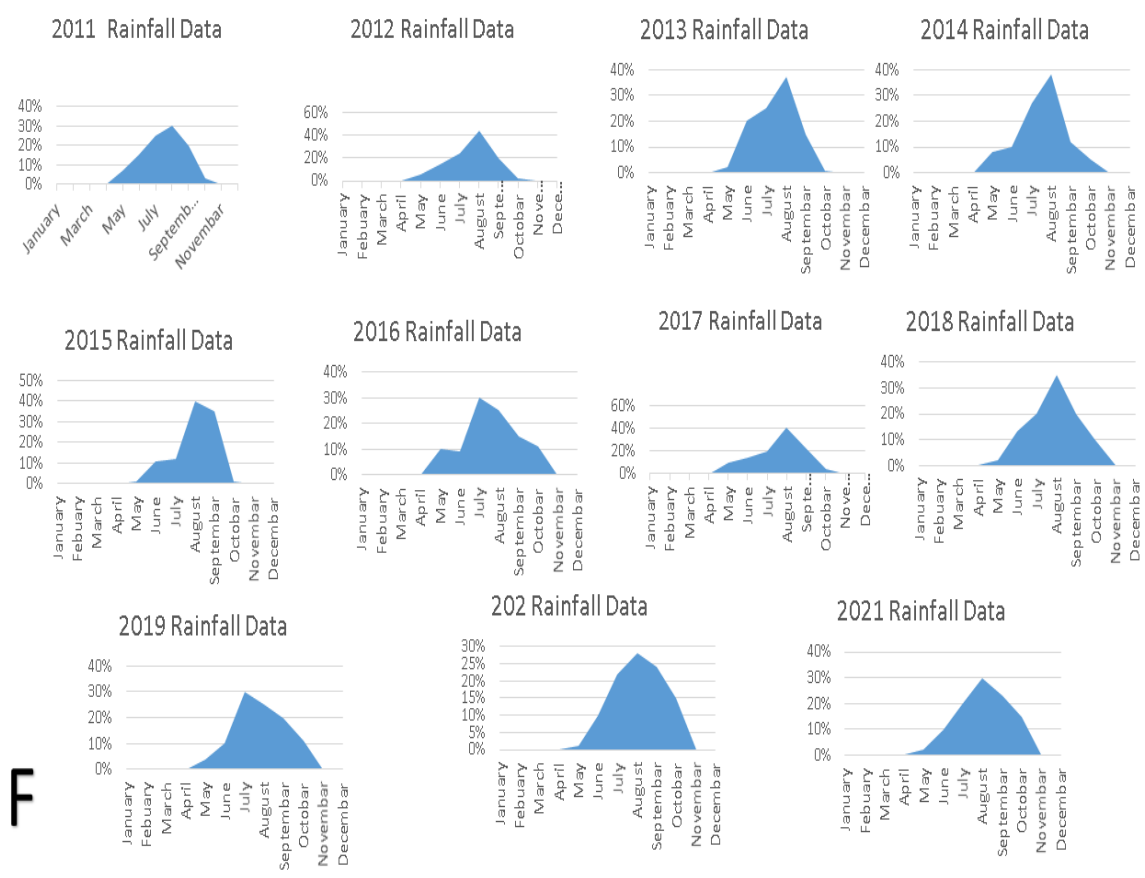
While (F) clearly indicate that Damagum are experiences rainfall for about six months, starting mostly from May and ends in October. The rainfall is at its peak in August and July, which indicates that most runoff and the destruction occur in these months. The concentration of the rainfall in raining season induces high runoff and effects high rate of erosion due to lack

of vegetation cover as reported in the work of Nagel and Nyanganji (1991). However, from figure a 6 it can be observed that from January to April and November to January there's no rainfall. Thus, this prolonged period of dry season and other anthropogenic activities result to drying of vegetation which in turn exposes the soil to erosion as assessed by Danlai *et al.*, (2014). The months of June, July and August on the other hand are characterized by heavy rainfall and since the soil is sandy in nature has low retention capacity it which enhances runoff and leads to so much destructions and increases the effect of gully erosion in the study area this is in line with the findings of (Ofomata, 2009). The work related rainfall intensity, rate of runoff, density of the vegetation cover and the size of the catchment area and conclude that if the amount of rainfall is greater than the holding capacity of the soil it will enhance runoff and accelerate the occurrence of gullies in the study area.

**Figure 6: - Monthly Rainfall of the Study Area for the last ten years**  
**Source: Fieldwork, 2022**

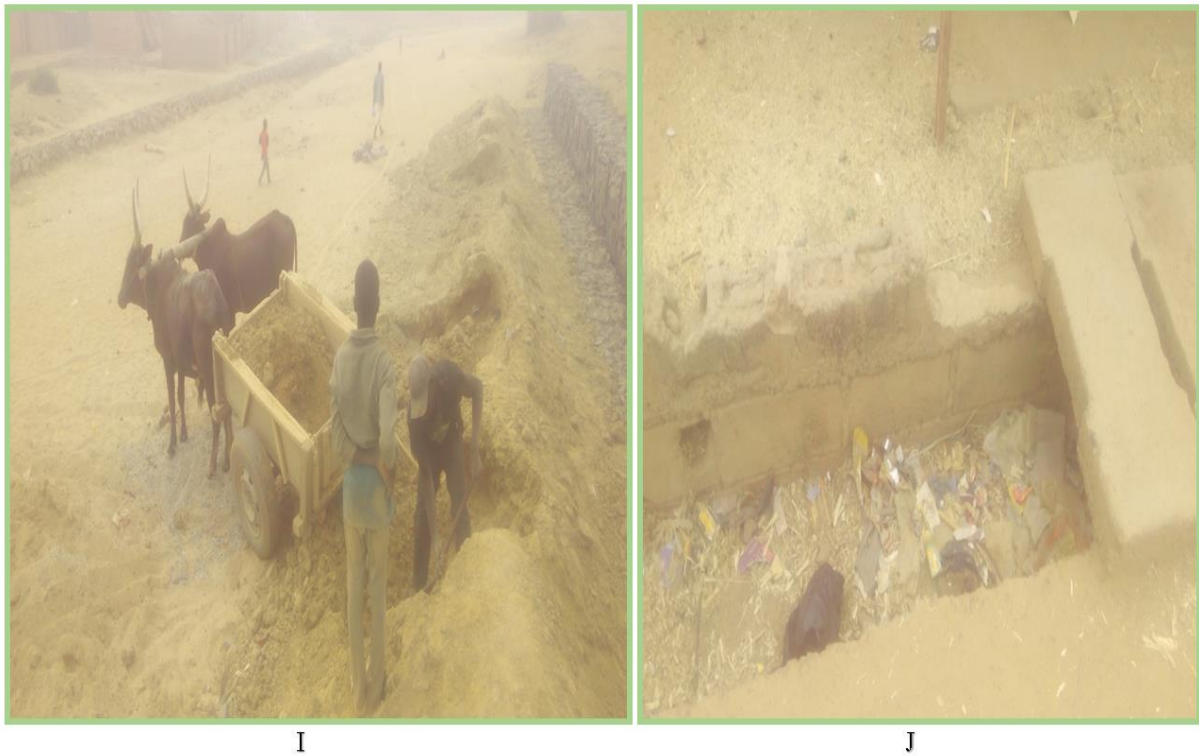
I  
J  
**Plate 1:- Some Human Activities Facilitating Erosion in the Study Area**  
Source field survey 2022

The first man-made factor that contributes to the gulying process identified in the study area is sand excavation as shown in **(I)** The people in the study area are highly engaged in sand excavation due to the high demand for sand by individuals and construction companies. Thus, this promotes excessive mining within the stream channels, which has already formed depression in the land forms as shown in plate 1 which results to a lowest point of 406m. While **(J)** is another cause of gully erosion in the study area. The members of Damagum community mismanage the environment. They dump waste into the drainage system and which causes blockage. This aggravates the damage of gully erosion.

Other man-made factors that contribute to gully erosion process have also been identified in this study. Plate (I) and (J) present them.
