Studying Bankline Migration of the Lower Pra Basin using Remote Sensing and GIS

The study investigated bank erosion and accretion of the lower section of the Pra River of Ghana using a topographical map of 1974 and satellite imagery of 2007, 2015, and 2018 which was augmented by field observation and key informant interviews. Bankline changes due to erosion and accretion and the total volumetric change in river channel were measured using Remote Sensing and Geographic Information System approaches. The study showed that erosion was more pronounced in both the right and left bank as compared to accretion. The study revealed that bank width area of the lower basin of Pra River increased by 50.7 m² from 16.2 m² in 1974 to 66.9 m² in 2018 eroding large portions of land along the right and left banks of the river. In general, the number of erosional spots in selected cross sections exceeded that of deposition. Erosion took place in 13 spots out of 20 spots constituting 65% with a rate ranging between 0.2 and 3.4 m/year. This research showed the value of channel morphological analysis as it brought to the fore, a quantitative perspective to bank erosion and accretion processes of fluvia

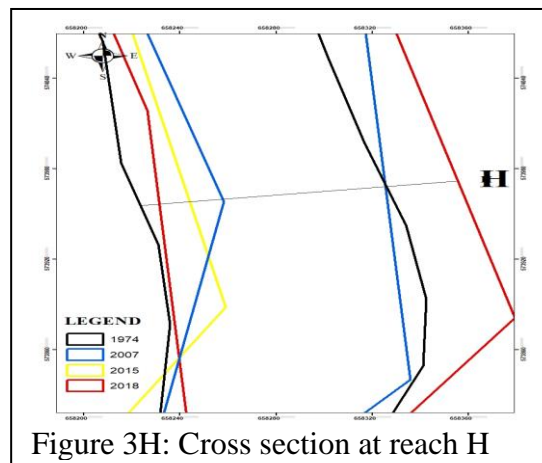
Figure 3H: Cross section at reach H

The changes at specified channel reaches are shown in Figs. 3A to 3J and the degree of changes are illustrated in Tables 2. The cross-sectional profiles indicated that certain areas of the lower Pra have experienced erosion; leading to the expansion of the channel reach while certain areas have experienced accretion resulting in an inward shift in channels. For example, between 1974 and 2007, four reaches of the right (A, G, H, and J) experienced channel accretion ranging between 18.8 and 101.9 m with a mean of 51.9 m while the remaining 6 reaches were eroded (B, C, D, E, F, and I) with a mean bank erosion of 24.4 m (Table 2). However, from 2007 to 2018 bank erosion was the dominant geomorphic process at all the right bank cross sections producing bank migrations ranging between 10 and 128.5 m with a mean of 38 m (Table 2). However, unlike the right bank, the left bank was subjected to more accretion than erosion between 1974 and 2018. Accretion occurred within 6 reaches and the magnitude ranged between 5.9 and 66 m with a mean of 33.1m while erosion happened in 4 sections and ranged from 0.8 to 32.7 m with a mean of 13.8m (Table 2). However, except cross section D where there was an accretion of about 12 m, the rest of the other profiles were subjected to bank wearing ranging from 0.5 – 156 m and a mean of 27.8 m between 2007 and 2018. Comparatively, accretion occurred in fewer sections, 4 out of 10 (40%) at the right bank however, in the left bank it was dominant, 6 out of the 10 sections (60%) between 1974 and 2007.

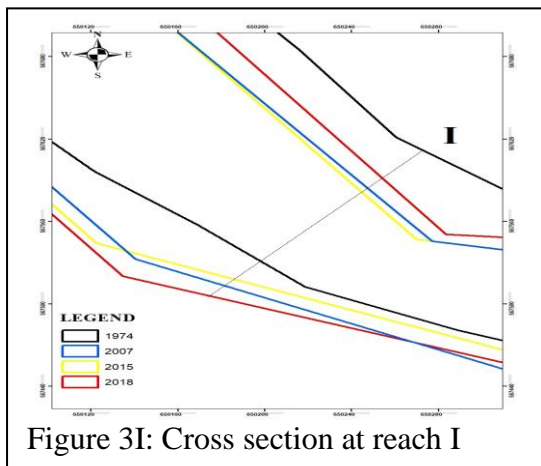
Figure 3I: Cross section at reach I

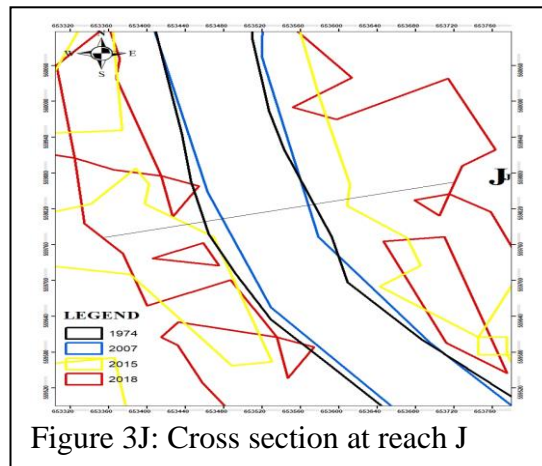
Figure 3J: Cross section at reach J

downstream to the mouth at cross section J at Shama. The issue related to mangrove harvesting was confirmed by the Assemblyman of Shama that:

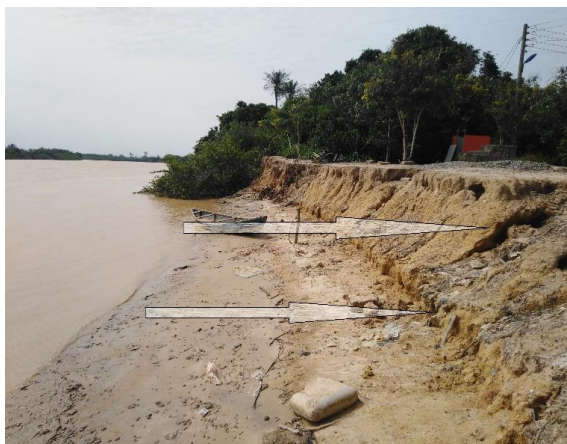
Figure 4a: Riverbank erosion at Krobo
Source: Field survey, 2019

Figures 4a and b show the extent of bank erosion at Krobo and Bosomdo all within Shama which has increased channel width of the river destroying farmlands, vegetation and settlements. It was also revealed from some of the key stakeholders that during the 2007 and 2018 period, illegal alluvial small scale gold mining activities were now rife within this section of the river. These activities involve the use of changfan, shovels and pickaxes to excavate bank materials for gold extraction. The excavation of riverbanks for gold by artisanal small-scale miners widened riverbanks accounting for the increased in bankline shifts during this period.

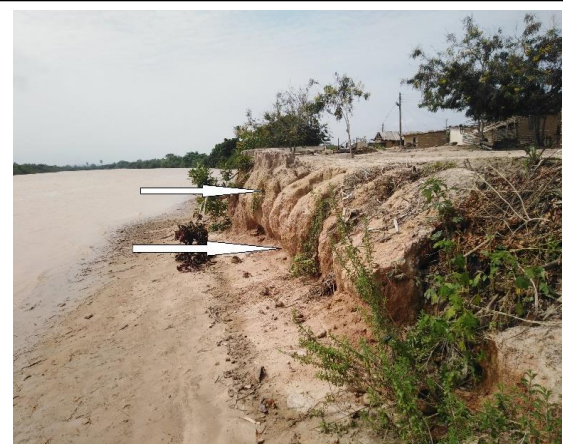
Figure 4b: Riverbank erosion at Bosomdo
Source: Field survey, 2019
