# EVALUATION OF CORROSION AND ENCRUSTATION POTENTIALS OF GROUNDWATER WELLS IN CALABAR AREA, SOUTHEASTERN NIGERIA

## E. A. AMAH, E. O. ESU AND E. E. U. NTEKIM

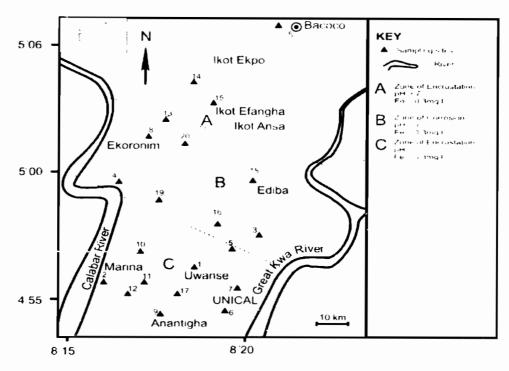
Fig. 1: Map of Calabar showing the study locations (see table 1), Corrosion and Encrustation Zones

The area under investigation lies between latitude 4°50' and 5°06'N and longitude 8°15' and 8°25'E (Fig. 1). It is characterized by a humid tropical climate with high temperatures (annual mean 26°C), high relative humidity (annual mean 85%) and high precipitation (annual mean 3855mm). Over 80% of the rainfall is recorded within the wet season (April to October) while the highest temperature is, recorded during the dry season that starts in November and ends in March (Edet et al. 2003). The area is drained by the Calabar River in the west and the Great Kwa River in the east (Fig.1).

In general, the study area can be divided on the basis of CEIP into three zones A, B and C. Zone A is characterized by water of pH>7, Fe≤0.3mg/l (Fig. 1) as found in the area, north of Calabar. Zone B and C are peculiar to the central and southern area of Calabar. The water in Zone B is acidic with pH<7, Fe≤0.3mg/l while Zone C has a high encrusting index parameters (pH>7, Fe>0.3mg/l).

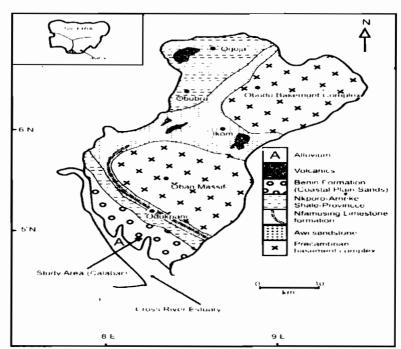
Fig. 2: Generalized geologic map of Cross River State including study area (after Ekwueme et al., 1985)

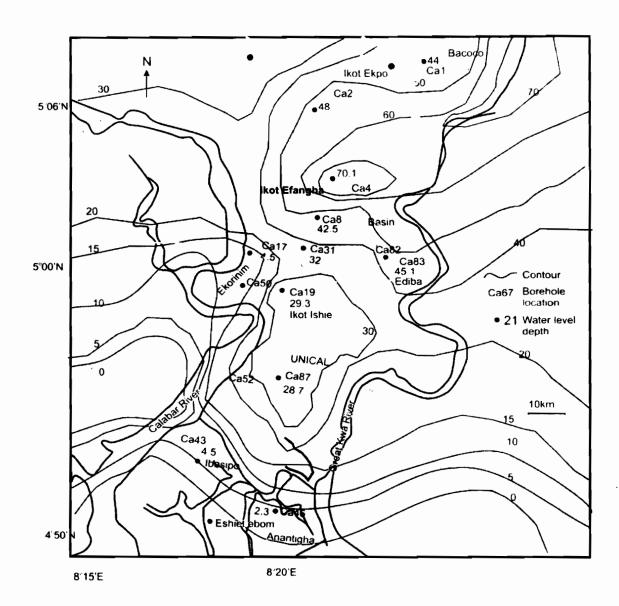
Fig. 3: Depth to water levels with respect to ground surface

cheisses, schists, granodiorite, granite, pegmatite, tonalite, charnokites and migmatites (Rahman et al. 1981, Ekwueme et. al., 1995). However, the Benin Formation (Coastal Plain Sands) is by far the most prolific aquiferous units in the area and all boreholes are located in this formation (Esu and Amah, 1999). Alluvial deposits aquifer overlies the Benin Formation in the southern parts of the study area. The depth of occurrence of groundwater in the formation varies from one locality to another but becomes progressively shallower coastward (Fig.3).

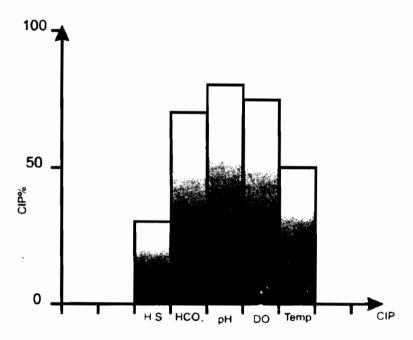
Fig. 4a: Histogram of percent Corrosion Index parameters (CIP

The higher the temperature of groundwater the more aggressive the environment and consequently the tendency towards corrosion of borehole installations as found in boreholes drilled in the Chad Basin of Borno State of Nigeria with surface temperature of not less than 28°C (Ogomigo, 1985). Temperature in Calabar area ranged from 25.0-27.5°C and may encourage corrosion of borehole installations. The high acidity (or low pH), dissolved oxygen DO, bicarbonate HCO<sub>3</sub> and Temperature (Fig.4a) are therefore the major causes of corrosion in Calabar area (Table 2).

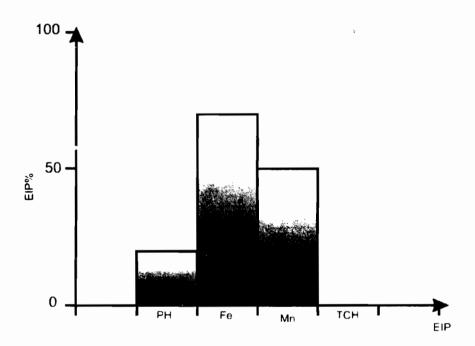
Fig. 4b: Histogram of percent Encrustation Index Parameters (EIP)

Encrustation may also result from fine particles of clay and silt being carried unto the screen in suspension. When this occurs, it is probably due to improper development of the borehole, wrong choice of screen slot size or screening a portion of the hole containing an abnormal amount of these materials. Encrustation from precipitation of carbonates of calcium and magnesium or their sulphates to form a scale is not common in the study area. The carbonate hardness recorded ranged from 2.35 to 8.5mg/l. Water with high concentration of total carbonate hardness exceeding 100mg/l leads to the formation of scales in boilers, encrustation of screens pipes and will not form lather with soap (WHO, 1993). According to Durfor and Becker (1964) hardness values of 0 to 60mg/l is an indication of soft water. Thus the groundwater is soft and its contributions to encrustation of water wells in the area is minimal. Encrustation of groundwater wells in the study area is therefore mainly due to high total Fe and Mn contents of the water (Fig.4b).
