## SLOPE ANGLE ESTIMATION OF AMOANDA EAST PIT OF ABOSSO GOLD FIELDS, GHANA

*This paper determines the possible modes of slope failure, and the effect of increasing the slope angle of the Amoanda East Pit Wall of Abooso Gold Fields Limited, Damang Mine by 5° and 10° from 70° because the designed slope angle (70°) will increase ore losses at Amoanda East. The methods employed include field geotechnical mapping of the slope face, and kinematic analysis using DIPS 6.0 software to analyse the modes of failures. Based on the kinematic analysis conducted using the slope angle per design (70°), it was found that the percentage of toppling, planar and wedge failures obtained were 20.05%, 5.41% and 0% respectively. Also, when the slope angle of Amoanda East Pit Wall was increased by 5° (75°) and 10° (80°), there was percentage increase in toppling and planar failures of (0.12 and 0.99) % and (2.59 and 4.18) % respectively, with no increment in wedge failure. Hence there is the possibility of planar and toppling failure with no wedge failure occurring at the Amoanda East. It is therefore recommended that, since the percentage increment in toppling and wedge were not significant when the slop

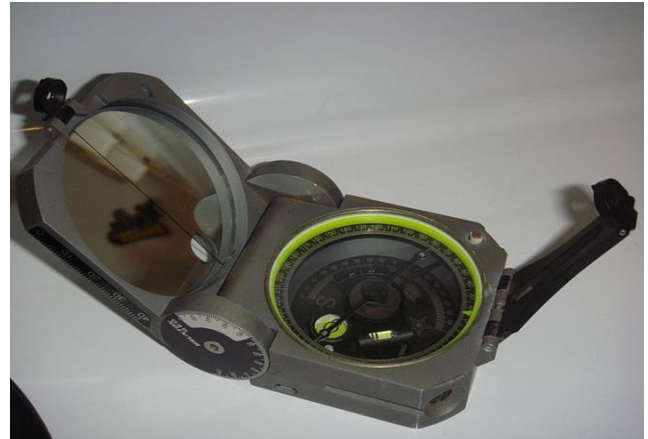
Figure 1: Brunton Compass

rock mass was done primarily by Window Mapping on the Amoanda East wall using a Brunton Pocket Transit, and kinematic analysis was done by the use of DIPS 6.0 software of Rock science. A diagram showing a Brunton Compass is shown in Figure 1.

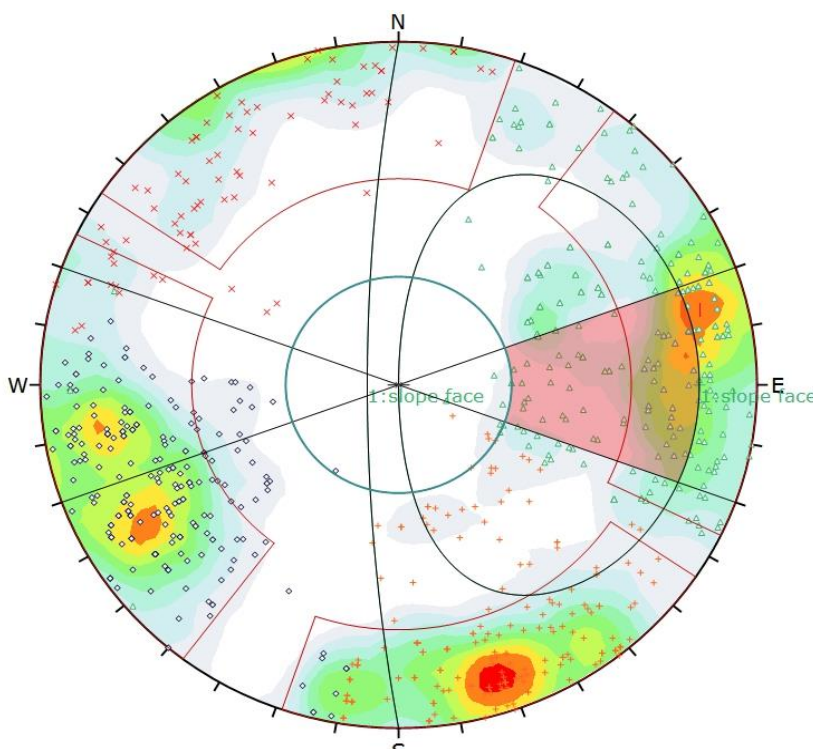
Stereonet analysis was performed for planar failure to indicate the unstable zones and the joints set that have the same property and behaviour. The extent of concentration of the joint sets have been displayed beside the stereonet in a legend, frictional cone and a daylight envelope, and planes showing the slope face were plotted during the analysis.

The crescent shape formed by the daylight envelope and the cone of friction encloses the region of planar sliding (unstable zone) and any joint found at that region represent joints which fell at the critical zone. For this type of failure to occur, the discontinuities must daylight (be seen) on the slope and must be near parallel to the slope face, at an angle greater than the angle of friction of the slope. A kinematic analysis

result of planar failure of the Amoanda East wall with a slope angle of 80° has been illustrated in Fig. 2

Symbol	TYPE	Quantity
◇	joint 1	234
×	joint 2	78
△	joint 3	298
★	joint 4	203

Color	Density Concentrations
	0.00 - 0.60
	0.60 - 1.20
	1.20 - 1.80
	1.80 - 2.40
	2.40 - 3.00
	3.00 - 3.60
	3.60 - 4.20
	4.20 - 4.80
	4.80 - 5.40
	5.40 - 6.00

Pit Area	Slope Dip Direction	Modes of Failure	Slope Angle	Percentage of Total Planar Failure	Comment
Amoanda East Wall	270°	Planar Failure	70°	5.41%	Percentage of Planar Failure to occur at this angle is minimal.
Amoanda East Wall	270°	Planar Failure	75°	8.00%	Percentage of failure is minimal
Amoanda East Wall	270°	Planar Failure	80°	12.18%	Percentage of failure is moderate

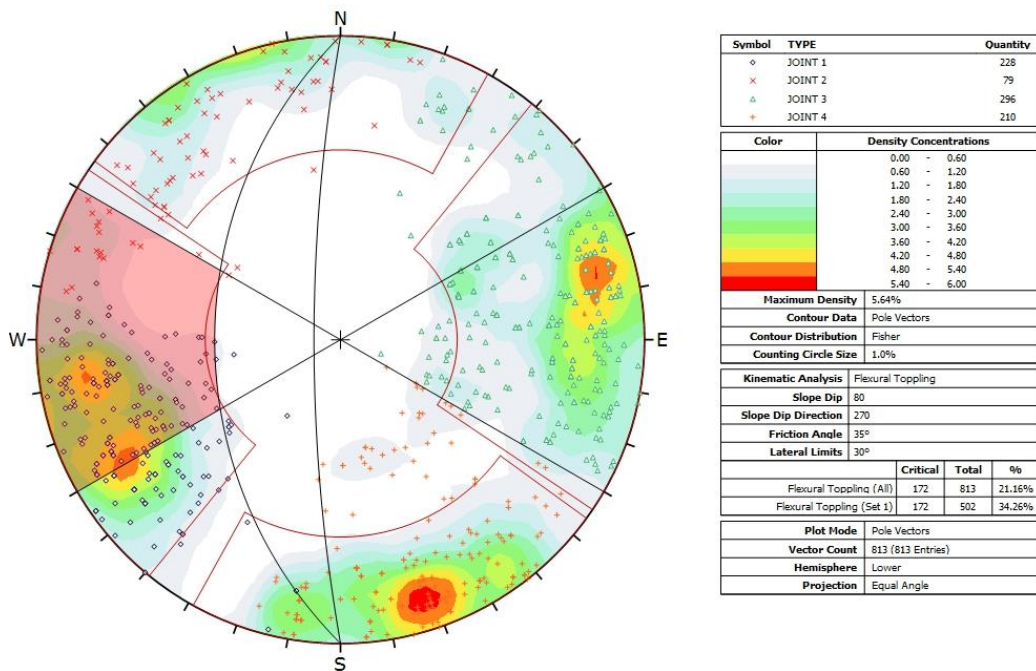
Fig. 3: Toppling Analysis of the Amoanda East Wall at 80

A toppling failure may result when a steeply dipping discontinuity dips away from the slope face and dips into it at an angle greater than the angle of friction of the slope [5]. In analyzing toppling, a slip limit based on joint frictional cone and pit slope which defines area of restriction or toppling was plotted. The poles that fall within the region created by the slip limit and the toppling envelope, forms the region for toppling failure. The result of toppling failure for slope angle of 80° has been shown in Fig. 3. The result of the planar analysis has been summarized in Table 5. A summary of the kinematic analysis for toppling failure, has been shown in Table 6.

Pit Area	Slope Dip Direction	Modes of Failure	Slope Angle	Percentage of Total Toppling Failure	Comment
Amoanda East Wall	270°	Toppling Failure	70°	20.05%	Percentage of Failure is moderate
Amoanda East Wall	270°	Toppling Failure	75°	20.17%	Percentage of failure is moderate
Amoanda East Wall	270°	Toppling Failure	80°	21.16%	Percentage of failure is moderate

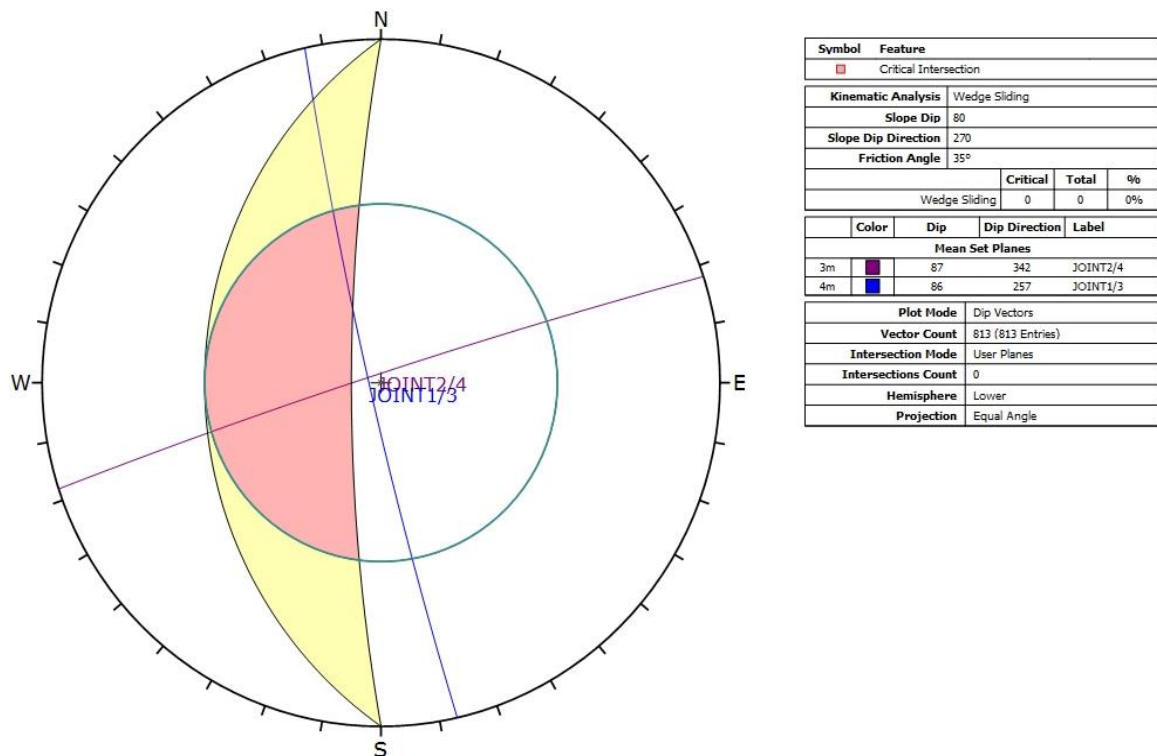
Fig. 4: Wedge Analysis of the Amoanda East Wall at 80°

For wedge failure to occur, the point of intersection between two discontinuities should be enclosed in the plane of friction cone and daylight into the slope face. A kinematic analysis results of wedge failure of the Amoanda East wall with a slope angle of 80° has been displayed in Fig. 4. A summary of the kinematic analysis for wedge failure, has been shown in Table 7.

Pit Area	Slope Dip Direction	Modes of Failure	Slope Angle	Percentage of Total Wedge Failure	Comment
Amoanda East Wall	270°	Wedge Failure	70°	0.00%	No Failure
Amoanda East Wall	270°	Wedge Failure	75°	0.00%	No Failure
Amoanda East Wall	270°	Wedge Failure	80°	0.00%	No Failure
