## Surface Characteristics Analysis and Adherence Evaluation of Hot-Dip Galvanized Low Alloy Steel

Lamia Darsouni<sup>\*1</sup>, Mohamed Zine Touhami<sup>1</sup>, Abdelkader Khettache<sup>2</sup> & Omar Benchiheb<sup>1</sup>

<sup>1</sup>Foundry Laboratory, Department of Metallurgy, Badji-Mokhtar University, PO Box 12, 23000, Annaba, Algeria.

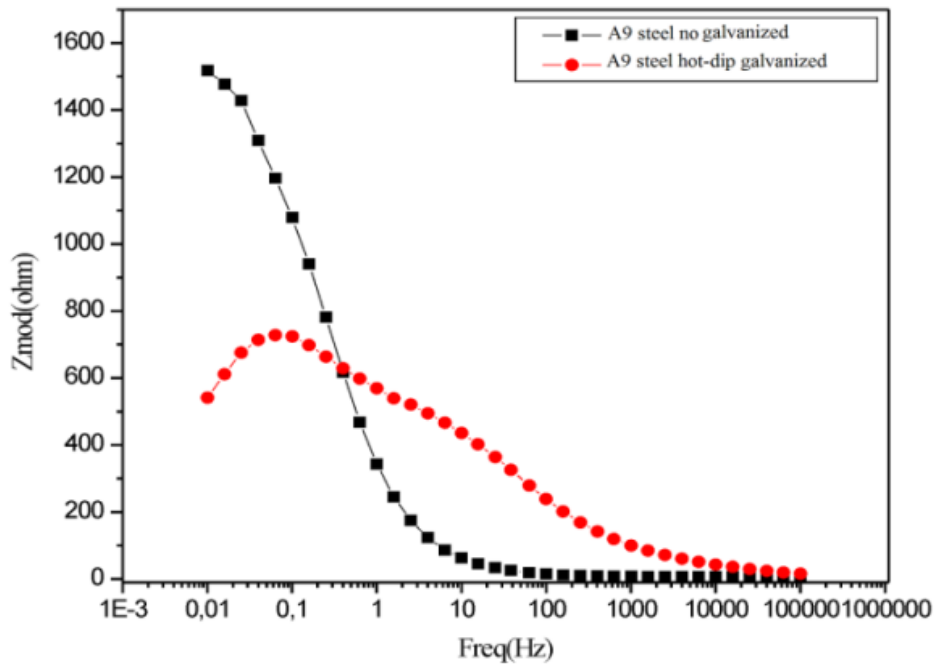
Figure 13. Variation of electrochemical impedance versus a frequency of A9 steels before coating and after hot-dip galvanized.

Figure.13 shows the evolution of the electrochemical impedance as a function of the frequency of the samples before and after galvanization. It has been found that for low frequencies, non-galvanized A9 steel has a high corrosion resistance characterized by the “Z” impedance, this increase being related to the surface state which is formed of highly resistant Iron Oxides corrosion and has good adhesion to the substrate. At high frequencies, we recorded a very significant decrease in impedance following the breakdown of the Iron Oxide film. For the Fe-Zn layers, it has been found that for low frequencies the impedance is low compared to the non-galvanized state, but at high impedances, the impedance decrease is less accentuated, probably due to the effect of the Fe-Zn layers which have better corrosion resistance and the destruction takes place progressively.
