Establishing Ground Vibration Threshold Level for Open Pit Mining Environment - A Case Study*

S. K. Yomekpe-Agbeno and M. Affam

Yomekpe-Agbeno, S. K. and Affam, M. (2008). "Establishing Ground Vibration Threshold Level for Open Pit Mining Environment - A Case Study", *Ghana Mining Journal*, pp. 19 - 24.

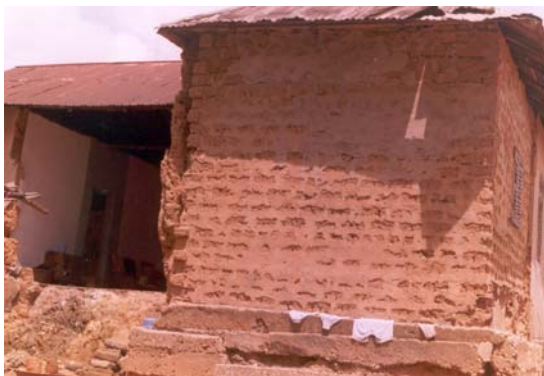
Associated foundation problems within the settlement resulted from factors attributed to poor foundation footings, shallow foundation depths, and seasonal weather changes, removal of vegetation cover, intensive surface run-offs, earth flow and clayey soil conditions. Most of these buildings have no drains around them and as there is little or no vegetation cover the foundations have been severely eroded resulting in the virtual suspension of many of structures.

Maintenance work on buildings has to be predictable (i.e. regular periodic work as and when necessary) or avoidable (i.e. required to rectify failure). Failure to engage in early repair work could result in eminent structural collapse (Fig. 1). It was noted most of the buildings within the settlement had not been given any major repairs or maintenance for a very long time while some of the structures had been left at the mercy of the weather.

Fig. 1 A Landcrete House with Distressed Foundation

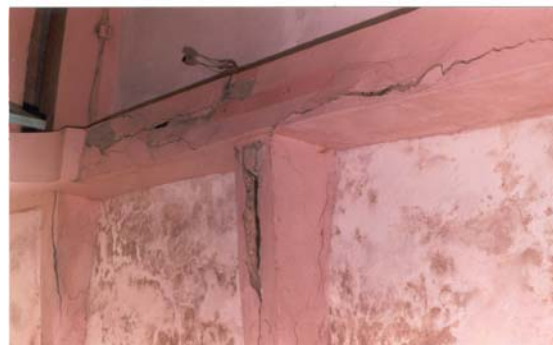
Prestea township the prevalent source of vibrations is attributed to the activities in the nearby open pit mine. Although investigations by building and road research establishments show that the risk of damage to normal buildings by vibration is extremely small (Seeley, 1985), blast vibrations from the pit may have compounded the already precarious situation at the township (Fig. 2).

Fig. 2 Serious Multiple Crack Damage in Building Attributed to Blasting
