The story of a lost guidewire

S Afr J Crit Care 2014;30(2):58. DOI:10.7196/SAJCC.195

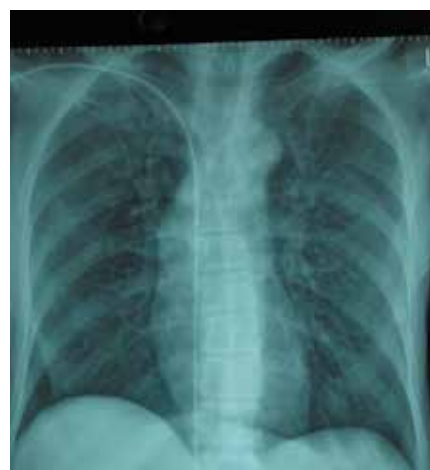
A 67-year-old male patient presented as an emergency with shock. The patient responded poorly to resuscitation, so central line placement was planned for central venous pressure (CVP) monitoring and for inotropic support. After skin disinfection and draping, the right infraclavicular subclavian route was attempted. Venous blood was aspirated and the guidewire was introduced smoothly. The cannula was removed with the guidewire *in situ* and the dilator was advanced to create a track. While advancing the dilator, the end of the guidewire accidentally slipped from the operator's hand. On withdrawal of the dilator, the guidewire was missing. A small incision was made at the insertion site to find the end of the guidewire in the subcutaneous tissue, but this was unsuccessful. A mobile chest X-ray revealed the guidewire passing from the right subclavian vein, through the heart to the inferior vena cava (Fig. 1). An interventional radiologist removed the guidewire via the femoral vein using a gooseneck snare. The patient recovered uneventfully.

Fig. 1. Chest X-ray revealing the guidewire passing from the right subclavian vein, through the heart to the inferior vena cava.

Lost guidewires must be retrieved and the method of choice is intervention radiology,^[2,3] although open surgical procedure is also reported.^[4] Usually retrieval is uncomplicated, but complications might arise due to fragment embolisation or from the formation of a thrombus over the guidewire.^[2,3]

- Avoid distractions during the catheter insertion.
- The length of the guidewire should always exceed that of the catheter.
- Never let go of the guidewire, which should be held either at the proximal end or at the skin puncture site, during the dilatation step *and* during the catheter insertion.
- After the procedure, always check the presence of the used guidewire in the procedure tray.
- As a routine, an early postprocedure X-ray should be performed to check for a lost guidewire and other complications.
- As measured by Andrews *et al.*,^[5] the distance between skin puncture site and cavo-atrial junction via various approaches is between 16 cm and 21 cm; we advise not to insert the guidewire beyond that required length.
