Influence of irrigation on the level, salinity and flow of groundwater at Vaalharts Irrigation Scheme

PMJ Verwey^{1*} and PD Vermeulen²

¹Department of Agriculture Forestry and Fisheries, Agricultural Engineering Services, Private Bag X 515, Silverton 0127, South Africa
²Institute of Groundwater Studies, University of the Free State, PO Box 339, Bloemfontein 9300, South Africa

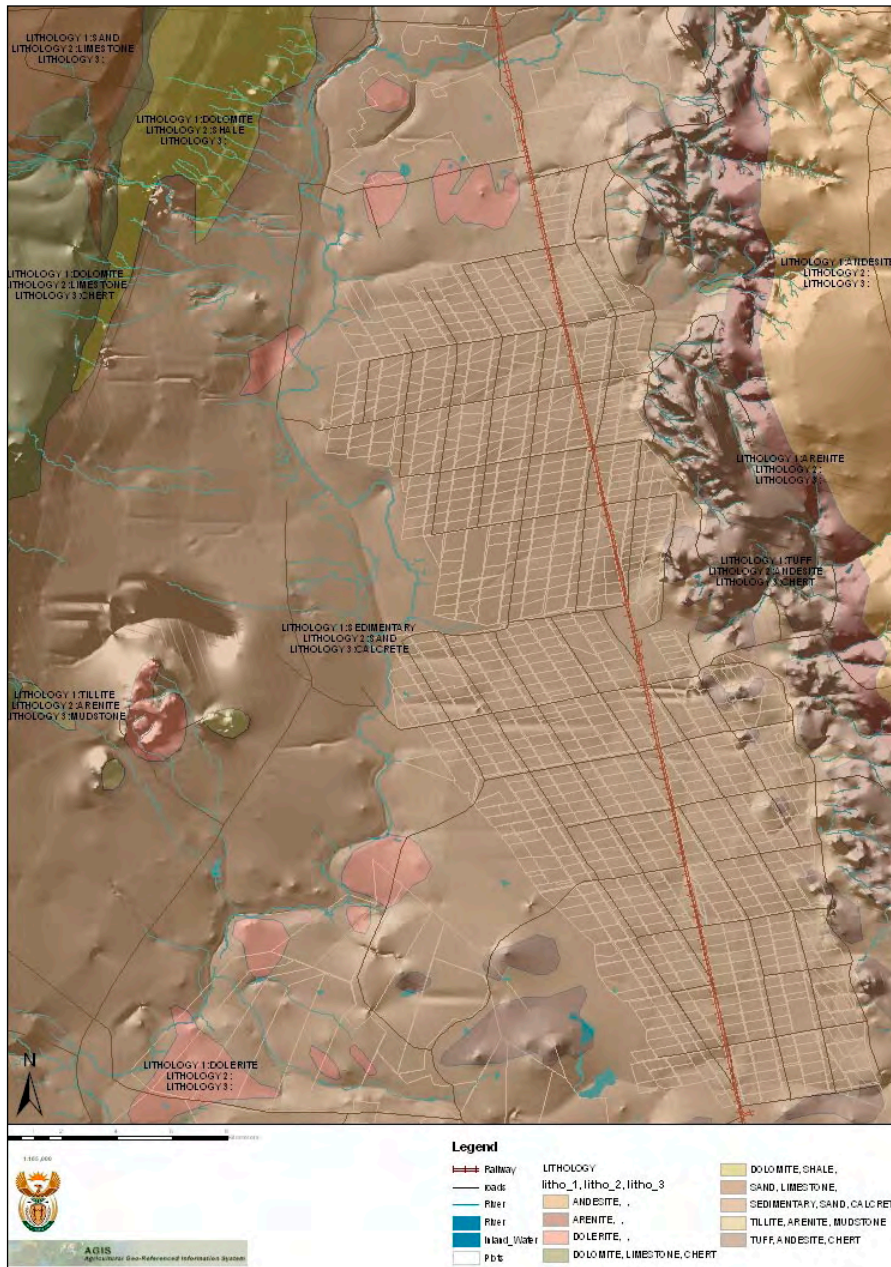
Figure 2
Lithology of the study area

The irrigation area is situated in a glacial valley which is drained by the Harts River. The altitude ranges from 1 050 to 1 175 m a.m.s.l., changing towards the west. The map provides a good idea of the topography (Fig. 2; AGIS, 2009). The irrigation scheme is predominantly flat, as 70% of the area comprises slopes of less than 1%. The lithostratigraphy classification of the area was named as the Bothaville Formation, Rietgat Subformation. The Rietgat Formation in the Taung-Jan Kempdorp area is known as the Phokwane Formation of the Hartswater Group. The Phokwane Formation mainly consists of porphyrite lava, volcanic tufa, tuffaceous sediments and chert (Schutte, 1994).

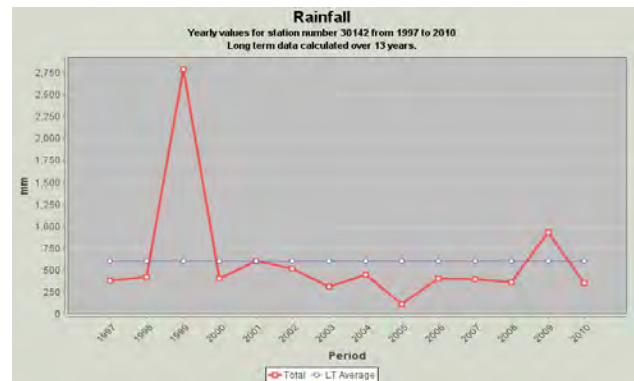
Figure 3
Yearly rainfall

The median annual simulated run-off in the area is in the range of 20 to 41 mm, with the lowest 10-year recording at 4.8 to 9.3 mm (Schmidt et al., 1987). The rainy season for the area is usually from October to March. In the winter months, almost no rainfall occurs. The average rainfall in the area is 477 mm in Jan Kempdorp and 450 mm in Taung (Figs. 3 and 4, AGIS, 2009). The average temperature of the spring and summer months is above 30°C and usually highest in February. Evapotranspiration due to the application of irrigation water, higher rainfall and plant growth in this month are high. The importance and relevance of evapotranspiration refers to the calculation of water use by a plant during a given season. The total average evapotranspiration for the crops planted in the study area for the period of study was 1 030 mm (Fritz, 2009) taking the growth cycle of the 2 most planted crops (maize and wheat) into consideration this figure can be reworked to 774 mm for the research period.

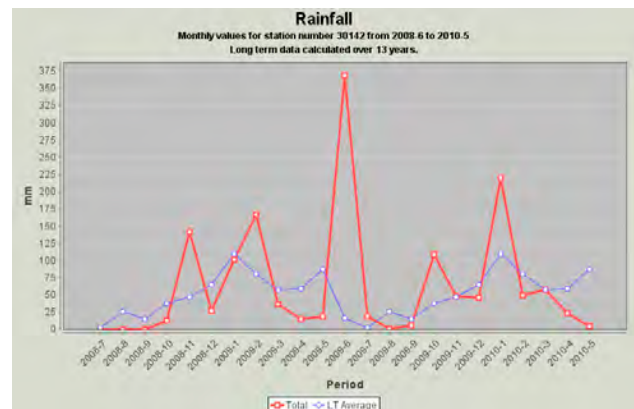
Figure 4
Monthly rainfall covering the study period

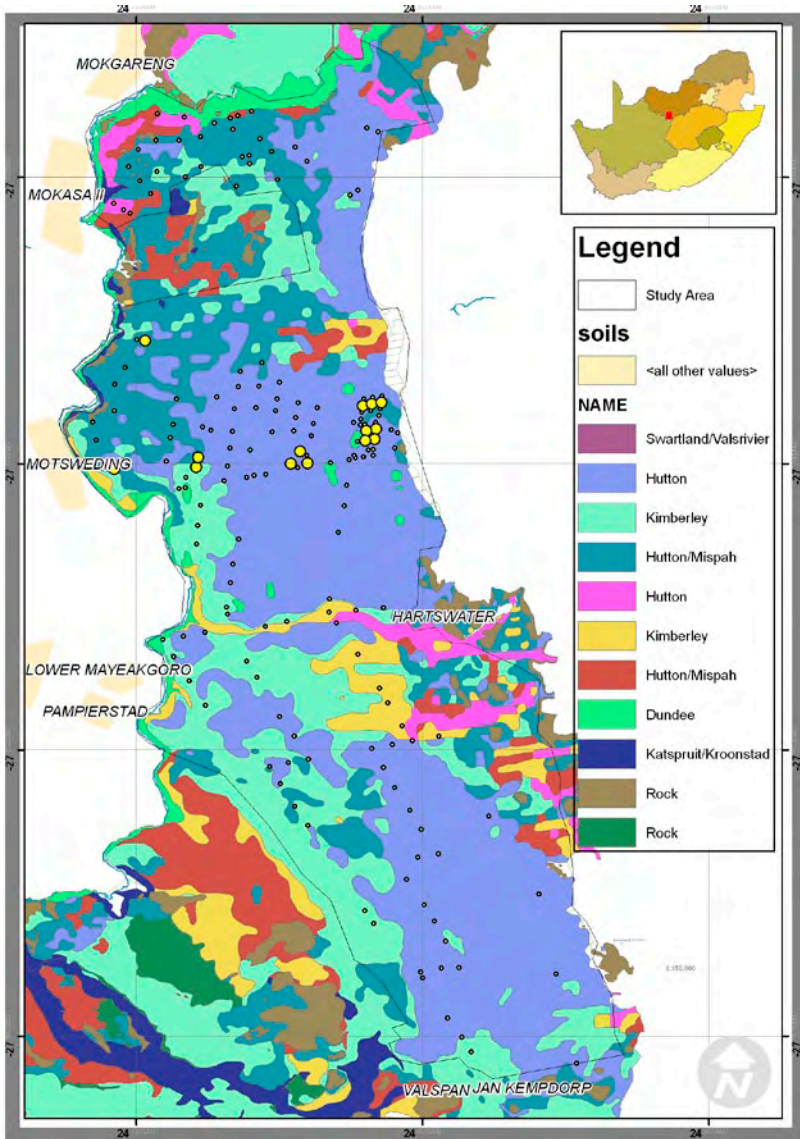
Figure 5
Soil map of the area showing also position of piezometers

The soils in the area are alluvial and described as Kalahari Sand (Hough and Rudolph, 2003) (Fig. 5). The soil layer is more than 3 m deep in this area. Soil types found in the study area are: Hutton, Kimberley, Hutton/Mispah, Dundee and Katspruit/Kroonstad (Barnard, 2008). On average soil mainly

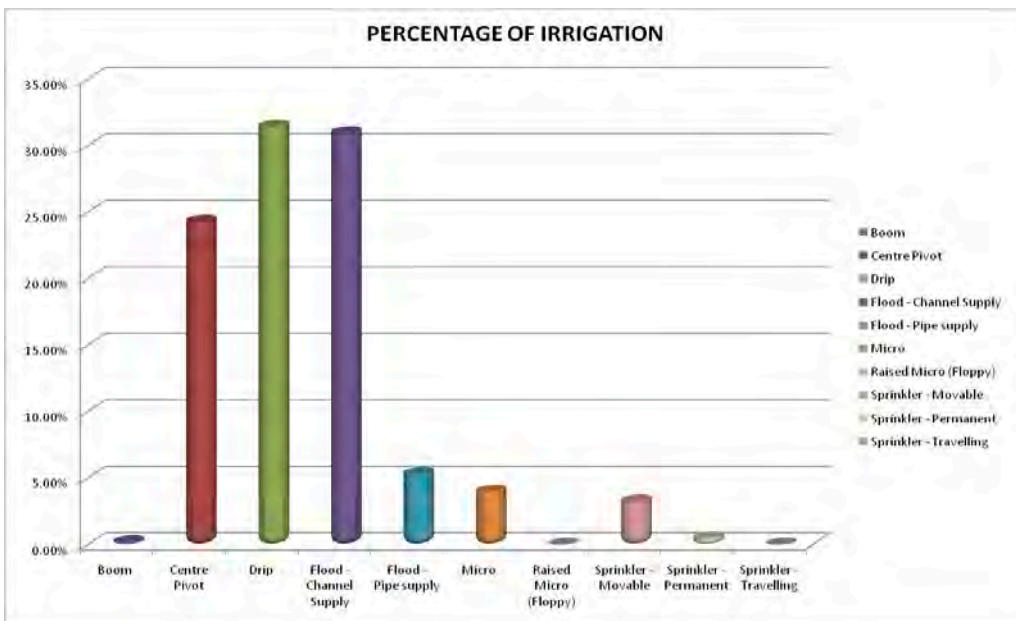
Figure 6
Comparison of the use of different irrigation methods

Vaalharts is the oldest irrigation scheme in the country and some of the farmers still make use of flood irrigation. Many farmers have changed to other practices like centre irrigation pivots and drip, due to the greater effectiveness of these systems.

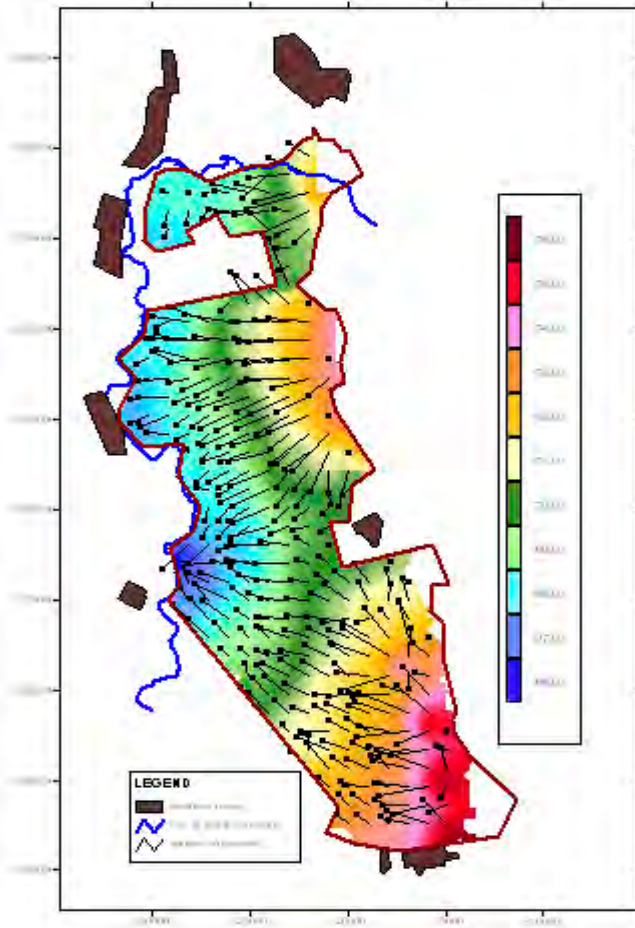
Figure 10
K-Value contour map

The K-value was determined by means of field tests. The groundwater was pumped or bailed out of the piezometers and the return flow was measured. Hooghoudt's method was used to rework the figures and determine the K in m/d. These values were used to develop a K-value contour map.

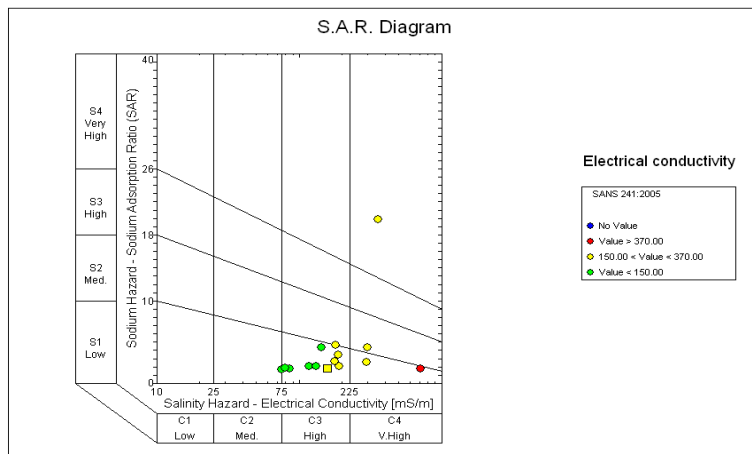
Figure 14 (above)

SAR Diagram of the groundwater samples taken from the 22 piezometers

- Continuous irrigation with water containing a SAR value >10 has detrimental effects on the crops. Samples taken in the area have a salinity index of high to very high but only one, m21, had a SAR of more than 10.
