The effect of ultrasound at 256 KHz on *Microcystis aeruginosa*, with and without gas vacuoles

Abstract

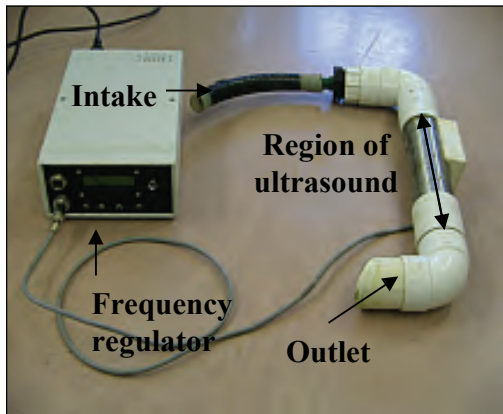
Figure 1
Ultrasonic flow device with frequency regulator

For the ultrasonic treatment, an ultrasonic flow device was used (Fig. 1). The water was circulated through it at a constant flow rate of 15.4 l/min. The frequency used was 256 KHz. For both cultures, a control culture was prepared. All basins were manually stirred twice a day to detach cells attached to surfaces.

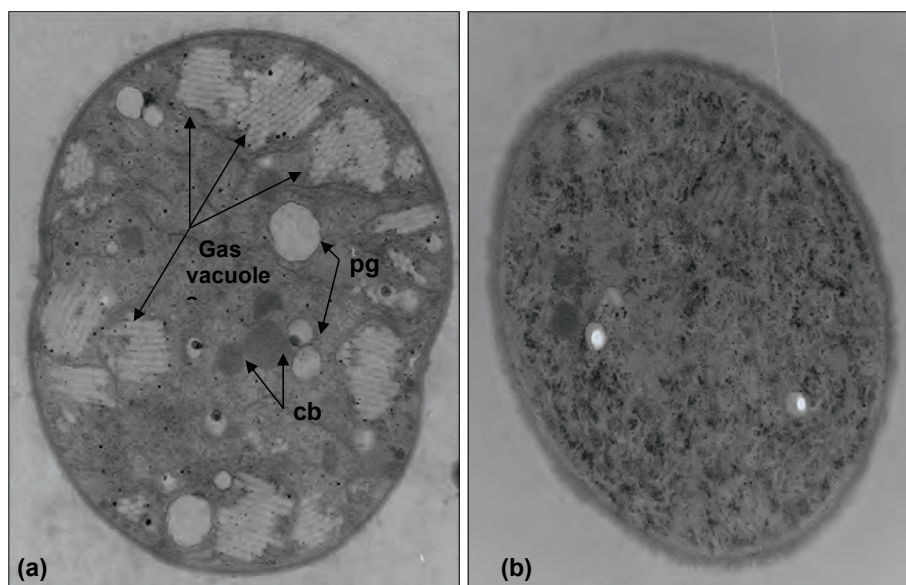
Figure 2
TEM picture of *M. aeruginosa* (a) HB Dam culture containing many gas vacuoles, phosphate granules (pg) and crystalline bodies (cb) (b) laboratory culture containing no gas vacuoles

within a few minutes, while the culture from the HB Dam continued floating, except for a few single cells that settled out. The HB Dam culture did however settle to the bottom after 9 d and 14 d. Figure 2a shows gas vacuoles in the *M. aeruginosa* HB Dam culture. In contrast to this, Fig. 2b shows a cell of the laboratory culture that did not contain any gas vacuoles. Several additional cells of both cultures were investigated and showed the same structural characteristics. In addition the HB Dam cells showed several granules, most likely phosphate granules and crystalline bodies, while the laboratory culture cell showed no granules.

TEM analysis of the two cultures confirmed that the HB Dam culture contained gas vacuoles and the laboratory culture did not. This can be

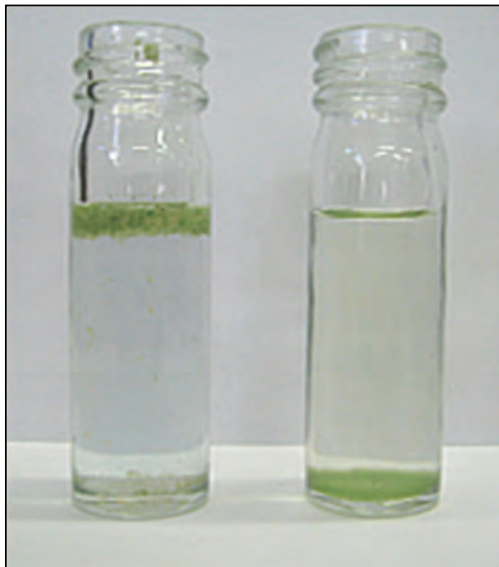
Figure 3
Floating characteristics of control and treated HB Dam culture

To examine the influence of ultrasound on the *M. aeruginosa* HB Dam culture, one basin was treated with ultrasound continuously for 9 d. During the experiment the cyanobacteria of the control, which was not treated with ultrasound, were floating on the water surface. From 6 d onwards some cyanobacteria in the control settled to the bottom. Their colour started to change from deep green to brown, which indicated a lack of chlorophyll-*a*. In the ultrasonic-treated basin the cellular aggregates, which were observed before the start of the experiment, disappeared after 1 day and no floating was noticeable in this basin anymore (Fig. 3). The experiment was repeated with the *M. aeruginosa* laboratory culture. During the experiment no cells were buoyant.

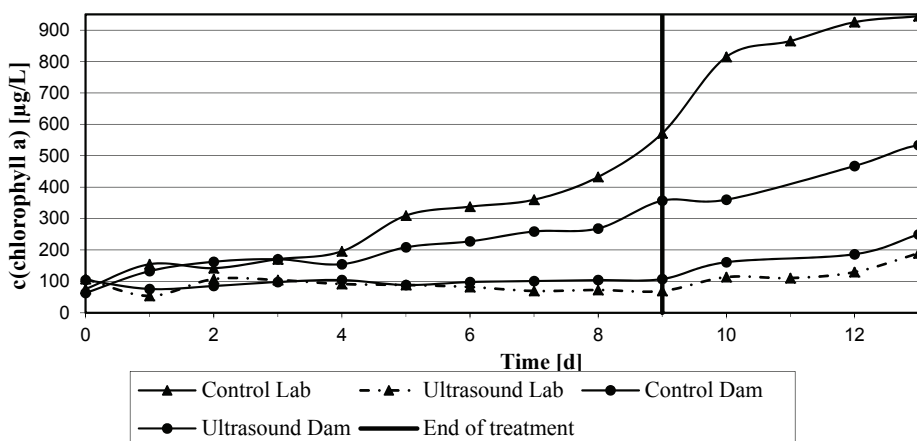
Figure 4
Chlorophyll-a concentration during and after ultrasonic treatment in control and treated sample of the laboratory and HB Dam *M. aeruginosa* cultures

The chlorophyll-*a* concentration was measured to determine the photosynthetic activity of *M. aeruginosa*. The concentration of chlorophyll-*a* in the control HB Dam culture increased continuously from about 60 µg/l at the start of the experiment to about 350 µg/l at Day 9 (Fig. 4). In the treated basin a small decrease of chlorophyll-*a* was observed during the first day in the treated HB Dam culture, which was followed by an increase to about 107 µg/l after 4 d. During the remaining days the concentration remained nearly constant. It was therefore concluded that the ultrasonic treatment had an influence on *M. aeruginosa*, resulting in inhibition of chlorophyll-*a*

formation and thereby also growth of the *M. aeruginosa* culture. The chlorophyll-*a* concentration of the laboratory culture control increased during the experiment, from 75.78 µg/l on Day 1 to 560 µg/l after 9 d (Fig. 4). When the laboratory culture was treated with ultrasound the chlorophyll-*a* concentration decreased from 107.36 µg/l to 69.47 µg/l over the experimental period. This demonstrated that ultrasonic treatment also had an effect on cells that did not contain gas vacuoles. The collapse of gas vacuoles was therefore not the only cause of inhibition of *M. aeruginosa* growth under laboratory conditions. After 9 d the ultrasonic treatment was terminated and the *M. aeruginosa* cultures were tested for 4 d to determine regeneration of the cultures. The chlorophyll-*a* concentration of the laboratory culture increased from 69.47 µg/l to 189.45 µg/l after 4 d, and the HB Dam culture from 107.36 µg/l to 249.44 µg/l (Fig. 4).

Compared with the respective control, after 9 d of treatment the HB Dam culture showed a 3.3 times lower chlorophyll-*a* concentration, while the laboratory culture showed a 8.2 times lower concentration. This showed that the efficiency of ultrasound was 2.5 times higher for the laboratory culture than for the HB Dam culture. Cyanobacterial cells were, however, able to regenerate after ultrasound treatment was terminated. The chlorophyll-*a* concentrations in both treated samples increased similarly to their respective controls during the first days of the experiment. After the treatment with ultrasound the HB Dam culture lost the gas vacuoles. This confirms the results of other studies (Ahn et al., 2003; Hao et al., 2004) which have indicated that ultrasonic treatment caused a collapse of gas vacuoles. Instead of gas vacuoles, dark membrane-like structures were observed in the treated samples and these were suspected to be the vestiges of the collapsed gas vacuoles.

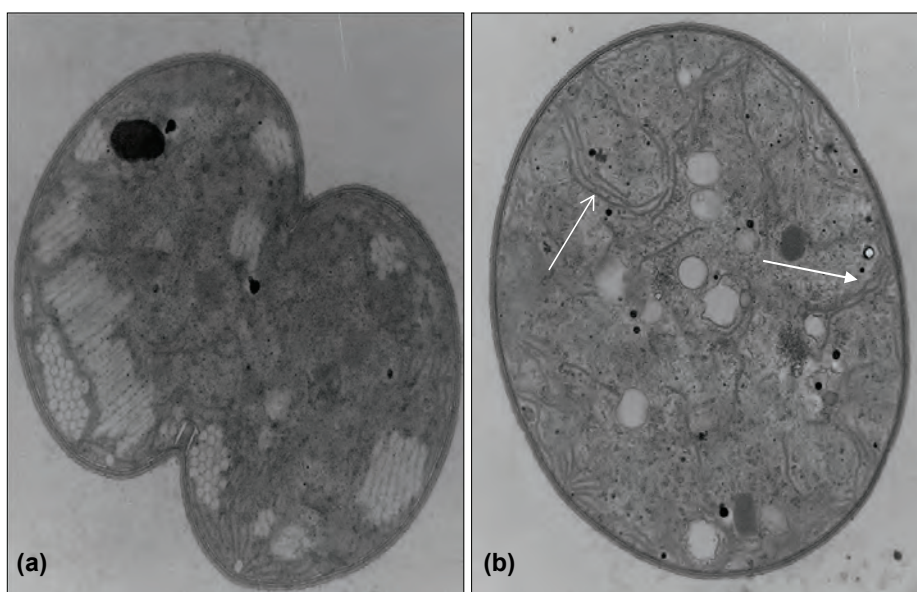
Figure 5 (left)
TEM pictures of *M. aeruginosa* HB Dam cell (a) before treatment (b) after treatment; arrows indicate membrane-like structures only observed in treated cells

After ultrasonic treatment for 9 d, samples of the control and of the treated samples were prepared for transmission electron microscopy (TEM). In contrast to the control the cells of the treated HB Dam sample showed no gas vacuoles (Fig. 5a). Instead, long, thin, dark, membrane-like structures could be observed, which may represent membranes of collapsed gas vacuoles (Fig. 5b). The transmission electron microscopy (TEM) images for the laboratory culture showed that cell membranes were ruptured after the treatment (Figs. 6a and 6b). This was not observed in the HB Dam culture.

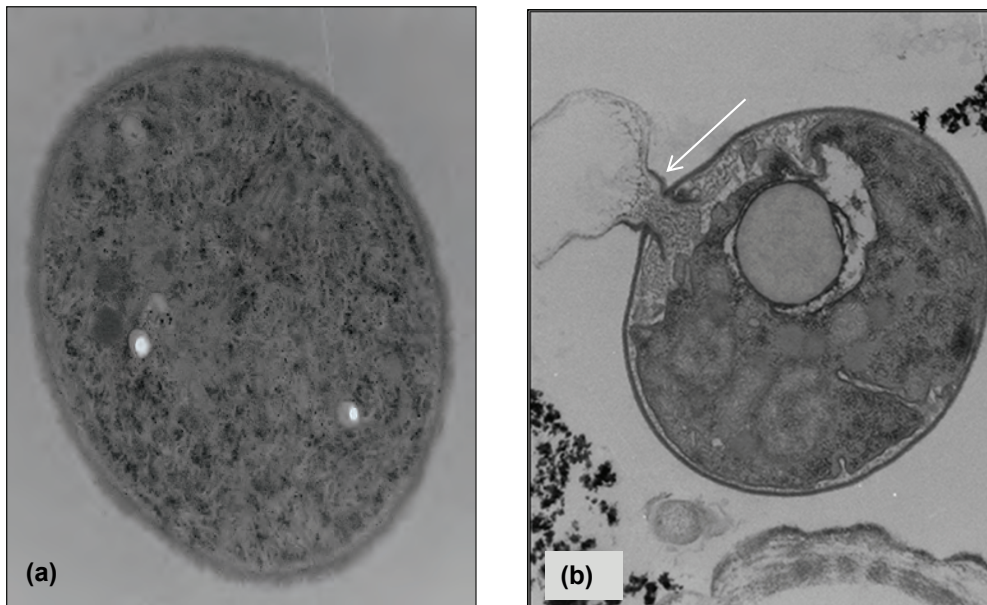
Figure 6
TEM pictures of *M. aeruginosa* laboratory culture (a) before treatment (b) after treatment with broken cell membranes; arrow indicates broken membranes

The treated sample of the laboratory culture showed a high incidence of membrane-damaged cells, which was not observed in the treated Dam culture. This confirmed that ultrasonic treatment can cause damage to the outer cell membrane. Damage to the outer cell membrane as a result of ultrasound treatment has been reported before (Ahn et al., 2003). However, no prior study evaluated the influence on a culture of *M. aeruginosa* without gas vacuoles. Therefore, this study highlights that the range of
